Manhole Inspection Report

Date:	04/27/2018	Weather:		Coding:	RZMACP
MH#:	M-606-008	Owner:	NA	Len. Surveyed:	7.1
P.O.#:		Surveyor:	Jen Costello	Rim to Invert:	8.2
Customer:		Cert. #:	U-907-5518	Wall Material:	Concrete (reinforced)

Street:	8th St. 188' East of 8th Pl.	Project:	Hobart, IN
City:	Hobart, IN	GPS Northing:	2904132.659
Location:		GPS Easting:	2904132.659
Drain Area:	Southwest	GPS Accuracy:	Sub-Meter
Cover Shape:	Circular	Evidence of Surcharge:	No
Cover Size:	22.5	Potential for Runoff:	None
Comments:

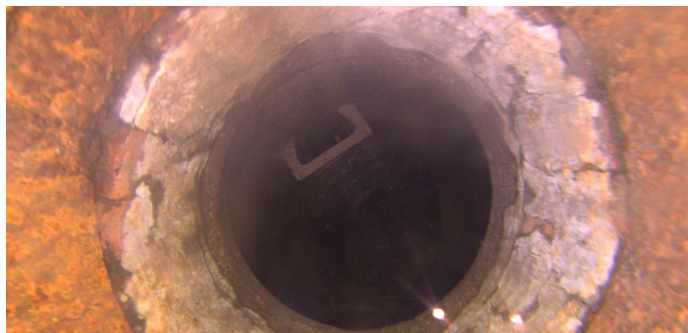
Code: **MGO**
Description: **General Observation**

Distance (ft): **.0**
Structural Grade: **0**
O&M Grade: **0**
Clock Start/From:
Clock To:
1st Value:
2nd Value:
Value Percent:
Step: **NO**
Remarks: **access MH**

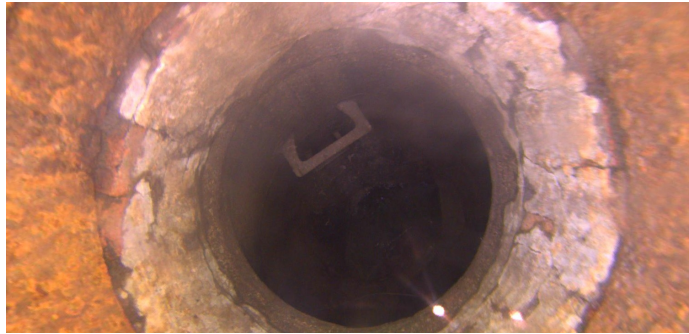
Code: **FM**
Description: **Fracture Multiple**

Distance (ft): **.0**
Structural Grade: **4**
O&M Grade: **0**
Clock Start/From: **12**
Clock To: **12**
1st Value:
2nd Value:
Value Percent:
Step: **NO**
Remarks:

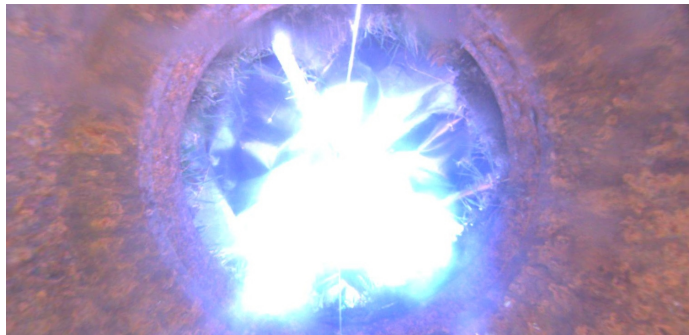
Code: **MGP**
Description: **General Photo**

Distance (ft): **2.0**
Structural Grade: **0**
O&M Grade: **0**
Clock Start/From:
Clock To:
1st Value:
2nd Value:
Value Percent:
Step: **NO**
Remarks: **UNDERSIDE OF FRAME**

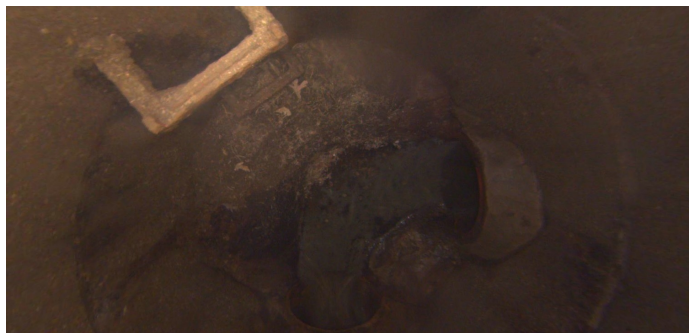
Code: **IW**
Description: **Infil Weeper**

Distance (ft): **4.1**
Structural Grade: **0**
O&M Grade: **2**
Clock Start/From: **8**
Clock To: **9**
1st Value:
2nd Value:
Value Percent:
Step: **NO**
Remarks:

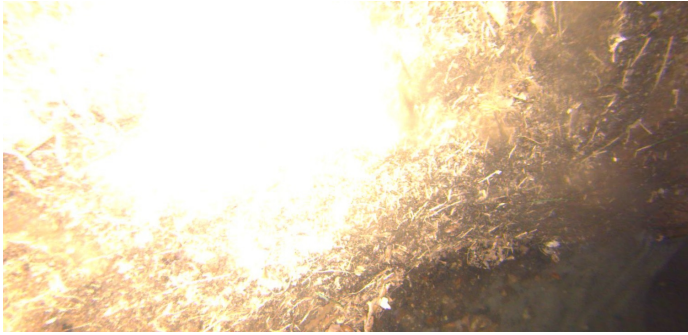
Code:	MGO
Description:	General Observation
Distance (ft):	7.1
Structural Grade:	0
O&M Grade:	0
Clock Start/From:	
Clock To:	
1st Value:	
2nd Value:	
Value Percent:	
Step:	NO
Remarks:	END SURVEY
