# Manhole Inspection Report

Date:	<b>04/27/2018</b>	Weather:		Coding:	<b>RZMACP</b>
MH#:	<b>M-606-010</b>	Owner:	<b>NA</b>	Len. Surveyed:	<b>7.3</b>
P.O.#:		Surveyor:	<b>Jen Costello</b>	Rim to Invert:	<b>8.3</b>
Customer:		Cert. #:	<b>U-907-5518</b>	Wall Material:	<b>Concrete (reinforced)</b>

Street:	<b>Intersection of 8th St. and 8th Pl. to</b>	Project:	<b>Hobart, IN</b>
City:	<b>Hobart, IN</b>	GPS Northing:	<b>2903979.587</b>
Location:		GPS Easting:	<b>2903979.587</b>
Drain Area:	<b>Southwest</b>	GPS Accuracy:	<b>Sub-Meter</b>
Cover Shape:	<b>Circular</b>	Evidence of Surcharge:	<b>No</b>
Cover Size:	<b>22.5</b>	Potential for Runoff:	<b>None</b>
Comments:

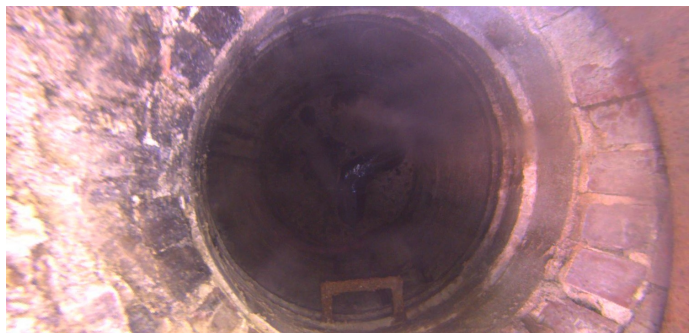
Code: **MGO**  
Description: **General Observation**

Distance (ft): **.0**  
Structural Grade: **0**  
O&M Grade: **0**  
Clock Start/From:  
Clock To:  
1st Value:  
2nd Value:  
Value Percent:  
Step: **NO**  
Remarks: **ACCESS MH**

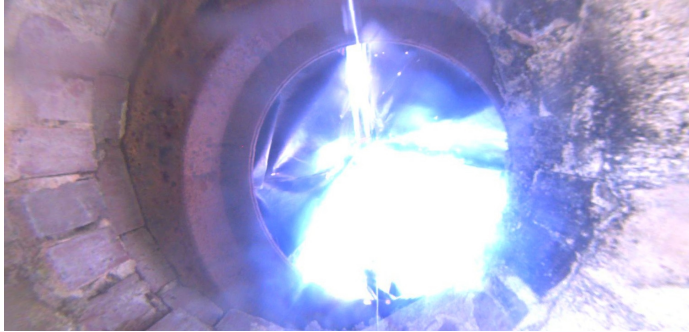
Code:	MGP
Description:	General Photo
Distance (ft):	2.5
Structural Grade:	0
O&M Grade:	0
Clock Start/From:	
Clock To:	
1st Value:	
2nd Value:	
Value Percent:	
Step:	NO
Remarks:	UNDERSIDE OF FRAME

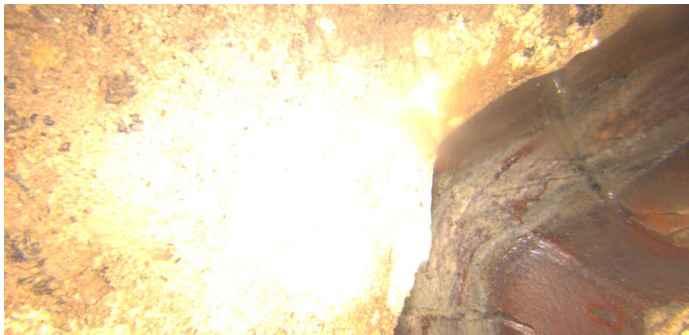
Code:	MGO
Description:	General Observation
Distance (ft):	7.3
Structural Grade:	0
O&M Grade:	0
Clock Start/From:	
Clock To:	
1st Value:	
2nd Value:	
Value Percent:	
Step:	NO
Remarks:	END SURVEY
