Manhole Inspection Report

Date:	04/27/2018	Weather:		Coding:	RZMACP
MH#:	M-606-011	Owner:	NA	Len. Surveyed:	9.6
P.O.#:		Surveyor:	Jen Costello	Rim to Invert:	10.7
Customer:		Cert. #:	U-907-5518	Wall Material:	Concrete (reinforced)

Street:	8th Pl. 255' South of 8th St.	Project:	Hobart, IN
City:	Hobart, IN	GPS Northing:	2903854.651
Location:		GPS Easting:	2903854.651
Drain Area:	Southwest	GPS Accuracy:	Sub-Meter
Cover Shape:	Circular	Evidence of Surcharge:	No
Cover Size:	22.5	Potential for Runoff:	None
Comments:

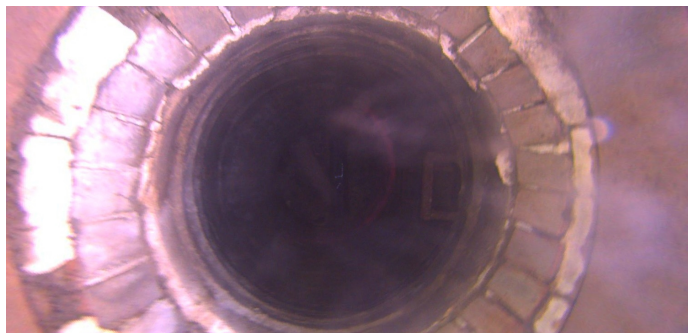
Code: **MGO**
 Description: **General Observation**

Distance (ft): **.0**
 Structural Grade: **0**
 O&M Grade: **0**
 Clock Start/From:
 Clock To:
 1st Value:
 2nd Value:
 Value Percent:
 Step: **NO**
 Remarks: **ACCESS MH**

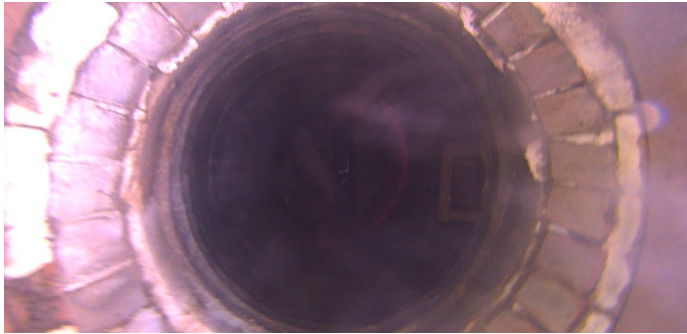
Code:	MGO
Description:	General Observation
Distance (ft):	.0
Structural Grade:	0
O&M Grade:	0
Clock Start/From:	
Clock To:	
1st Value:	
2nd Value:	
Value Percent:	
Step:	NO
Remarks:	ACCESS MH

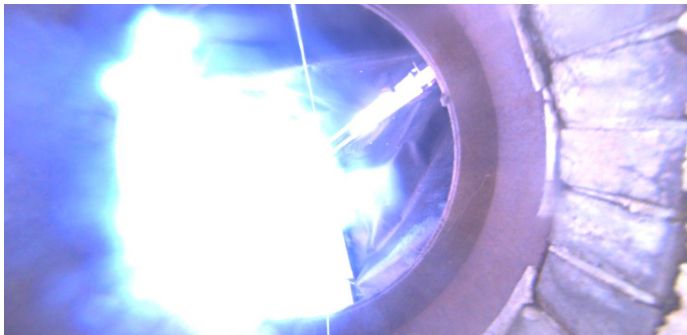
Code:	MGP
Description:	General Photo
Distance (ft):	1.9
Structural Grade:	0
O&M Grade:	0
Clock Start/From:	
Clock To:	
1st Value:	
2nd Value:	
Value Percent:	
Step:	NO
Remarks:	UNDERSIDE OF FRAME

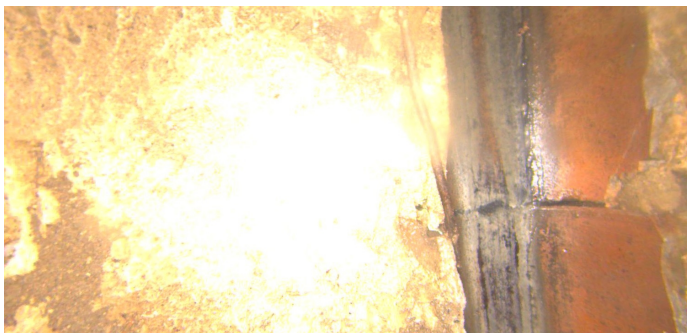
Code:	MGO
Description:	General Observation
Distance (ft):	9.6
Structural Grade:	0
O&M Grade:	0
Clock Start/From:	
Clock To:	
1st Value:	
2nd Value:	
Value Percent:	
Step:	NO
Remarks:	END SURVEY
