Manhole Inspection Report

Date:	04/24/2018	Weather:		Coding:	RZMACP
MH#:	M-606-012	Owner:	NA	Len. Surveyed:	10.5
P.O.#:		Surveyor:	John Kuglmaier	Rim to Invert:	10.6
Customer:	8.7	Cert. #:	U-1215-07002349	Wall Material:	Concrete (reinforced)

Street:	8th Pl. 478' South of 8th St.	Project:	Hobart, IN
City:	Hobart, IN	GPS Northing:	0.0
Location:		GPS Easting:	0.0
Drain Area:	Southwest	GPS Accuracy:	Nearest Meter
Cover Shape:	Circular	Evidence of Surcharge:	No
Cover Size:	22.5	Potential for Runoff:	None
Comments:

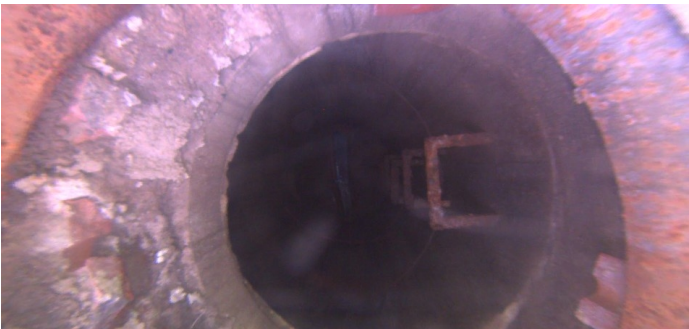
Code: **MGP**
Description: **General Photo**

Distance (ft): **.0**
Structural Grade: **0**
O&M Grade: **0**
Clock Start/From:
Clock To:
1st Value:
2nd Value:
Value Percent:
Step: **NO**
Remarks:

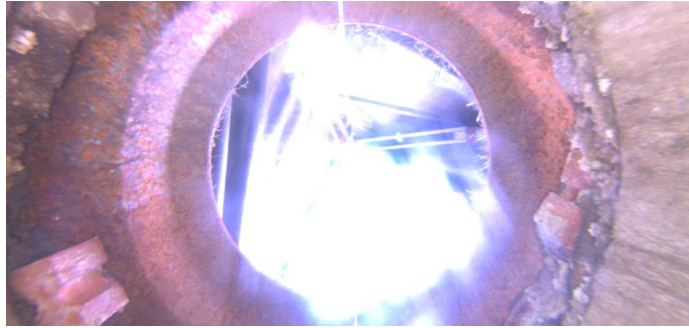
Code: **MGP**
Description: **General Photo**

Distance (ft): **2.5**
Structural Grade: **0**
O&M Grade: **0**
Clock Start/From:
Clock To:
1st Value:
2nd Value:
Value Percent:
Step: **NO**
Remarks:

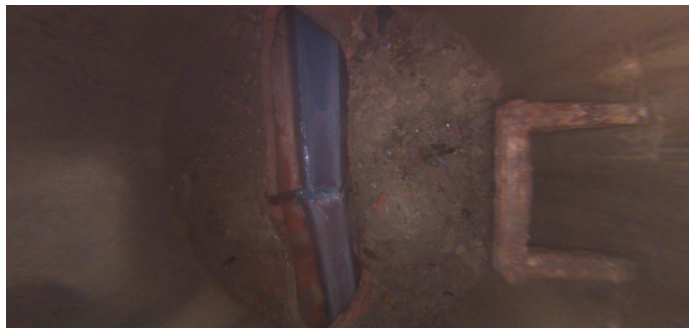
Code: **DAZ**
Description: **Deposits Attached Other**

Distance (ft): **8.2**
Structural Grade: **0**
O&M Grade: **2**
Clock Start/From: **12**
Clock To: **12**
1st Value:
2nd Value:
Value Percent: **5.000**
Step: **NO**
Remarks: **Mixed materials**

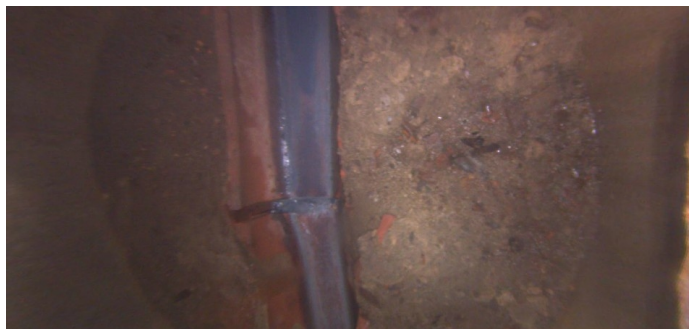
Code: **MGO**
Description: **General Observation**

Distance (ft): **9.0**
Structural Grade: **0**
O&M Grade: **0**
Clock Start/From:
Clock To:
1st Value:
2nd Value:
Value Percent:
Step: **NO**
Remarks: **Ins. Comp.**
