Manhole Inspection Report

Date:	04/24/2018	Weather:		Coding:	RZMACP
MH#:	M-606-014	Owner:	NA	Len. Surveyed:	10.9
P.O.#:		Surveyor:	John Kuglmaier	Rim to Invert:	10.8
Customer:	8.7	Cert. #:	U-1215-07002349	Wall Material:	Concrete (reinforced)

Street:	8th Pl. 148' East of Henry Ct.	Project:	Hobart, IN
City:	Hobart, IN	GPS Northing:	0.0
Location:		GPS Easting:	0.0
Drain Area:	Southwest	GPS Accuracy:	Nearest Meter
Cover Shape:	Circular	Evidence of Surcharge:	No
Cover Size:	22.5	Potential for Runoff:	None
Comments:

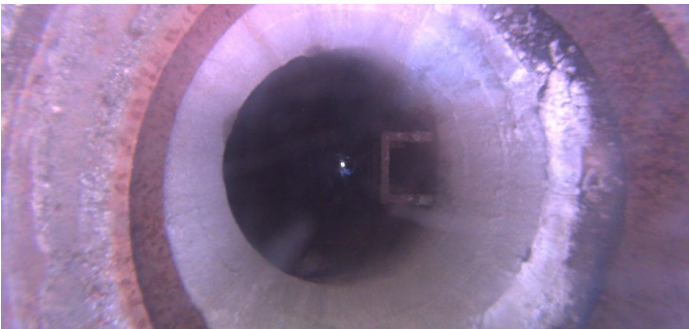
Code: **MGP**
Description: **General Photo**

Distance (ft): **.0**
Structural Grade: **0**
O&M Grade: **0**
Clock Start/From:
Clock To:
1st Value:
2nd Value:
Value Percent:
Step: **NO**
Remarks:

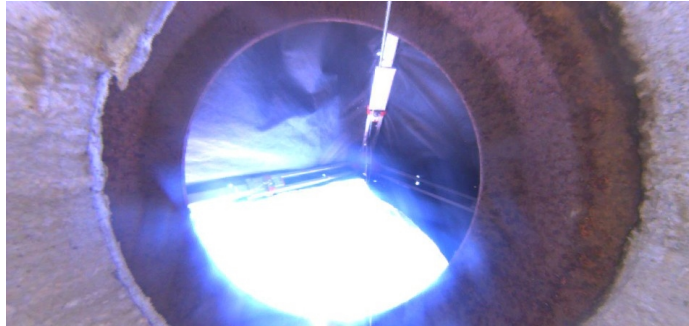
Code: **MGP**
Description: **General Photo**

Distance (ft): **2.8**
Structural Grade: **0**
O&M Grade: **0**
Clock Start/From:
Clock To:
1st Value:
2nd Value:
Value Percent:
Step: **NO**
Remarks:

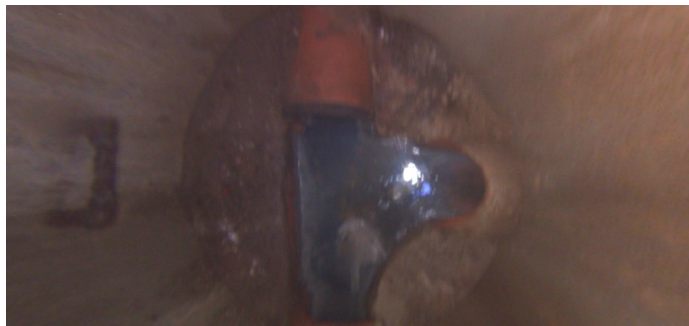
Code: **DSF**
Description: **Deposits Settled Fine**

Distance (ft): **8.5**
Structural Grade: **0**
O&M Grade: **2**
Clock Start/From: **6**
Clock To: **12**
1st Value:
2nd Value:
Value Percent: **5.000**
Step: **NO**
Remarks:

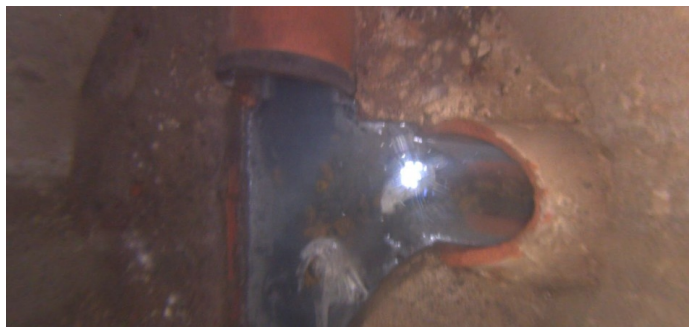
Code: **MGO**
Description: **General Observation**

Distance (ft): **9.7**
Structural Grade: **0**
O&M Grade: **0**
Clock Start/From:
Clock To:
1st Value:
2nd Value:
Value Percent:
Step: **NO**
Remarks: **Ins. Comp.**
