Manhole Inspection Report

Date:	04/27/2018	Weather:		Coding:	RZMACP
MH#:	M-606-020	Owner:	NA	Len. Surveyed:	6.3
P.O.#:		Surveyor:	Jen Costello	Rim to Invert:	6.6
Customer:		Cert. #:	U-907-5518	Wall Material:	Concrete (reinforced)

Street:	Northwest of Henry Ct. and 159' Eas	Project:	Hobart, IN
City:	Hobart, IN	GPS Northing:	2903341.247
Location:		GPS Easting:	2903341.247
Drain Area:	Southwest	GPS Accuracy:	Sub-Meter
Cover Shape:	Circular	Evidence of Surcharge:	No
Cover Size:	22.5	Potential for Runoff:	None
Comments:

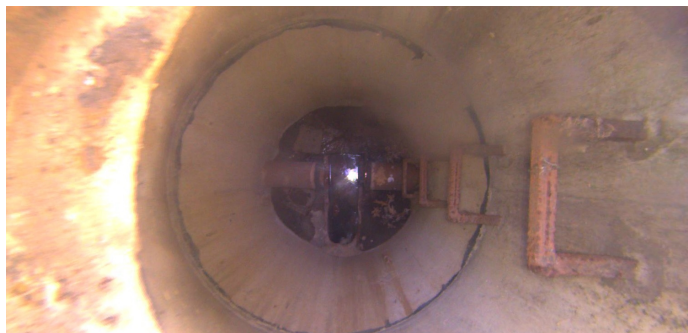
Code: **MGO**
Description: **General Observation**

Distance (ft): **.0**
Structural Grade: **0**
O&M Grade: **0**
Clock Start/From:
Clock To:
1st Value:
2nd Value:
Value Percent:
Step: **NO**
Remarks: **ACCESS MH**

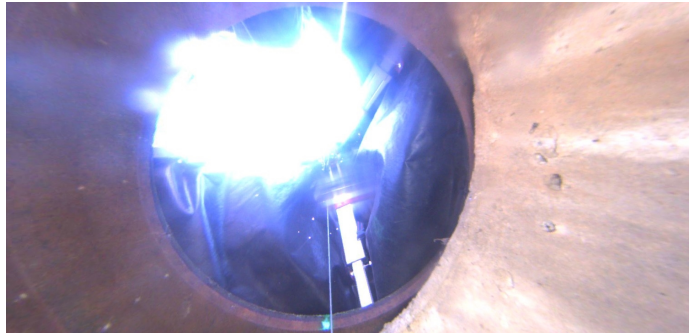
Code:	MGP
Description:	General Photo
Distance (ft):	1.4
Structural Grade:	0
O&M Grade:	0
Clock Start/From:	
Clock To:	
1st Value:	
2nd Value:	
Value Percent:	
Step:	NO
Remarks:	UNDERSIDE OF FRAME

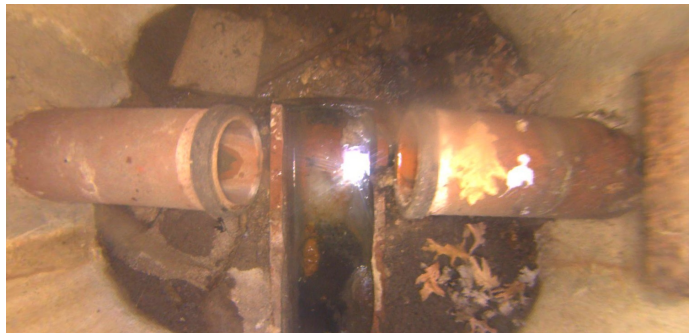
Code:	OBM
Description:	Obstacle Pipe Material
Distance (ft):	4.6
Structural Grade:	0
O&M Grade:	2
Clock Start/From:	8
Clock To:	11
1st Value:	
2nd Value:	
Value Percent:	5.000
Step:	NO
Remarks:

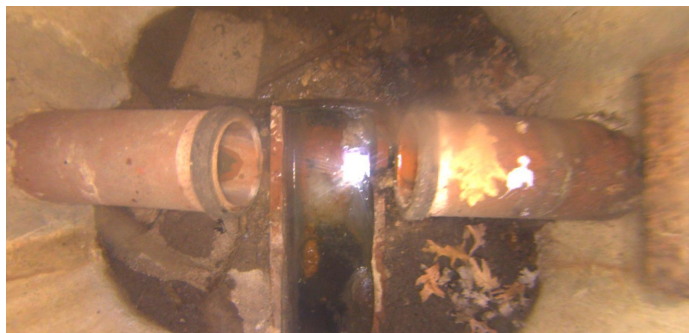
Code:	DSF
Description:	Deposits Settled Fine
Distance (ft):	4.6
Structural Grade:	0
O&M Grade:	2
Clock Start/From:	12
Clock To:	12
1st Value:	
2nd Value:	
Value Percent:	5.000
Step:	NO
Remarks:

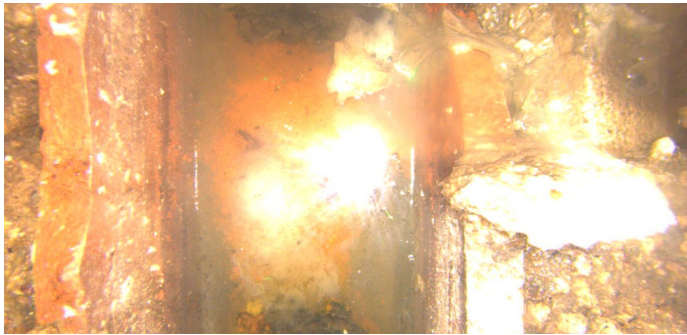
Code:	MGO
Description:	General Observation
Distance (ft):	6.3
Structural Grade:	0
O&M Grade:	0
Clock Start/From:	
Clock To:	
1st Value:	
2nd Value:	
Value Percent:	
Step:	NO
Remarks:	UNDERSIDE OF FRAME
