# Manhole Inspection Report

Date:	<b>09/25/2022</b>	Weather:		Coding:	<b>RZMACP</b>
MH#:	<b>M-606-024</b>	Owner:	<b>NA</b>	Len. Surveyed:	<b>7.9</b>
P.O.#:		Surveyor:	<b>Jen Costello</b>	Rim to Invert:	<b>11.2</b>
Customer:		Cert. #:	<b>U-907-5518</b>	Wall Material:	<b>Concrete (cast in place)</b>

Street:	<b>Intersection of 8th St. and Lake Park</b>	Project:	<b>502259S9MACP26Jan2023</b>
City:	<b>Hobart, IN</b>	GPS Northing:	<b>2904531.853</b>
Location:		GPS Easting:	<b>2904531.853</b>
Drain Area:	<b>Southeast</b>	GPS Accuracy:	<b>Sub-Meter</b>
Cover Shape:	<b>Circular</b>	Evidence of Surcharge:	<b>Yes</b>
Cover Size:	<b>24.0</b>	Potential for Runoff:	<b>None</b>
Comments:

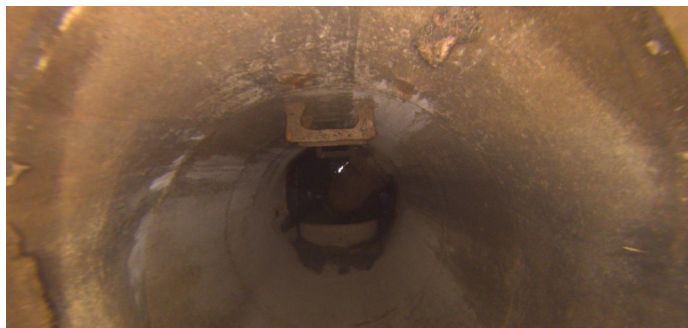
Code: **MGO**  
Description: **General Observation**

Distance (ft): **.0**  
Structural Grade: **0**  
O&M Grade: **0**  
Clock Start/From:  
Clock To:  
1st Value:  
2nd Value:  
Value Percent:  
Step: **NO**  
Remarks: **access mh**

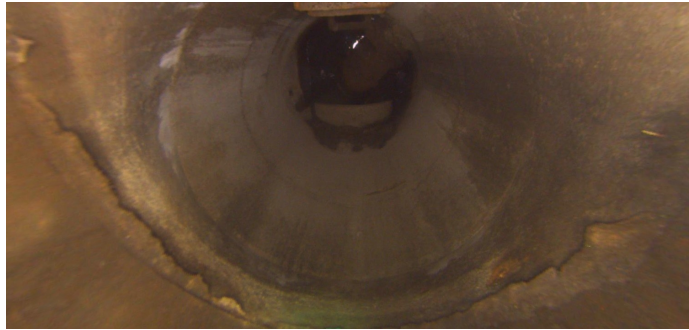
Code: **ISGT**  
Description: **Intruding Sealing Grout**

Distance (ft): **.0**  
Structural Grade: **0**  
O&M Grade: **2**  
Clock Start/From: **3**  
Clock To: **9**  
1st Value:  
2nd Value:  
Value Percent: **5.000**  
Step: **NO**  
Remarks:

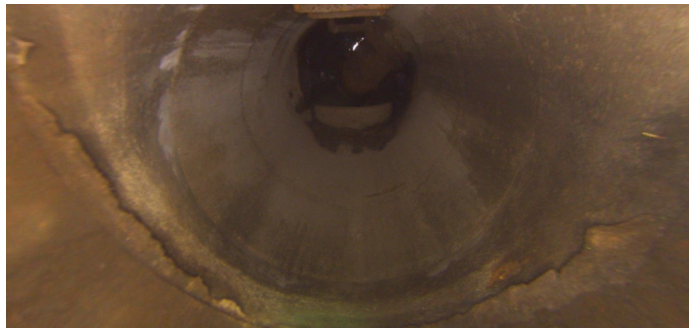
Code: **SRI**  
Description: **Surface Roughness Increased**

Distance (ft): **.0**  
Structural Grade: **1**  
O&M Grade: **0**  
Clock Start/From: **12**  
Clock To: **12**  
1st Value:  
2nd Value:  
Value Percent:  
Step: **NO**  
Remarks:

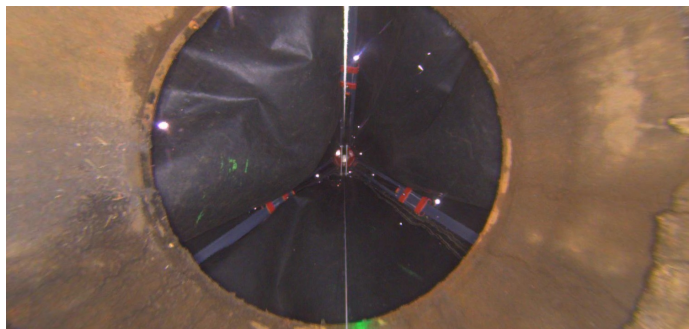
Code: **MGO**  
Description: **General Observation**

Distance (ft): **1.7**  
Structural Grade: **0**  
O&M Grade: **0**  
Clock Start/From:  
Clock To:  
1st Value:  
2nd Value:  
Value Percent:  
Step: **NO**  
Remarks: **underside of frame**

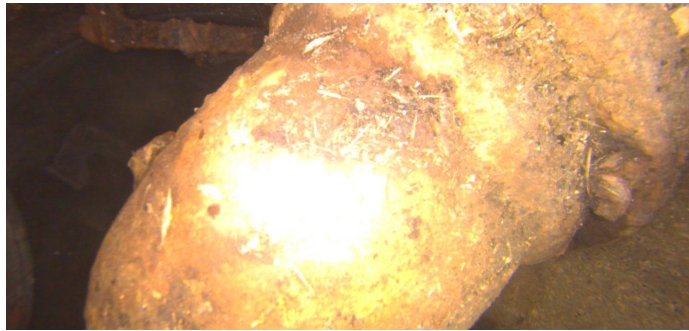
Code: **MGO**  
Description: **General Observation**

Distance (ft): **7.9**  
Structural Grade: **0**  
O&M Grade: **0**  
Clock Start/From:  
Clock To:  
1st Value:  
2nd Value:  
Value Percent:  
Step: **NO**  
Remarks: **end of survey**

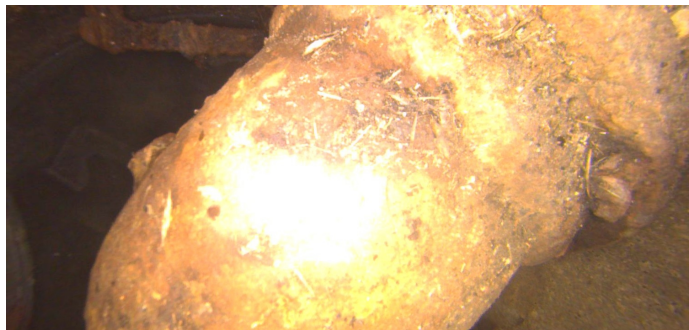
Code: **MGO**  
Description: **General Observation**

Distance (ft): **7.9**  
Structural Grade: **0**  
O&M Grade: **0**  
Clock Start/From:  
Clock To:  
1st Value:  
2nd Value:  
Value Percent:  
Step: **NO**  
Remarks: **doesnt reach bottom**

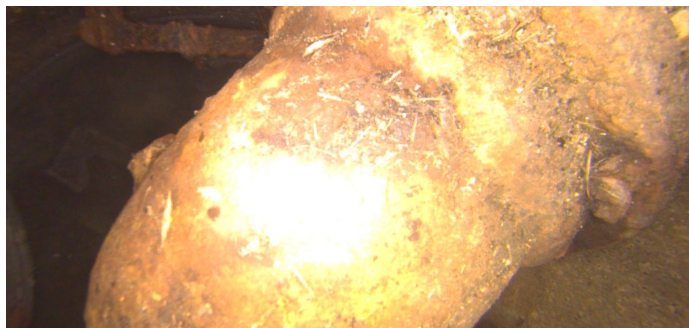
Code: **SRI**  
Description: **Surface Roughness Increased**

Distance (ft): **7.9**  
Structural Grade: **1**  
O&M Grade: **0**  
Clock Start/From: **12**  
Clock To: **12**  
1st Value:  
2nd Value:  
Value Percent:  
Step: **NO**  
Remarks:

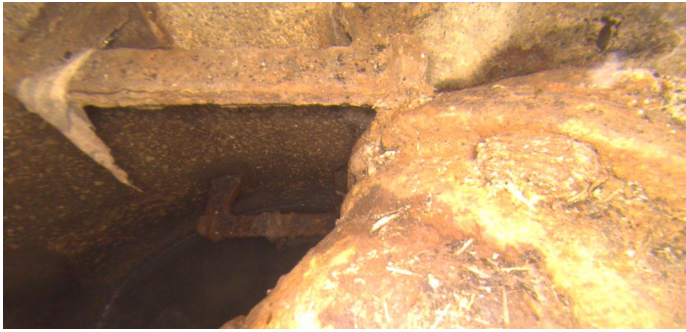
Code:	<b>DAR</b>
Description:	<b>Deposits Attached Ragging</b>
Distance (ft):	<b>7.9</b>
Structural Grade:	<b>0</b>
O&M Grade:	<b>2</b>
Clock Start/From:	<b>11</b>
Clock To:	
1st Value:	
2nd Value:	
Value Percent:	<b>5.000</b>
Step:	<b>YES</b>
Remarks:

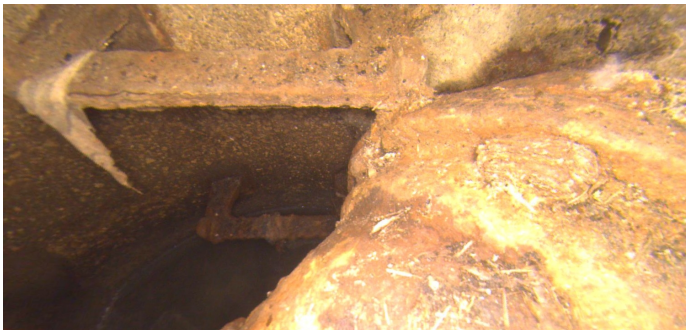
Code:	<b>SAV</b>
Description:	<b>Surface Aggregate Visible</b>
Distance (ft):	<b>7.9</b>
Structural Grade:	<b>3</b>
O&M Grade:	<b>0</b>
Clock Start/From:	<b>12</b>
Clock To:	<b>12</b>
1st Value:	
2nd Value:	
Value Percent:	
Step:	<b>NO</b>
Remarks:
