# Manhole Inspection Report

Date:	<b>04/27/2018</b>	Weather:		Coding:	<b>RZMACP</b>
MH#:	<b>M-606-025</b>	Owner:	<b>NA</b>	Len. Surveyed:	<b>11.8</b>
P.O.#:		Surveyor:	<b>Jen Costello</b>	Rim to Invert:	<b>12.3</b>
Customer:		Cert. #:	<b>U-907-5518</b>	Wall Material:	<b>Concrete (reinforced)</b>

Street:	<b>Lake Park Ave. 262' South of 8th St.</b>	Project:	<b>Hobart, IN</b>
City:	<b>Hobart, IN</b>	GPS Northing:	<b>2904524.884</b>
Location:		GPS Easting:	<b>2904524.884</b>
Drain Area:	<b>Southeast</b>	GPS Accuracy:	<b>Sub-Meter</b>
Cover Shape:	<b>Circular</b>	Evidence of Surcharge:	<b>No</b>
Cover Size:	<b>22.5</b>	Potential for Runoff:	<b>None</b>
Comments:

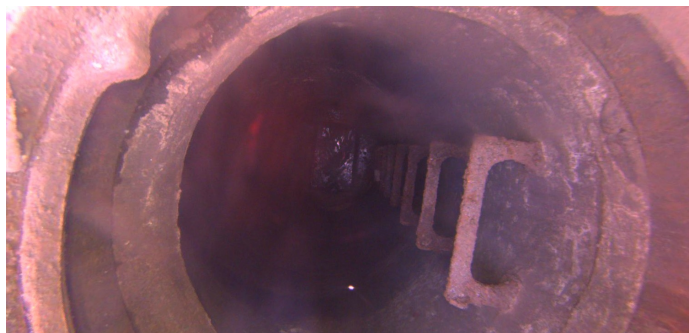
Code: **MGO**  
Description: **General Observation**

Distance (ft): **.0**  
Structural Grade: **0**  
O&M Grade: **0**  
Clock Start/From:  
Clock To:  
1st Value:  
2nd Value:  
Value Percent:  
Step: **NO**  
Remarks: **ACCESS MH**

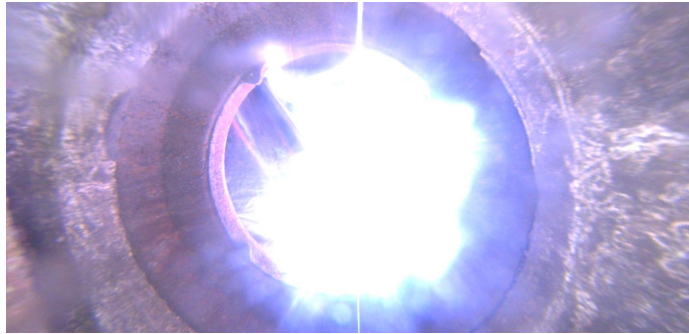
Code:	MGP
Description:	General Photo
Distance (ft):	2.0
Structural Grade:	0
O&M Grade:	0
Clock Start/From:	
Clock To:	
1st Value:	
2nd Value:	
Value Percent:	
Step:	NO
Remarks:	UNDERSIDE OF FRAME

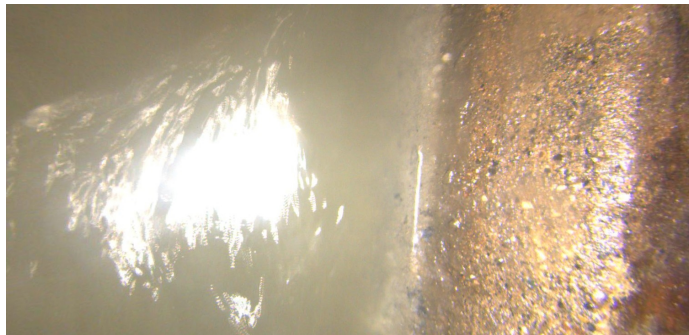
Code:	MGO
Description:	General Observation
Distance (ft):	11.8
Structural Grade:	0
O&M Grade:	0
Clock Start/From:	
Clock To:	
1st Value:	
2nd Value:	
Value Percent:	
Step:	NO
Remarks:	END SURVEY
