Manhole Inspection Report

Date:	04/26/2018	Weather:		Coding:	RZMACP
MH#:	M-606-027	Owner:	NA	Len. Surveyed:	13.6
P.O.#:		Surveyor:	Jen Costello	Rim to Invert:	13.4
Customer:		Cert. #:	U-907-5518	Wall Material:	Concrete (reinforced)

Street:	Lake Park Ave. 523' North of 10th St.	Project:	Hobart, IN
City:	Hobart, IN	GPS Northing:	2904537.401
Location:		GPS Easting:	2904537.401
Drain Area:	Southeast	GPS Accuracy:	Sub-Meter
Cover Shape:	Circular	Evidence of Surcharge:	No
Cover Size:	22.5	Potential for Runoff:	None
Comments:

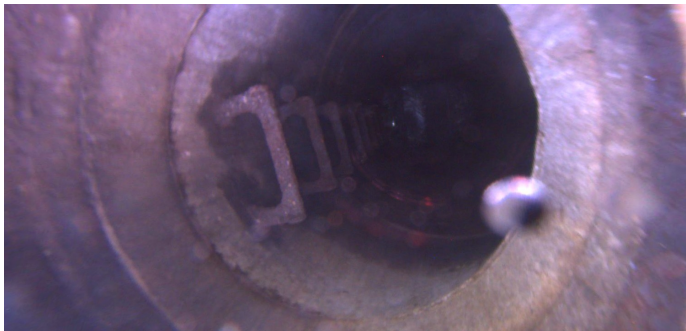
Code:	MGO
Description:	General Observation

Distance (ft):	.7
Structural Grade:	0
O&M Grade:	0
Clock Start/From:	
Clock To:	
1st Value:	
2nd Value:	
Value Percent:	
Step:	NO
Remarks:	AC

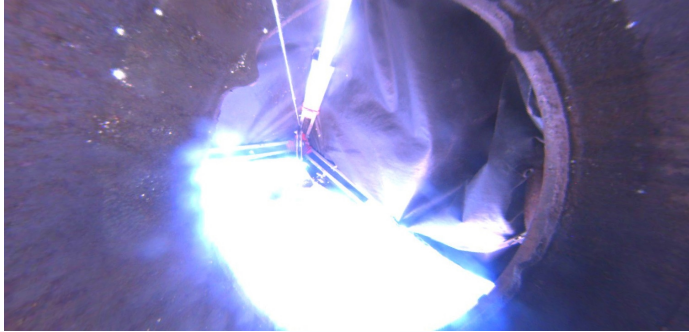
Code:	MGO
Description:	General Observation
Distance (ft):	1.9
Structural Grade:	0
O&M Grade:	0
Clock Start/From:	
Clock To:	
1st Value:	
2nd Value:	
Value Percent:	
Step:	NO
Remarks:	UNDERSIDE OF FRAME
