Manhole Inspection Report

Date:	04/26/2018	Weather:		Coding:	RZMACP
MH#:	M-606-028	Owner:	NA	Len. Surveyed:	11.8
P.O.#:		Surveyor:	Jen Costello	Rim to Invert:	12.7
Customer:		Cert. #:	U-907-5518	Wall Material:	Concrete (reinforced)

Street:	Lake Park Ave. 264' North of 10th St.	Project:	Hobart, IN
City:	Hobart, IN	GPS Northing:	0.0
Location:		GPS Easting:	0.0
Drain Area:	Southeast	GPS Accuracy:	Nearest Meter
Cover Shape:	Circular	Evidence of Surcharge:	No
Cover Size:	22.5	Potential for Runoff:	None
Comments:

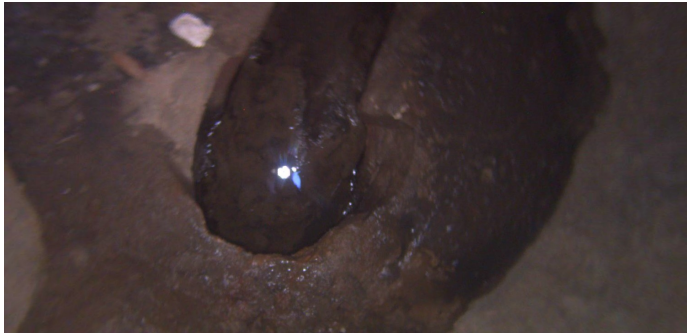
Code: **DSF**
Description: **Deposits Settled Fine**

Distance (ft): **10.6**
Structural Grade: **0**
O&M Grade: **2**
Clock Start/From: **12**
Clock To: **12**
1st Value:
2nd Value:
Value Percent: **5.000**
Step: **NO**
Remarks:

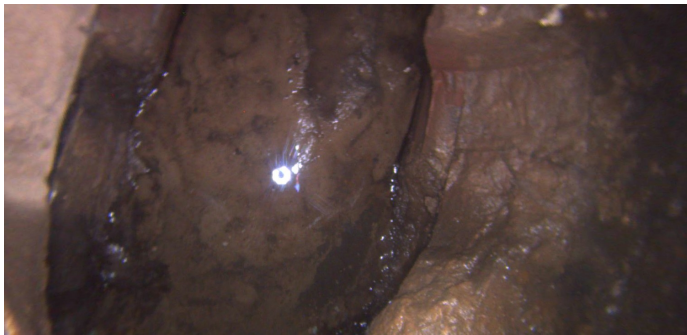
Code: **MGO**
Description: **General Observation**

Distance (ft): **11.8**
Structural Grade: **0**
O&M Grade: **0**
Clock Start/From:
Clock To:
1st Value:
2nd Value:
Value Percent:
Step: **NO**
Remarks: **END SURVEY**
