Manhole Inspection Report

Date:	04/26/2018	Weather:		Coding:	RZMACP
MH#:	M-606-028	Owner:	NA	Len. Surveyed:	13.6
P.O.#:		Surveyor:	Jen Costello	Rim to Invert:	.0
Customer:		Cert. #:	U-907-5518	Wall Material:	Concrete (reinforced)

Street:	Lake Park Ave. 264' North of 10th St.	Project:	Hobart, IN
City:	Hobart, IN	GPS Northing:	0.0
Location:		GPS Easting:	0.0
Drain Area:	Southeast	GPS Accuracy:	Nearest Meter
Cover Shape:	Circular	Evidence of Surcharge:	No
Cover Size:	22.5	Potential for Runoff:	None
Comments:

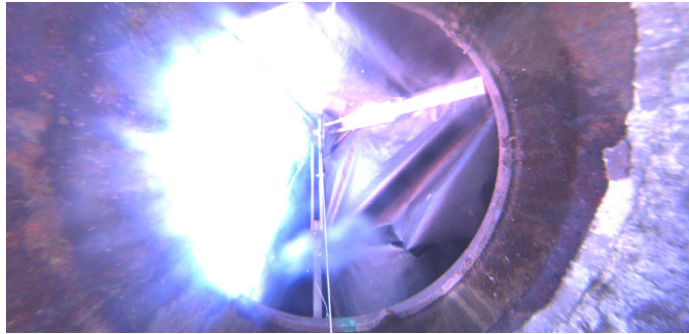
Code: **MGO**
Description: **General Observation**

Distance (ft): **1.9**
Structural Grade: **0**
O&M Grade: **0**
Clock Start/From:
Clock To:
1st Value:
2nd Value:
Value Percent:
Step: **NO**
Remarks: **UNDERSIDE OF FRAME**

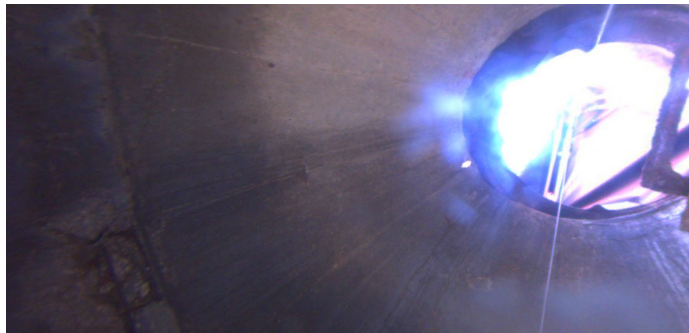
Code: **SRV**
Description: **Surface Reinforcement Visible**

Distance (ft): **5.2**
Structural Grade: **5**
O&M Grade: **0**
Clock Start/From: **4**
Clock To: **5**
1st Value:
2nd Value:
Value Percent:
Step: **NO**
Remarks:

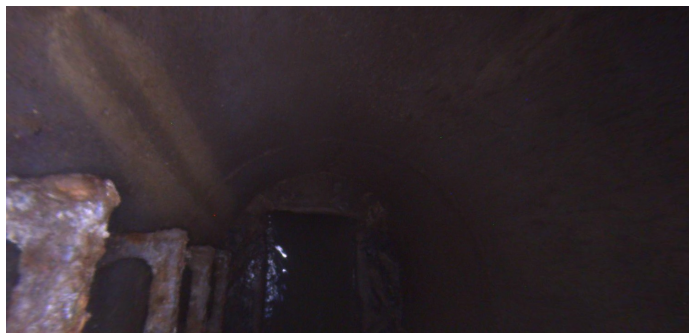
Code: **IW**
Description: **Infil Weeper**

Distance (ft): **8.0**
Structural Grade: **0**
O&M Grade: **2**
Clock Start/From: **10**
Clock To:
1st Value:
2nd Value:
Value Percent:
Step: **NO**
Remarks:

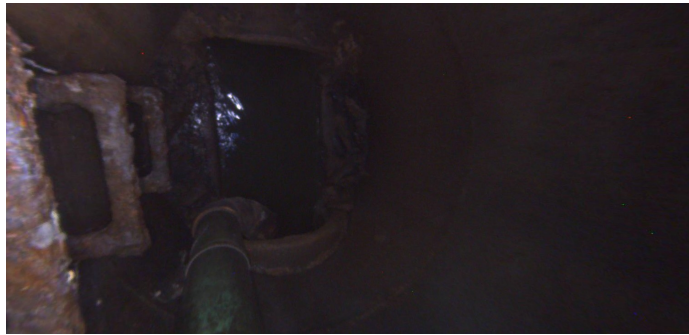
Code: **OBP**
Description: **Obstacle External Pipe or Cable**

Distance (ft): **8.9**
Structural Grade: **0**
O&M Grade: **2**
Clock Start/From: **7**
Clock To:
1st Value:
2nd Value:
Value Percent: **10.000**
Step: **NO**
Remarks:

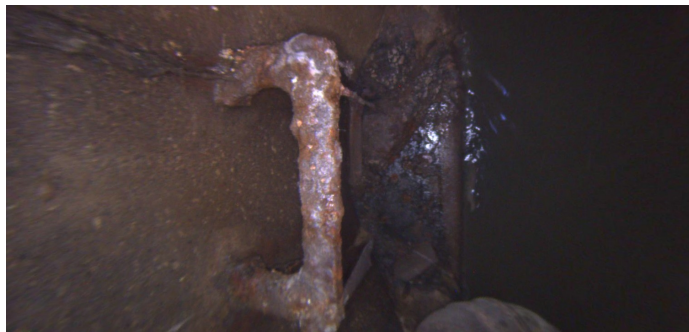
Code: **SAV**
Description: **Surface Aggregate Visible**

Distance (ft): **11.5**
Structural Grade: **3**
O&M Grade: **0**
Clock Start/From: **12**
Clock To: **12**
1st Value:
2nd Value:
Value Percent:
Step: **NO**
Remarks:

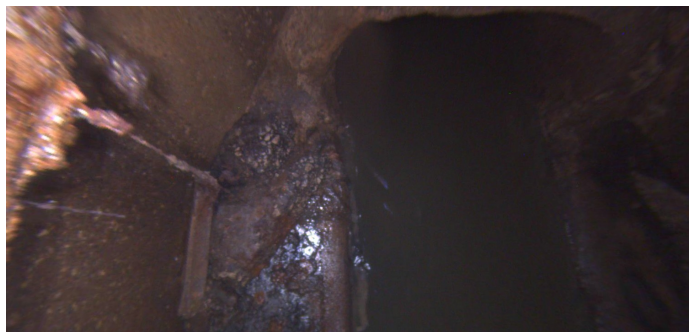
Code: **SAV**
Description: **Surface Aggregate Visible**

Distance (ft): **12.2**
Structural Grade: **3**
O&M Grade: **0**
Clock Start/From: **12**
Clock To: **12**
1st Value:
2nd Value:
Value Percent:
Step: **NO**
Remarks:

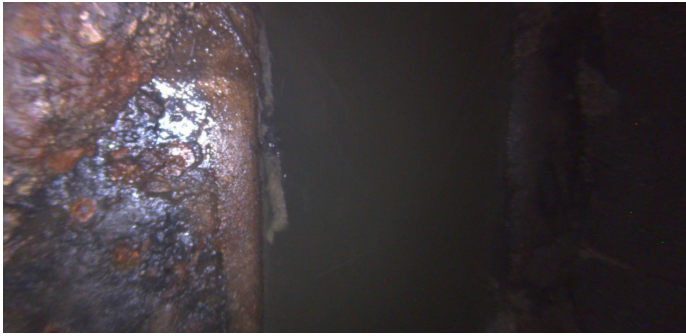
Code: **DSF**
Description: **Deposits Settled Fine**

Distance (ft): **13.0**
Structural Grade: **0**
O&M Grade: **2**
Clock Start/From: **12**
Clock To: **12**
1st Value:
2nd Value:
Value Percent: **5.000**
Step: **NO**
Remarks:
