Manhole Inspection Report

Date:	04/26/2018	Weather:		Coding:	RZMACP
MH#:	M-606-054	Owner:	NA	Len. Surveyed:	7.7
P.O.#:		Surveyor:	Jen Costello	Rim to Invert:	8.1
Customer:		Cert. #:	U-907-5518	Wall Material:	Concrete (reinforced)

Street:	Riverside Dr. 186' North of Lagoon A	Project:	Hobart, IN
City:	Hobart, IN	GPS Northing:	2903082.466
Location:		GPS Easting:	2903082.466
Drain Area:	Southwest	GPS Accuracy:	Sub-Meter
Cover Shape:	Circular	Evidence of Surcharge:	No
Cover Size:	22.5	Potential for Runoff:	None
Comments:

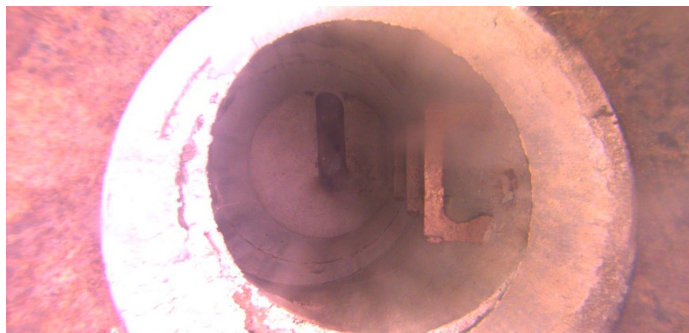
Code: **MGO**
Description: **General Observation**

Distance (ft): **.0**
Structural Grade: **0**
O&M Grade: **0**
Clock Start/From:
Clock To:
1st Value:
2nd Value:
Value Percent:
Step: **NO**
Remarks: **ACCESS MH**

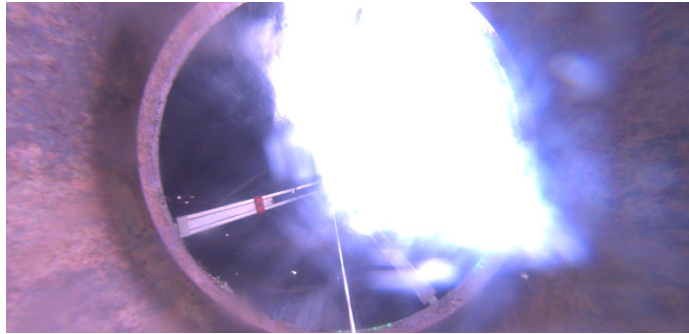
Code:	MGO
Description:	General Observation
Distance (ft):	1.5
Structural Grade:	0
O&M Grade:	0
Clock Start/From:	
Clock To:	
1st Value:	
2nd Value:	
Value Percent:	
Step:	NO
Remarks:	UNDERSIDE OF FRAME

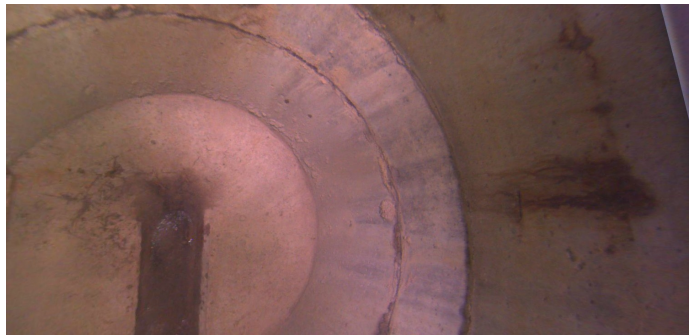
Code:	IW
Description:	Infil Weeper
Distance (ft):	3.0
Structural Grade:	0
O&M Grade:	2
Clock Start/From:	3
Clock To:	
1st Value:	
2nd Value:	
Value Percent:	
Step:	NO
Remarks:

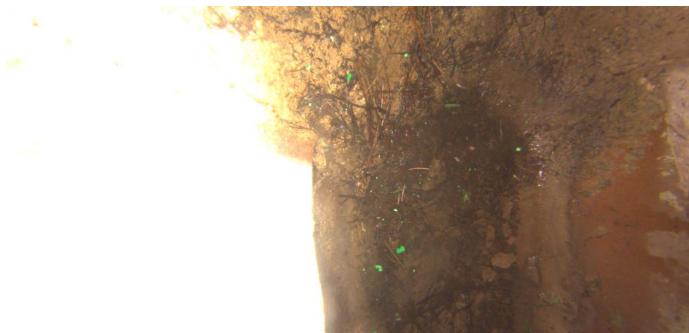
Code:	MGO
Description:	General Observation
Distance (ft):	7.7
Structural Grade:	0
O&M Grade:	0
Clock Start/From:	
Clock To:	
1st Value:	
2nd Value:	
Value Percent:	
Step:	NO
Remarks:	END SURVEY
