Manhole Inspection Report

Date:	09/29/2022	Weather:		Coding:	RZMACP
MH#:	M-606-057	Owner:	NA	Len. Surveyed:	17.4
P.O.#:		Surveyor:	Jen Costello	Rim to Invert:	19.3
Customer:		Cert. #:	U-907-5518	Wall Material:	Concrete (cast in place)

Street:	Intersection of 8th St. and Glendale	Project:	Hobart, IN
City:	Hobart, IN	GPS Northing:	2286501.632
Location:	Local Rural Streets	GPS Easting:	2902195.933
Drain Area:	Southwest	GPS Accuracy:	Sub-Meter
Cover Shape:	Circular	Evidence of Surcharge:	No
Cover Size:	24.0	Potential for Runoff:	None
Comments:

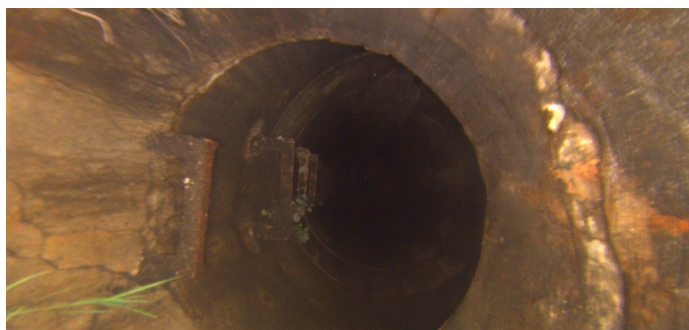
Code: **MGO**
Description: **General Observation**

Distance (ft): **.0**
Structural Grade: **0**
O&M Grade: **0**
Clock Start/From:
Clock To:
1st Value:
2nd Value:
Value Percent:
Step: **NO**
Remarks: **access mh**

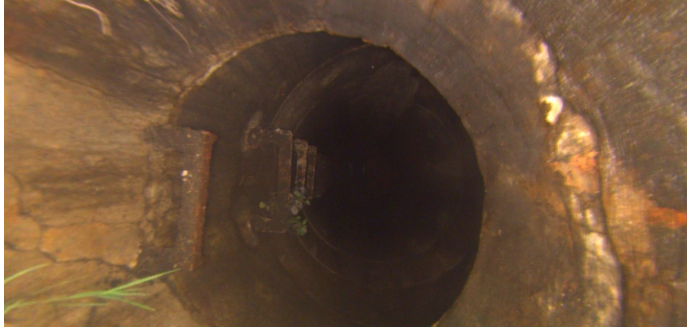
Code: **ISGT**
Description: **Intruding Sealing Grout**

Distance (ft): **.0**
Structural Grade: **0**
O&M Grade: **2**
Clock Start/From: **12**
Clock To: **5**
1st Value:
2nd Value:
Value Percent: **5.000**
Step: **NO**
Remarks:

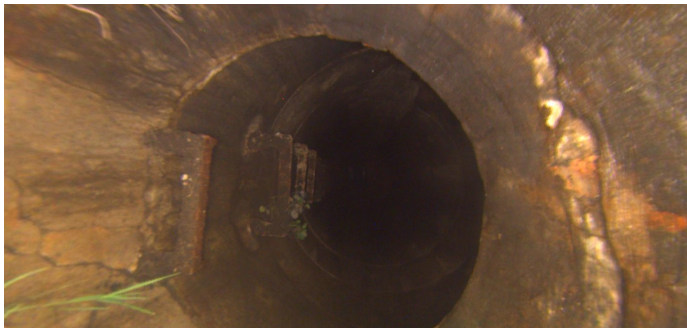
Code: **SRI**
Description: **Surface Roughness Increased**

Distance (ft): **.0**
Structural Grade: **1**
O&M Grade: **0**
Clock Start/From: **12**
Clock To: **12**
1st Value:
2nd Value:
Value Percent:
Step: **NO**
Remarks:

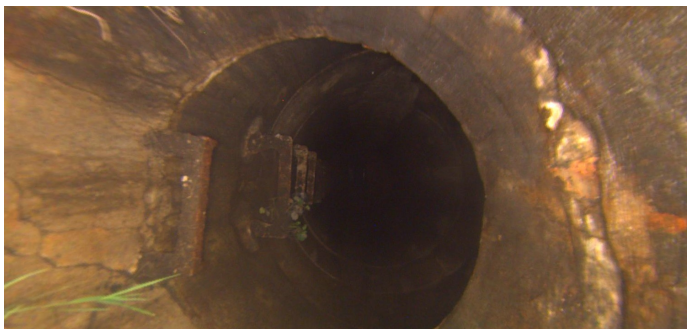
Code: **FM**
Description: **Fracture Multiple**

Distance (ft): **.0**
Structural Grade: **4**
O&M Grade: **0**
Clock Start/From: **6**
Clock To: **12**
1st Value:
2nd Value:
Value Percent:
Step: **NO**
Remarks:

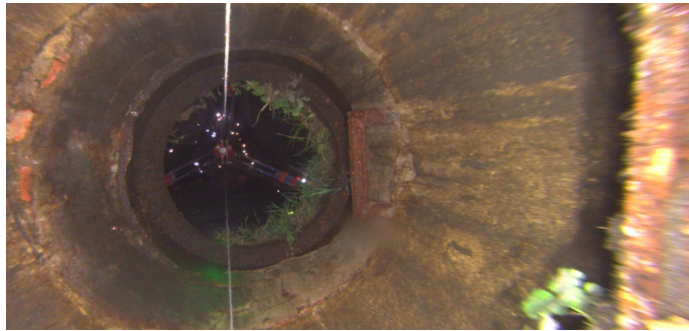
Code: **MGO**
Description: **General Observation**

Distance (ft): **3.3**
Structural Grade: **0**
O&M Grade: **0**
Clock Start/From:
Clock To:
1st Value:
2nd Value:
Value Percent:
Step: **NO**
Remarks: **underside of frame**

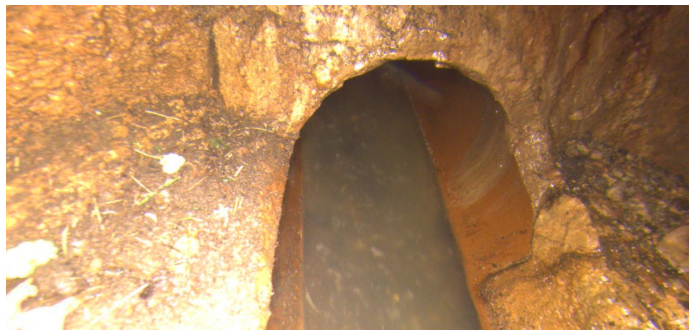
Code: **DAE**
Description: **Deposits Attached Encrustation**

Distance (ft): **17.4**
Structural Grade: **0**
O&M Grade: **2**
Clock Start/From: **12**
Clock To: **12**
1st Value:
2nd Value:
Value Percent: **5.000**
Step: **NO**
Remarks:

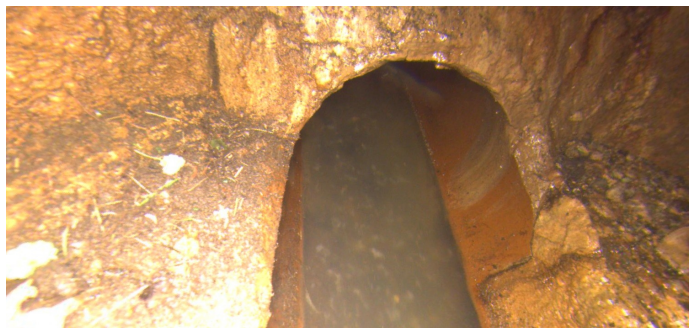
Code: **IW**
Description: **Infil Weeper**

Distance (ft): **17.4**
Structural Grade: **0**
O&M Grade: **2**
Clock Start/From: **12**
Clock To: **12**
1st Value:
2nd Value:
Value Percent:
Step: **NO**
Remarks:

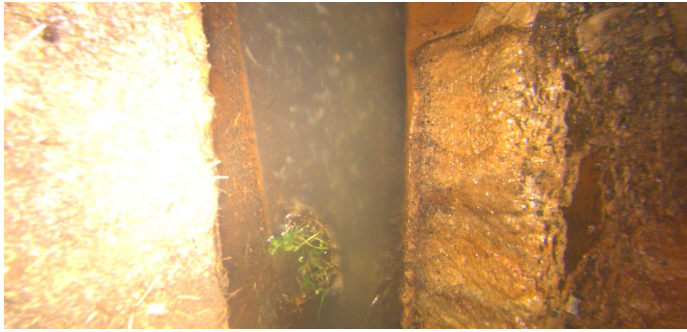
Code: **DSGV**
Description: **Deposits Settled Gravel**

Distance (ft): **17.4**
Structural Grade: **0**
O&M Grade: **2**
Clock Start/From: **12**
Clock To: **12**
1st Value:
2nd Value:
Value Percent: **5.000**
Step: **NO**
Remarks:

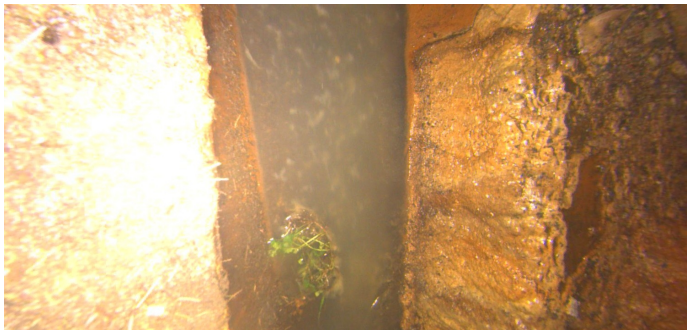
Code: **DAE**
Description: **Deposits Attached Encrustation**

Distance (ft): **17.4**
Structural Grade: **0**
O&M Grade: **2**
Clock Start/From: **3**
Clock To: **5**
1st Value:
2nd Value:
Value Percent: **10.000**
Step: **NO**
Remarks:

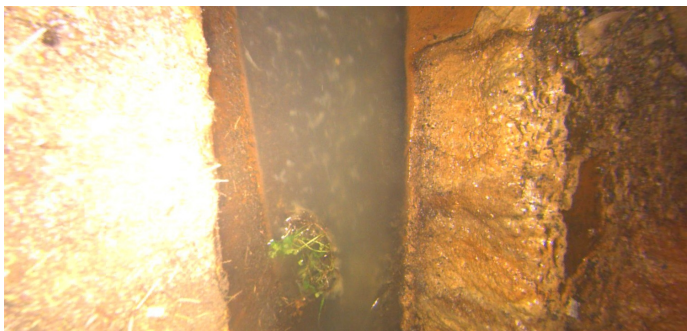
Code: **SRI**
Description: **Surface Roughness Increased**

Distance (ft): **17.4**
Structural Grade: **1**
O&M Grade: **0**
Clock Start/From: **12**
Clock To: **12**
1st Value:
2nd Value:
Value Percent:
Step: **NO**
Remarks:

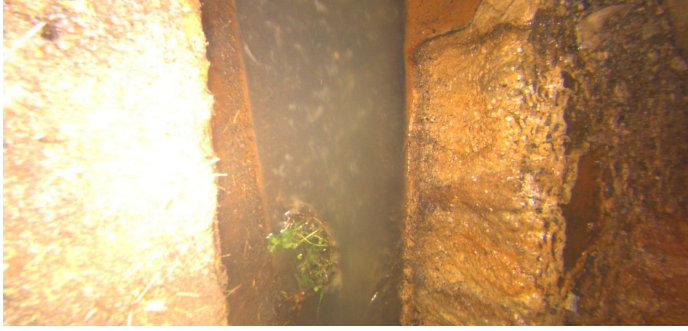
Code:	MGO
Description:	General Observation
Distance (ft):	17.4
Structural Grade:	0
O&M Grade:	0
Clock Start/From:	
Clock To:	
1st Value:	
2nd Value:	
Value Percent:	
Step:	NO
Remarks:	end of survey
