Manhole Inspection Report

Date:	09/28/2022	Weather:		Coding:	RZMACP
MH#:	M-606-058	Owner:	NA	Len. Surveyed:	17.6
P.O.#:		Surveyor:	Jen Costello	Rim to Invert:	19.4
Customer:		Cert. #:	U-907-5518	Wall Material:	Concrete (cast in place)

Street:	8th St. 168' East of Wisconsin St.	Project:	Hobart, IN
City:	Hobart, IN	GPS Northing:	2286498.222
Location:	Yard	GPS Easting:	2902034.898
Drain Area:	Southwest	GPS Accuracy:	Sub-Meter
Cover Shape:	Circular	Evidence of Surcharge:	No
Cover Size:	24.0	Potential for Runoff:	None
Comments:

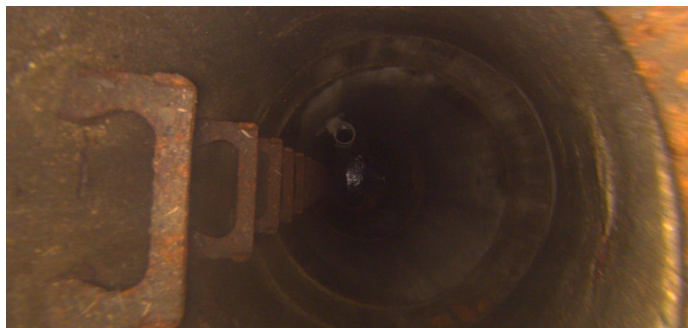
Code: **MGO**
Description: **General Observation**

Distance (ft): **.0**
Structural Grade: **0**
O&M Grade: **0**
Clock Start/From:
Clock To:
1st Value:
2nd Value:
Value Percent:
Step: **NO**
Remarks: **access mh**

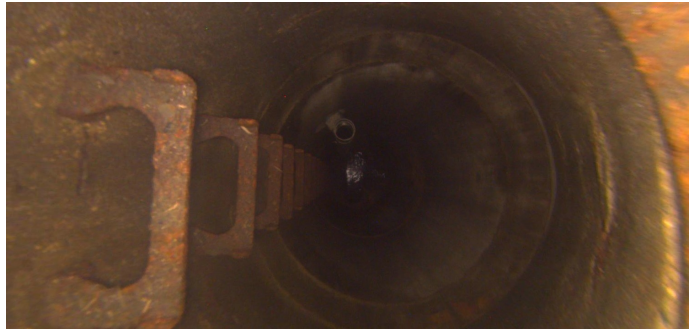
Code:	SRI
Description:	Surface Roughness Increased
Distance (ft):	.0
Structural Grade:	1
O&M Grade:	0
Clock Start/From:	12
Clock To:	12
1st Value:	
2nd Value:	
Value Percent:	
Step:	NO
Remarks:

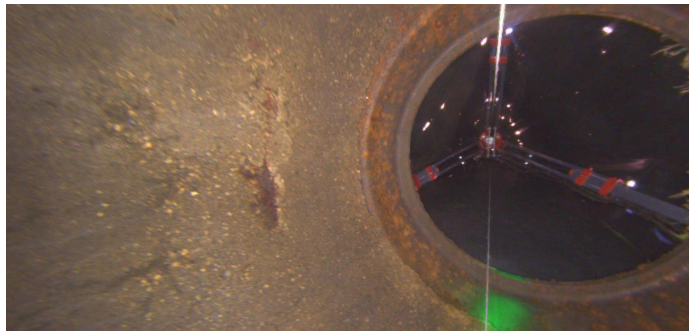
Code:	FM
Description:	Fracture Multiple
Distance (ft):	2.5
Structural Grade:	4
O&M Grade:	0
Clock Start/From:	2
Clock To:	3
1st Value:	
2nd Value:	
Value Percent:	
Step:	NO
Remarks:

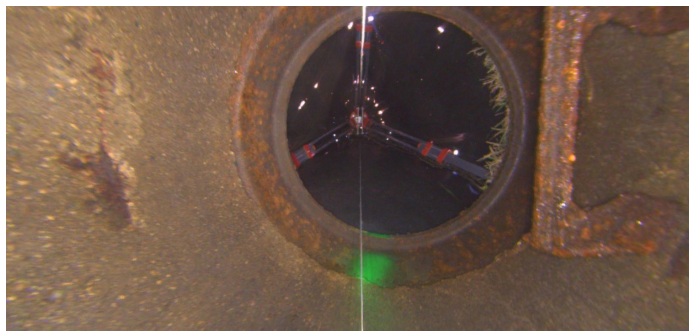
Code:	MGO
Description:	General Observation
Distance (ft):	2.5
Structural Grade:	0
O&M Grade:	0
Clock Start/From:	
Clock To:	
1st Value:	
2nd Value:	
Value Percent:	
Step:	NO
Remarks:	underside of frame

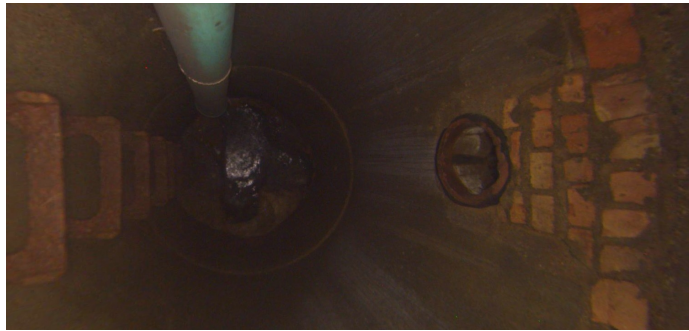
Code: **RPP**
Description: **Repair Patch**

Distance (ft): **8.9**
Structural Grade: **0**
O&M Grade: **0**
Clock Start/From: **2**
Clock To: **3**
1st Value:
2nd Value:
Value Percent:
Step: **NO**
Remarks: **brick**

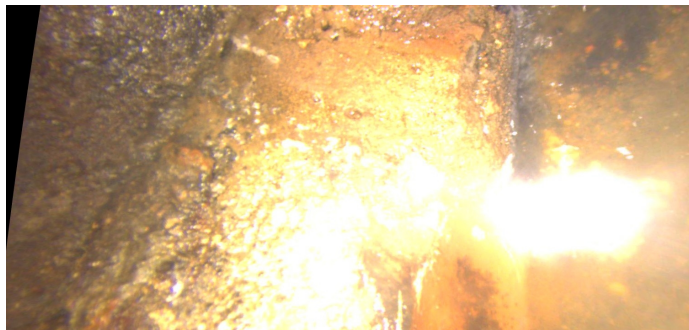
Code: **DSGV**
Description: **Deposits Settled Gravel**

Distance (ft): **17.6**
Structural Grade: **0**
O&M Grade: **2**
Clock Start/From: **12**
Clock To: **12**
1st Value:
2nd Value:
Value Percent: **5.000**
Step: **NO**
Remarks:

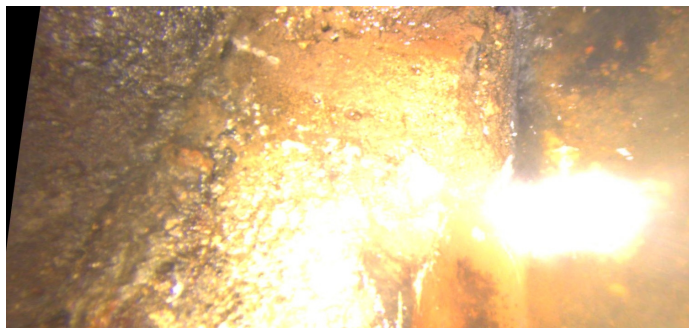
Code: **SRI**
Description: **Surface Roughness Increased**

Distance (ft): **17.6**
Structural Grade: **1**
O&M Grade: **0**
Clock Start/From: **12**
Clock To: **12**
1st Value:
2nd Value:
Value Percent:
Step: **NO**
Remarks:

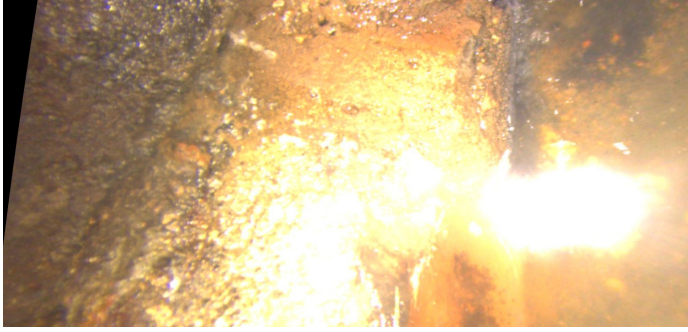
Code:	MGO
Description:	General Observation
Distance (ft):	17.6
Structural Grade:	0
O&M Grade:	0
Clock Start/From:	
Clock To:	
1st Value:	
2nd Value:	
Value Percent:	
Step:	NO
Remarks:	end of survey
