# Manhole Inspection Report

Date:	04/26/2018	Weather:		Coding:	RZMACP
MH#:	M-606-060	Owner:	NA	Len. Surveyed:	9.1
P.O.#:		Surveyor:	Jen Costello	Rim to Invert:	9.7
Customer:		Cert. #:	U-907-5518	Wall Material:	Concrete (reinforced)

Street:	North of 8th St. 50' East of Sunset St	Project:	Hobart, IN
City:	Hobart, IN	GPS Northing:	41.5259285
Location:		GPS Easting:	-87.39159393
Drain Area:	Southwest	GPS Accuracy:	Nearest Meter
Cover Shape:	Circular	Evidence of Surcharge:	No
Cover Size:	22.5	Potential for Runoff:	None
Comments:

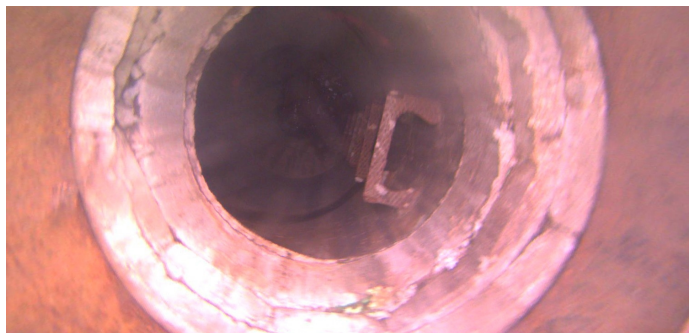
Code: **MGO**  
Description: **General Observation**

Distance (ft): **.0**  
Structural Grade: **0**  
O&M Grade: **0**  
Clock Start/From:  
Clock To:  
1st Value:  
2nd Value:  
Value Percent:  
Step: **NO**  
Remarks: **ACCESS MH**

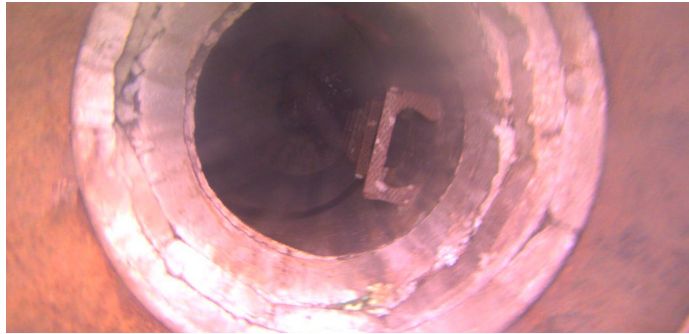
Code: **FM**  
Description: **Fracture Multiple**

Distance (ft): **.0**  
Structural Grade: **4**  
O&M Grade: **0**  
Clock Start/From: **12**  
Clock To: **12**  
1st Value:  
2nd Value:  
Value Percent:  
Step: **NO**  
Remarks:

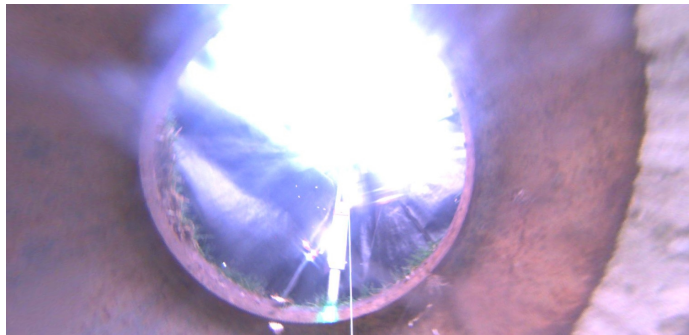
Code: **MGO**  
Description: **General Observation**

Distance (ft): **1.6**  
Structural Grade: **0**  
O&M Grade: **0**  
Clock Start/From:  
Clock To:  
1st Value:  
2nd Value:  
Value Percent:  
Step: **NO**  
Remarks: **UNDERSIDE OF FRAME**

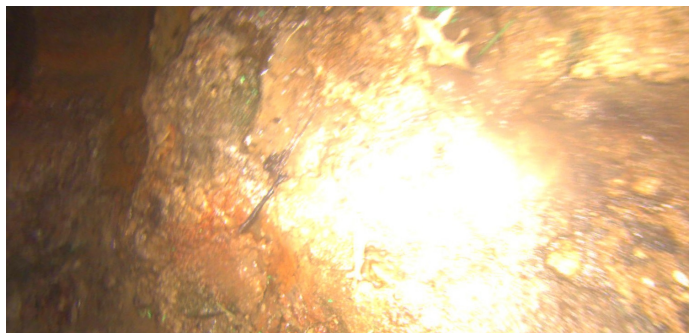
Code: **MGO**  
Description: **General Observation**

Distance (ft): **9.1**  
Structural Grade: **0**  
O&M Grade: **0**  
Clock Start/From:  
Clock To:  
1st Value:  
2nd Value:  
Value Percent:  
Step: **NO**  
Remarks: **END SURVEY**
