# Manhole Inspection Report

Date:	<b>04/27/2018</b>	Weather:		Coding:	<b>RZMACP</b>
MH#:	<b>M-606-061</b>	Owner:	<b>NA</b>	Len. Surveyed:	<b>10.1</b>
P.O.#:		Surveyor:	<b>Jen Costello</b>	Rim to Invert:	<b>11.0</b>
Customer:		Cert. #:	<b>U-907-5518</b>	Wall Material:	<b>Concrete (reinforced)</b>

Street:	<b>North of 8th St. 156' West of Riversi</b>	Project:	<b>Hobart, IN</b>
City:	<b>Hobart, IN</b>	GPS Northing:	<b>2902816.978</b>
Location:		GPS Easting:	<b>2902816.978</b>
Drain Area:	<b>Southwest</b>	GPS Accuracy:	<b>Sub-Meter</b>
Cover Shape:	<b>Circular</b>	Evidence of Surcharge:	<b>No</b>
Cover Size:	<b>22.5</b>	Potential for Runoff:	<b>None</b>
Comments:

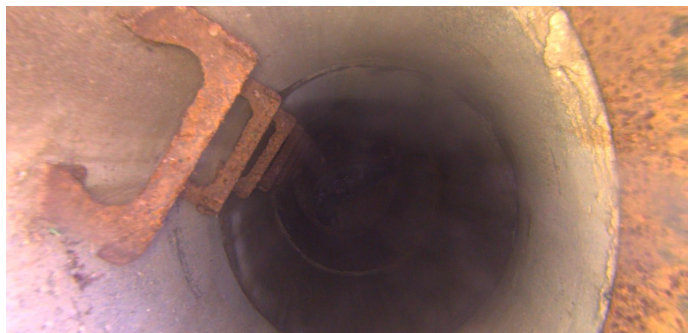
Code: **MGO**  
Description: **General Observation**

Distance (ft): **.0**  
Structural Grade: **0**  
O&M Grade: **0**  
Clock Start/From:  
Clock To:  
1st Value:  
2nd Value:  
Value Percent:  
Step: **NO**  
Remarks: **ACCESS MH**

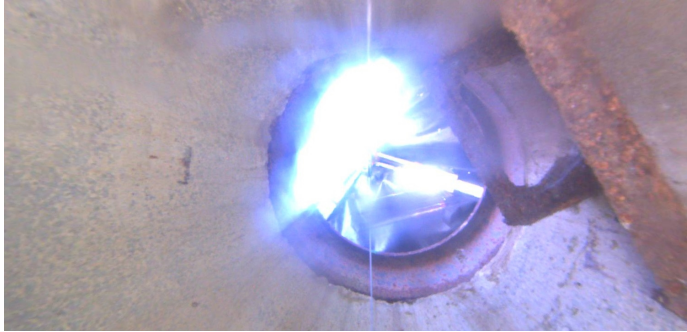
Code:	<b>MGP</b>
Description:	<b>General Photo</b>
Distance (ft):	<b>3.3</b>
Structural Grade:	<b>0</b>
O&M Grade:	<b>0</b>
Clock Start/From:	
Clock To:	
1st Value:	
2nd Value:	
Value Percent:	
Step:	<b>NO</b>
Remarks:	<b>UNDERSIDE OF FRAME</b>

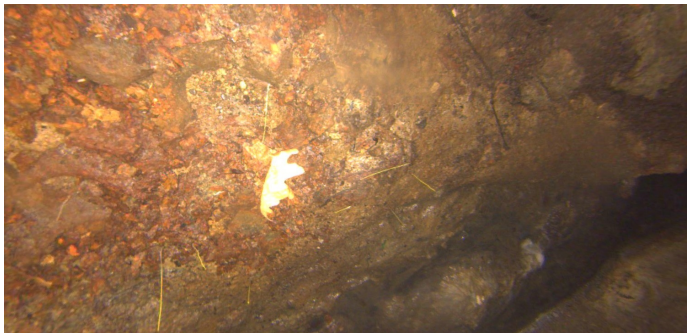
Code:	<b>MGO</b>
Description:	<b>General Observation</b>
Distance (ft):	<b>10.1</b>
Structural Grade:	<b>0</b>
O&M Grade:	<b>0</b>
Clock Start/From:	
Clock To:	
1st Value:	
2nd Value:	
Value Percent:	
Step:	<b>NO</b>
Remarks:	<b>END SURVEY</b>
