Manhole Inspection Report

Date:	04/26/2018	Weather:		Coding:	RZMACP
MH#:	M-606-064	Owner:	NA	Len. Surveyed:	13.4
P.O.#:		Surveyor:	Jen Costello	Rim to Invert:	15.1
Customer:		Cert. #:	U-907-5518	Wall Material:	Concrete (reinforced)

Street:	North of Lagoon Ave. 189' West of R	Project:	Hobart, IN
City:	Hobart, IN	GPS Northing:	2902923.154
Location:		GPS Easting:	2902923.154
Drain Area:	Southwest	GPS Accuracy:	Sub-Meter
Cover Shape:	Circular	Evidence of Surcharge:	No
Cover Size:	22.5	Potential for Runoff:	None
Comments:

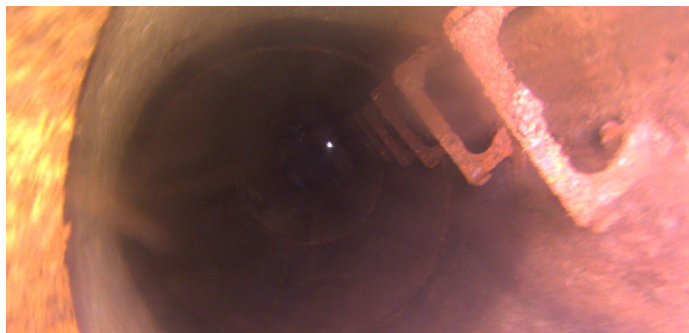
Code: **MGO**
 Description: **General Observation**

Distance (ft): **.0**
 Structural Grade: **0**
 O&M Grade: **0**
 Clock Start/From:
 Clock To:
 1st Value:
 2nd Value:
 Value Percent:
 Step: **NO**
 Remarks: **access MH**

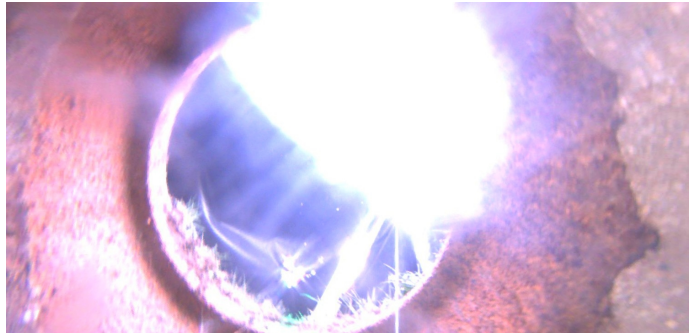
Code:	MGP
Description:	General Photo
Distance (ft):	1.5
Structural Grade:	0
O&M Grade:	0
Clock Start/From:	
Clock To:	
1st Value:	
2nd Value:	
Value Percent:	
Step:	NO
Remarks:	UNDERSIDE OF FRAME

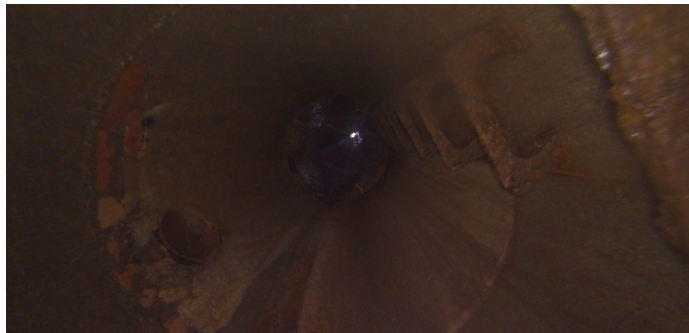
Code:	IW
Description:	Infil Weeper
Distance (ft):	5.6
Structural Grade:	0
O&M Grade:	2
Clock Start/From:	6
Clock To:	
1st Value:	
2nd Value:	
Value Percent:	
Step:	NO
Remarks:

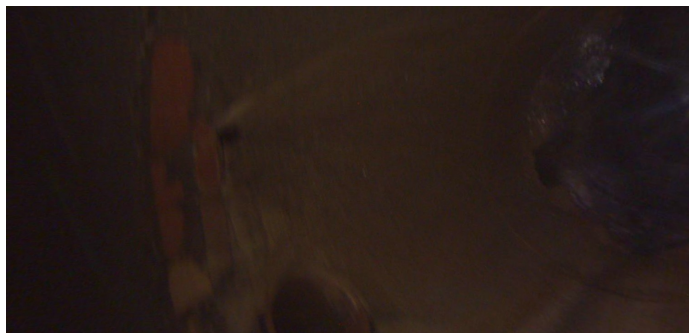
Code:	RPP
Description:	Repair Patch
Distance (ft):	6.8
Structural Grade:	0
O&M Grade:	0
Clock Start/From:	8
Clock To:	9
1st Value:	
2nd Value:	
Value Percent:	
Step:	NO
Remarks:	BRICKS

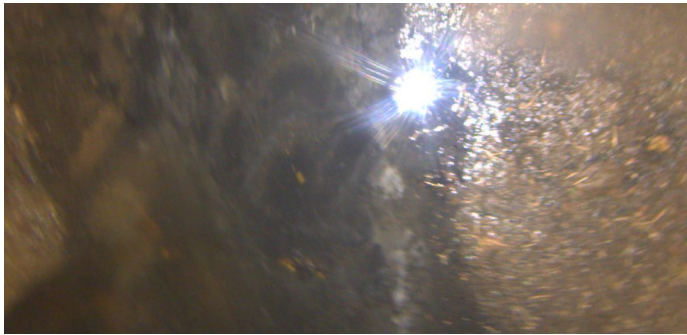
Code:	MGO
Description:	General Observation
Distance (ft):	13.4
Structural Grade:	0
O&M Grade:	0
Clock Start/From:	
Clock To:	
1st Value:	
2nd Value:	
Value Percent:	
Step:	NO
Remarks:	END SURVEY
