Manhole Inspection Report

Date:	04/26/2018	Weather:		Coding:	RZMACP
MH#:	M-606-065	Owner:	NA	Len. Surveyed:	9.0
P.O.#:		Surveyor:	Jen Costello	Rim to Invert:	8.9
Customer:		Cert. #:	U-907-5518	Wall Material:	Concrete (reinforced)

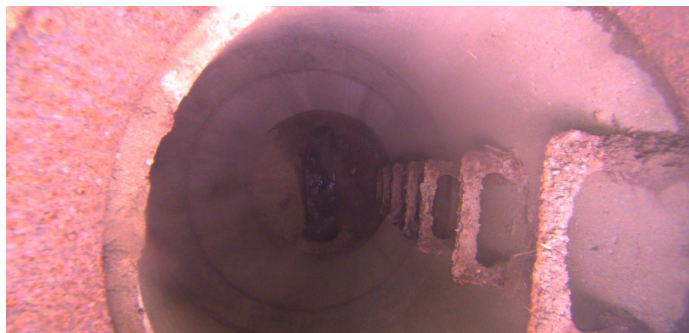
Code: **MGO**
Description: **General Observation**

Distance (ft): **.0**
Structural Grade: **0**
O&M Grade: **0**
Clock Start/From:
Clock To:
1st Value:
2nd Value:
Value Percent:
Step: **NO**
Remarks: **ACCESS MH**

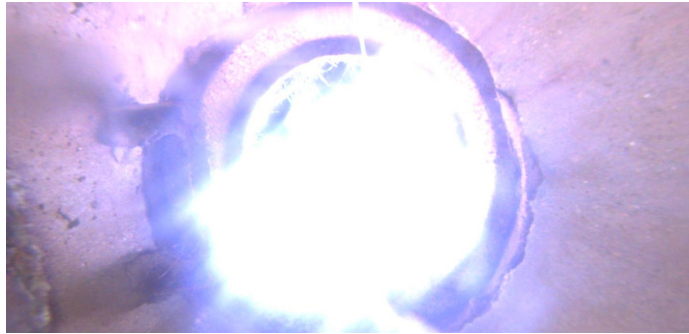
Code: **MGP**
Description: **General Photo**

Distance (ft): **3.1**
Structural Grade: **0**
O&M Grade: **0**
Clock Start/From:
Clock To:
1st Value:
2nd Value:
Value Percent:
Step: **NO**
Remarks: **UNDERSIDE OF FRAME**

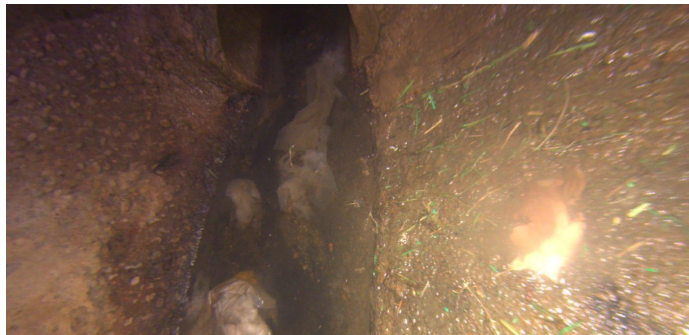
Code: **SAP**
Description: **Surface Aggregate Projecting**

Distance (ft): **8.4**
Structural Grade: **3**
O&M Grade: **0**
Clock Start/From: **9**
Clock To: **12**
1st Value:
2nd Value:
Value Percent:
Step: **NO**
Remarks:

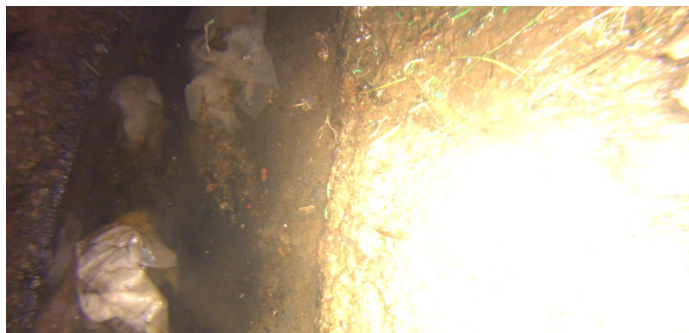
Code: **MGO**
Description: **General Observation**

Distance (ft): **9.0**
Structural Grade: **0**
O&M Grade: **0**
Clock Start/From:
Clock To:
1st Value:
2nd Value:
Value Percent:
Step: **NO**
Remarks: **END SURVEY**
