Manhole Inspection Report

Date:	04/26/2018	Weather:		Coding:	RZMACP
MH#:	M-606-065	Owner:	NA	Len. Surveyed:	14.6
P.O.#:		Surveyor:	Jen Costello	Rim to Invert:	15.4
Customer:		Cert. #:	U-907-5518	Wall Material:	Concrete (reinforced)

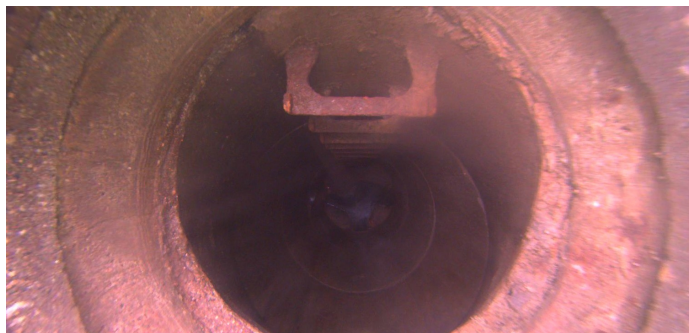
Code: **MGO**
Description: **General Observation**

Distance (ft): **.0**
Structural Grade: **0**
O&M Grade: **0**
Clock Start/From:
Clock To:
1st Value:
2nd Value:
Value Percent:
Step: **NO**
Remarks: **ACCESS MH**

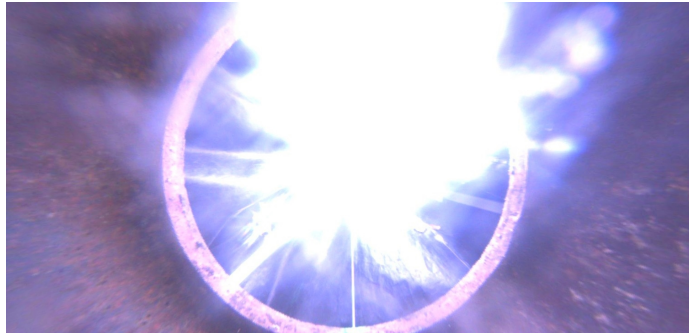
Code:	MGP
Description:	General Photo
Distance (ft):	1.3
Structural Grade:	0
O&M Grade:	0
Clock Start/From:	
Clock To:	
1st Value:	
2nd Value:	
Value Percent:	
Step:	NO
Remarks:	UNDERSIDE OF FRAME

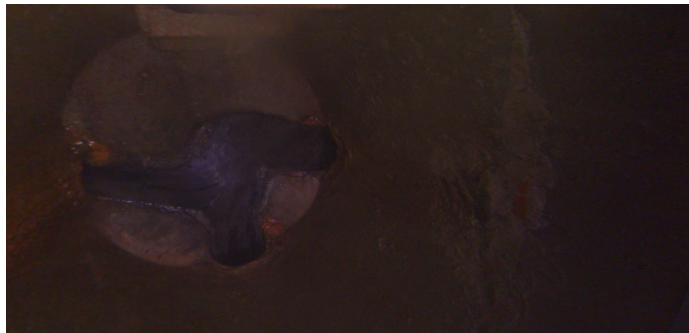
Code:	IS
Description:	Infil Stain
Distance (ft):	10.6
Structural Grade:	0
O&M Grade:	0
Clock Start/From:	3
Clock To:	
1st Value:	
2nd Value:	
Value Percent:	
Step:	NO
Remarks:

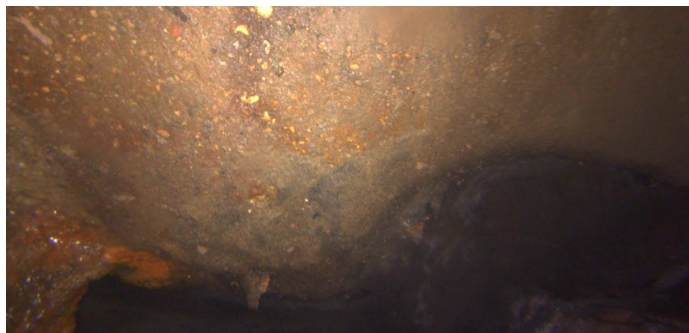
Code:	MGP
Description:	General Photo
Distance (ft):	14.6
Structural Grade:	0
O&M Grade:	0
Clock Start/From:	
Clock To:	
1st Value:	
2nd Value:	
Value Percent:	
Step:	NO
Remarks:	END SURVEY
