Manhole Inspection Report

Date:	04/26/2018	Weather:		Coding:	RZMACP
MH#:	M-606-067	Owner:	NA	Len. Surveyed:	13.9
P.O.#:		Surveyor:	Jen Costello	Rim to Invert:	14.7
Customer:		Cert. #:	U-907-5518	Wall Material:	Concrete (reinforced)

Street:	7th St. and Hollywood Blvd. to the E	Project:	Hobart, IN
City:	Hobart, IN	GPS Northing:	2903020.477
Location:		GPS Easting:	2903020.477
Drain Area:	Southwest	GPS Accuracy:	Sub-Meter
Cover Shape:	Circular	Evidence of Surcharge:	No
Cover Size:	22.5	Potential for Runoff:	None
Comments:

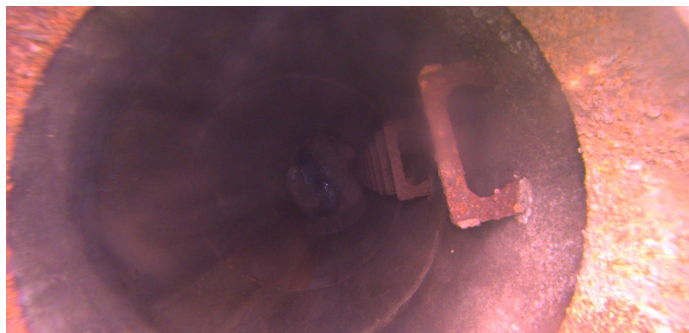
Code: **MGO**
Description: **General Observation**

Distance (ft): **.0**
Structural Grade: **0**
O&M Grade: **0**
Clock Start/From:
Clock To:
1st Value:
2nd Value:
Value Percent:
Step: **NO**
Remarks: **ACCESS MH**

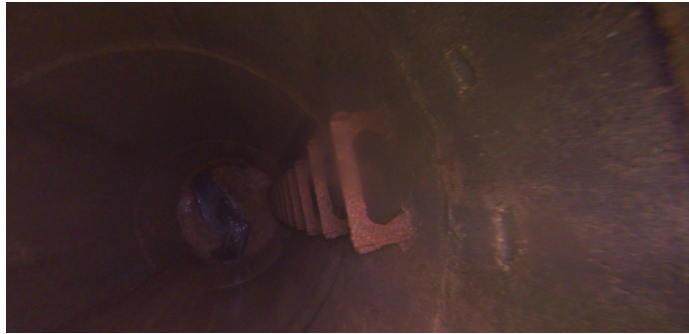
Code:	MGO
Description:	General Observation
Distance (ft):	1.9
Structural Grade:	0
O&M Grade:	0
Clock Start/From:	
Clock To:	
1st Value:	
2nd Value:	
Value Percent:	
Step:	NO
Remarks:	MISSING STEP

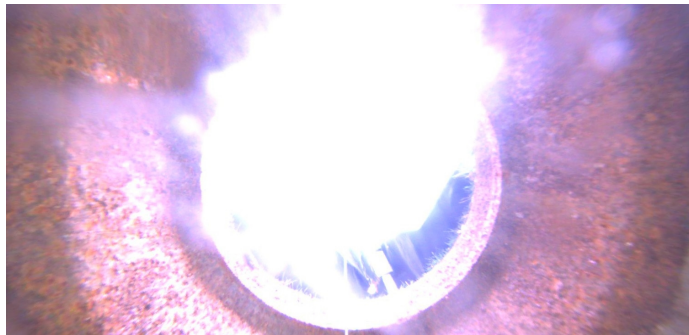
Code:	MGP
Description:	General Photo
Distance (ft):	1.9
Structural Grade:	0
O&M Grade:	0
Clock Start/From:	
Clock To:	
1st Value:	
2nd Value:	
Value Percent:	
Step:	NO
Remarks:	UNDERSIDE OF FRAME

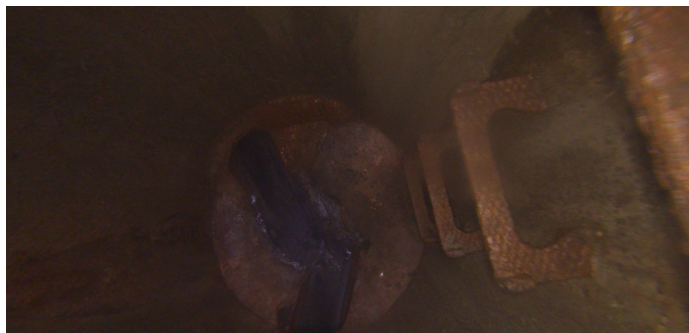
Code:	IS
Description:	Infil Stain
Distance (ft):	9.4
Structural Grade:	0
O&M Grade:	0
Clock Start/From:	12
Clock To:	12
1st Value:	
2nd Value:	
Value Percent:	
Step:	NO
Remarks:

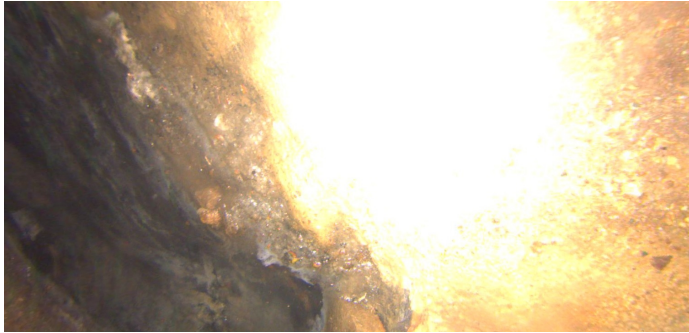
Code:	MGO
Description:	General Observation
Distance (ft):	13.9
Structural Grade:	0
O&M Grade:	0
Clock Start/From:	
Clock To:	
1st Value:	
2nd Value:	
Value Percent:	
Step:	NO
Remarks:	END SURVEY
