Manhole Inspection Report

Date:	04/26/2018	Weather:		Coding:	RZMACP
MH#:	M-606-074	Owner:	NA	Len. Surveyed:	14.5
P.O.#:		Surveyor:	Jen Costello	Rim to Invert:	15.1
Customer:		Cert. #:	U-907-5518	Wall Material:	Concrete (reinforced)

Street:	155' North of 7th St. and East of Holl	Project:	Hobart, IN
City:	Hobart, IN	GPS Northing:	2903017.305
Location:		GPS Easting:	2903017.305
Drain Area:	Southwest	GPS Accuracy:	Sub-Meter
Cover Shape:	Circular	Evidence of Surcharge:	No
Cover Size:	22.5	Potential for Runoff:	None
Comments:

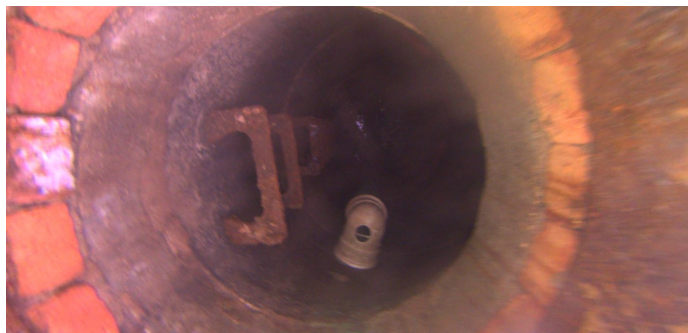
Code: **MGO**
Description: **General Observation**

Distance (ft): **.0**
Structural Grade: **0**
O&M Grade: **0**
Clock Start/From:
Clock To:
1st Value:
2nd Value:
Value Percent:
Step: **NO**
Remarks: **ACCESS MH**

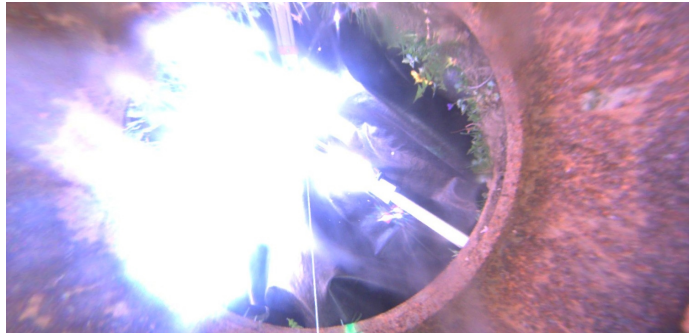
Code:	MGP
Description:	General Photo
Distance (ft):	1.4
Structural Grade:	0
O&M Grade:	0
Clock Start/From:	
Clock To:	
1st Value:	
2nd Value:	
Value Percent:	
Step:	NO
Remarks:	UNDERSIDE OF FRAME

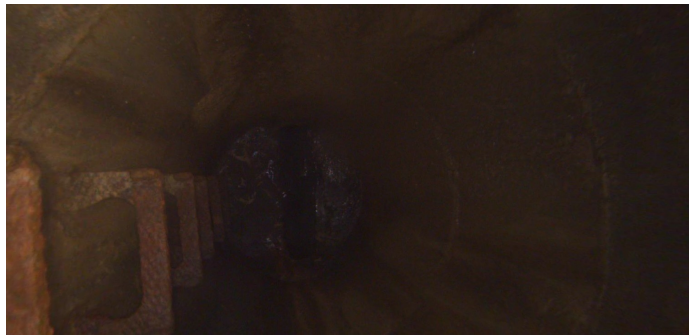
Code:	IS
Description:	Infil Stain
Distance (ft):	7.3
Structural Grade:	0
O&M Grade:	0
Clock Start/From:	12
Clock To:	12
1st Value:	
2nd Value:	
Value Percent:	
Step:	NO
Remarks:

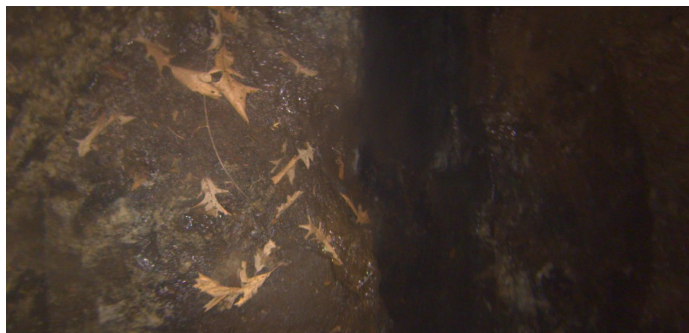
Code:	DSF
Description:	Deposits Settled Fine
Distance (ft):	13.4
Structural Grade:	0
O&M Grade:	2
Clock Start/From:	12
Clock To:	12
1st Value:	
2nd Value:	
Value Percent:	5.000
Step:	NO
Remarks:

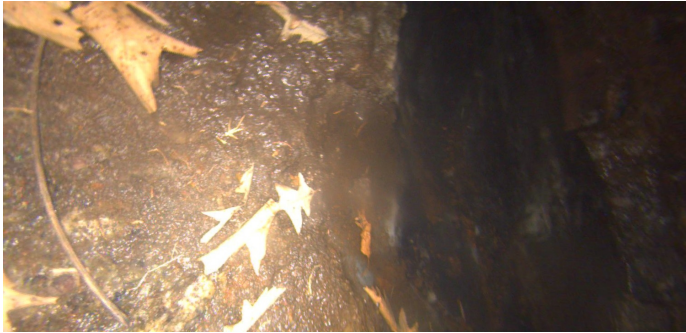
Code: **MGO**
Description: **General Observation**

Distance (ft): **14.5**
Structural Grade: **0**
O&M Grade: **0**
Clock Start/From:
Clock To:
1st Value:
2nd Value:
Value Percent:
Step: **NO**
Remarks: **END SURVEY**
