# Manhole Inspection Report

Date:	<b>04/26/2018</b>	Weather:		Coding:	<b>RZMACP</b>
MH#:	<b>M-606-077</b>	Owner:	<b>NA</b>	Len. Surveyed:	<b>9.4</b>
P.O.#:		Surveyor:	<b>Jen Costello</b>	Rim to Invert:	<b>9.6</b>
Customer:		Cert. #:	<b>U-907-5518</b>	Wall Material:	<b>Concrete (reinforced)</b>

Street:	<b>Hollywood Blvd. 179' South of Lake</b>	Project:	<b>Hobart, IN</b>
City:	<b>Hobart, IN</b>	GPS Northing:	<b>2902862.915</b>
Location:		GPS Easting:	<b>2902862.915</b>
Drain Area:	<b>Southwest</b>	GPS Accuracy:	<b>Sub-Meter</b>
Cover Shape:	<b>Circular</b>	Evidence of Surcharge:	<b>No</b>
Cover Size:	<b>22.5</b>	Potential for Runoff:	<b>None</b>
Comments:

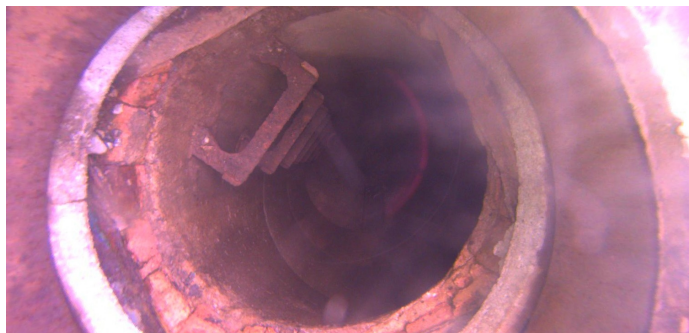
Code: **MGO**  
Description: **General Observation**

Distance (ft): **.0**  
Structural Grade: **0**  
O&M Grade: **0**  
Clock Start/From:  
Clock To:  
1st Value:  
2nd Value:  
Value Percent:  
Step: **NO**  
Remarks: **ACCESS MH**

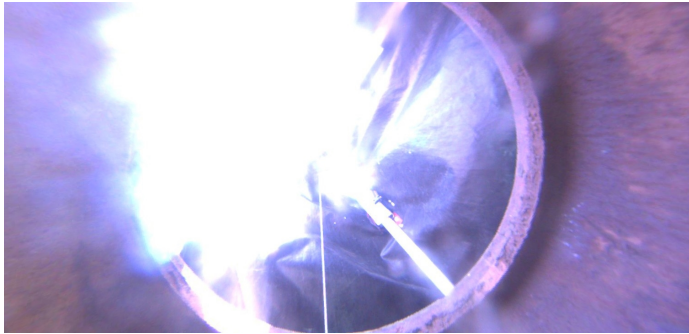
Code:	<b>MGP</b>
Description:	<b>General Photo</b>
Distance (ft):	<b>1.6</b>
Structural Grade:	<b>0</b>
O&M Grade:	<b>0</b>
Clock Start/From:	
Clock To:	
1st Value:	
2nd Value:	
Value Percent:	
Step:	<b>NO</b>
Remarks:	<b>UNDERSIDE OF FRAME</b>

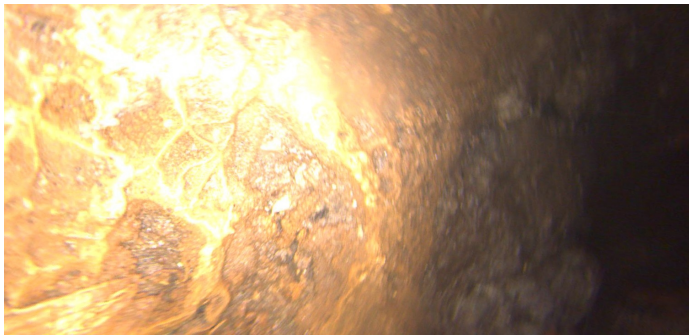
Code:	<b>MGO</b>
Description:	<b>General Observation</b>
Distance (ft):	<b>9.4</b>
Structural Grade:	<b>0</b>
O&M Grade:	<b>0</b>
Clock Start/From:	
Clock To:	
1st Value:	
2nd Value:	
Value Percent:	
Step:	<b>NO</b>
Remarks:	<b>END SURVEY</b>
