Manhole Inspection Report

Date:	04/27/2018	Weather:		Coding:	RZMACP
MH#:	M-606-079	Owner:	NA	Len. Surveyed:	7.8
P.O.#:		Surveyor:	Jen Costello	Rim to Invert:	8.2
Customer:		Cert. #:	U-907-5518	Wall Material:	Concrete (reinforced)

Street:	46' North of 7th St. East of Sunset St	Project:	Hobart, IN
City:	Hobart, IN	GPS Northing:	2902687.186
Location:		GPS Easting:	2902687.186
Drain Area:	Southwest	GPS Accuracy:	Sub-Meter
Cover Shape:	Circular	Evidence of Surcharge:	No
Cover Size:	22.5	Potential for Runoff:	None
Comments:

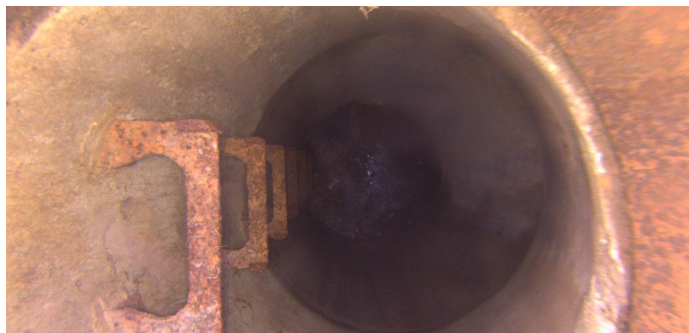
Code: **MGO**
Description: **General Observation**

Distance (ft): **.0**
Structural Grade: **0**
O&M Grade: **0**
Clock Start/From:
Clock To:
1st Value:
2nd Value:
Value Percent:
Step: **NO**
Remarks: **access MH**

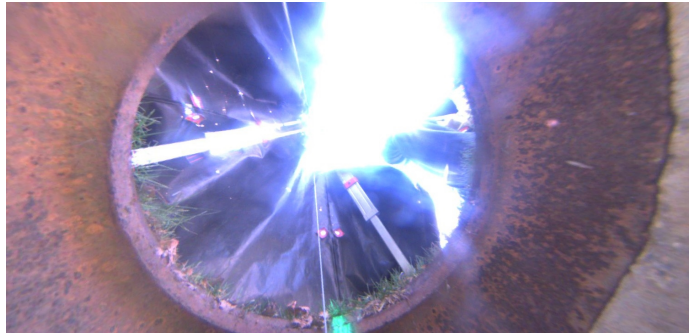
Code:	MGP
Description:	General Photo
Distance (ft):	1.2
Structural Grade:	0
O&M Grade:	0
Clock Start/From:	
Clock To:	
1st Value:	
2nd Value:	
Value Percent:	
Step:	NO
Remarks:	UNDERSIDE OF FRAME

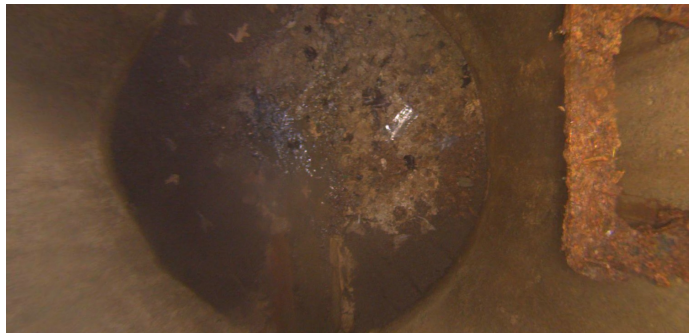
Code:	DSF
Description:	Deposits Settled Fine
Distance (ft):	5.4
Structural Grade:	0
O&M Grade:	2
Clock Start/From:	12
Clock To:	12
1st Value:	
2nd Value:	
Value Percent:	5.000
Step:	NO
Remarks:

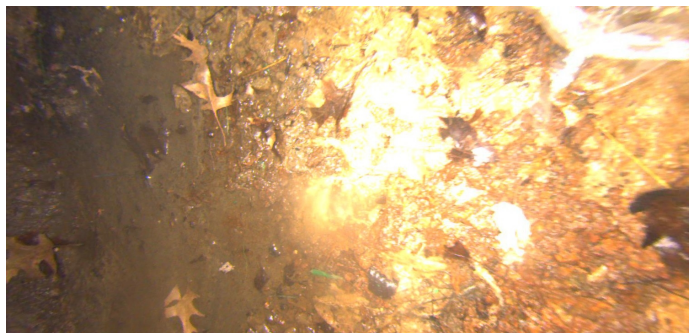
Code:	MGO
Description:	General Observation
Distance (ft):	7.8
Structural Grade:	0
O&M Grade:	0
Clock Start/From:	
Clock To:	
1st Value:	
2nd Value:	
Value Percent:	
Step:	NO
Remarks:	END SURVEY
