Manhole Inspection Report

Date:	04/26/2018	Weather:		Coding:	RZMACP
MH#:	M-606-082	Owner:	NA	Len. Surveyed:	8.1
P.O.#:		Surveyor:	Jen Costello	Rim to Invert:	8.4
Customer:		Cert. #:	U-907-5518	Wall Material:	Concrete (reinforced)

Street:	North of 7th St. 157' West of Sunset	Project:	Hobart, IN
City:	Hobart, IN	GPS Northing:	2902365.23
Location:		GPS Easting:	2902365.23
Drain Area:	Southwest	GPS Accuracy:	Sub-Meter
Cover Shape:	Circular	Evidence of Surcharge:	No
Cover Size:	22.5	Potential for Runoff:	None
Comments:

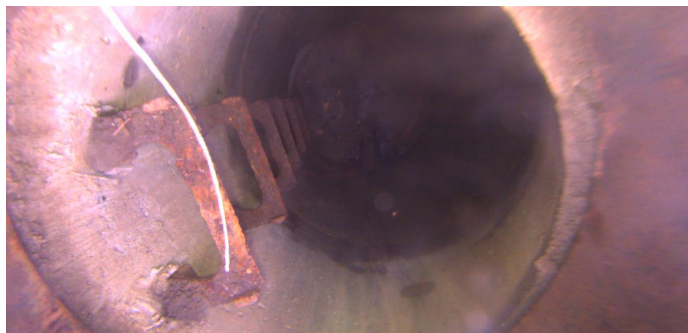
Code: **MGO**
Description: **General Observation**

Distance (ft): **.0**
Structural Grade: **0**
O&M Grade: **0**
Clock Start/From:
Clock To:
1st Value:
2nd Value:
Value Percent:
Step: **NO**
Remarks: **ACCESS MH**

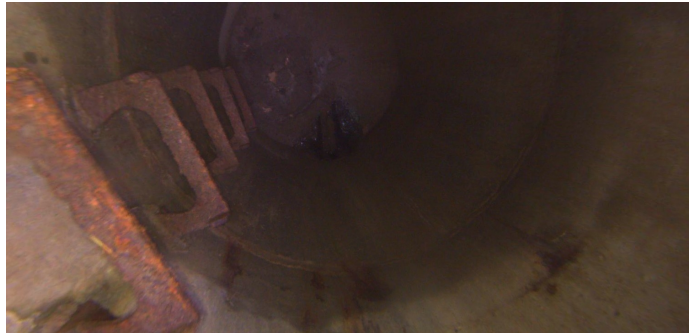
Code: **IS**
Description: **Infil Stain**

Distance (ft): **1.5**
Structural Grade: **0**
O&M Grade: **0**
Clock Start/From: **5**
Clock To: **7**
1st Value:
2nd Value:
Value Percent:
Step: **NO**
Remarks:

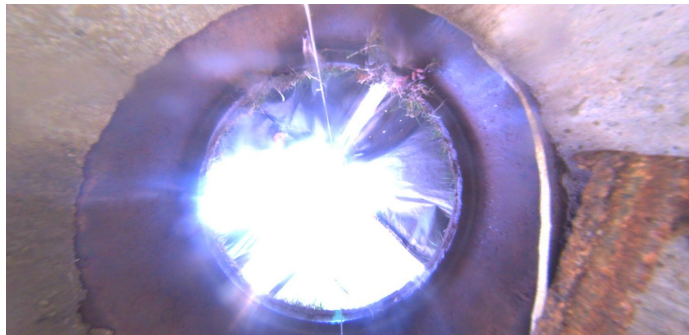
Code: **MGO**
Description: **General Observation**

Distance (ft): **2.0**
Structural Grade: **0**
O&M Grade: **0**
Clock Start/From:
Clock To:
1st Value:
2nd Value:
Value Percent:
Step: **NO**
Remarks: **UNDERSIDE OF FRAME**

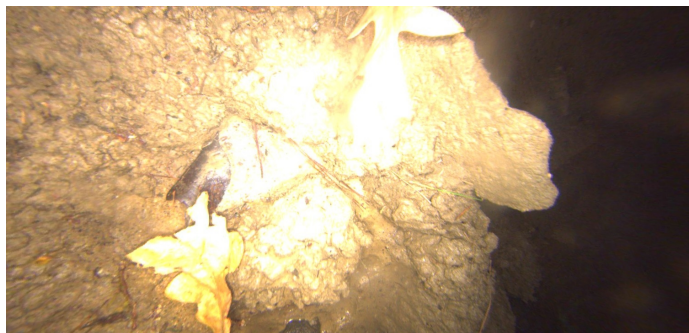
Code: **DSF**
Description: **Deposits Settled Fine**

Distance (ft): **8.1**
Structural Grade: **0**
O&M Grade: **3**
Clock Start/From: **12**
Clock To: **12**
1st Value:
2nd Value:
Value Percent: **20.000**
Step: **NO**
Remarks:

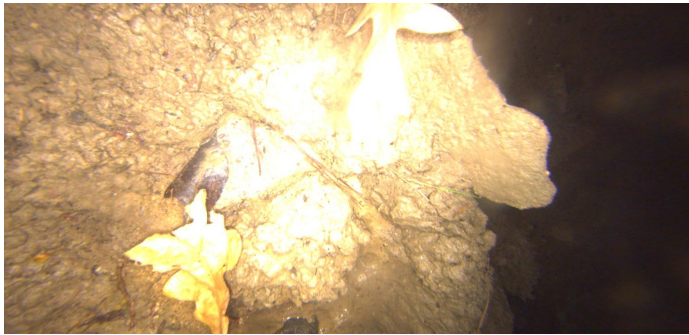
Code:	MGO
Description:	General Observation
Distance (ft):	8.1
Structural Grade:	0
O&M Grade:	0
Clock Start/From:	
Clock To:	
1st Value:	
2nd Value:	
Value Percent:	
Step:	NO
Remarks:	END SURVEY
