Manhole Inspection Report

Date:	04/26/2018	Weather:		Coding:	RZMACP
MH#:	M-606-088	Owner:	NA	Len. Surveyed:	13.9
P.O.#:		Surveyor:	Jen Costello	Rim to Invert:	14.5
Customer:		Cert. #:	U-907-5518	Wall Material:	Concrete (reinforced)

Street:	Intersection of Glendale and Lake Sh	Project:	Hobart, IN
City:	Hobart, IN	GPS Northing:	2902215.037
Location:		GPS Easting:	2902215.037
Drain Area:	Southwest	GPS Accuracy:	Sub-Meter
Cover Shape:	Circular	Evidence of Surcharge:	No
Cover Size:	22.5	Potential for Runoff:	None
Comments:

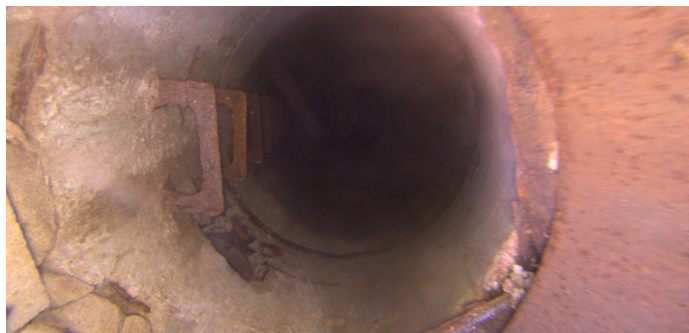
Code: **MGO**

Description: **General Observation**

Distance (ft): **.0**

Remarks: **ACCESS MH**

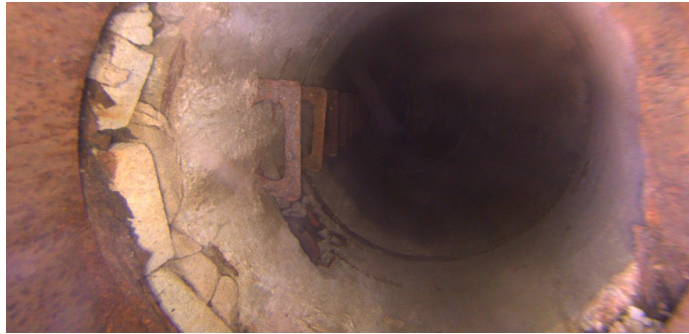
Code: **B**
Description: **Broken**

Distance (ft): **.0**
Structural Grade: **5**
O&M Grade: **0**
Clock Start/From: **7**
Clock To: **11**
1st Value:
2nd Value:
Value Percent:
Step: **NO**
Remarks:

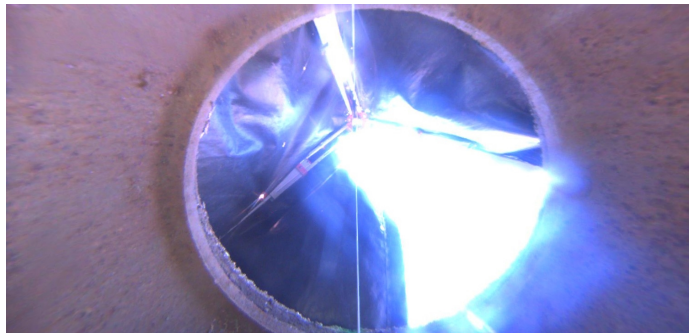
Code: **MGO**
Description: **General Observation**

Distance (ft): **1.5**
Structural Grade: **0**
O&M Grade: **0**
Clock Start/From:
Clock To:
1st Value:
2nd Value:
Value Percent:
Step: **NO**
Remarks: **UNDERSIDE OF FRAME**

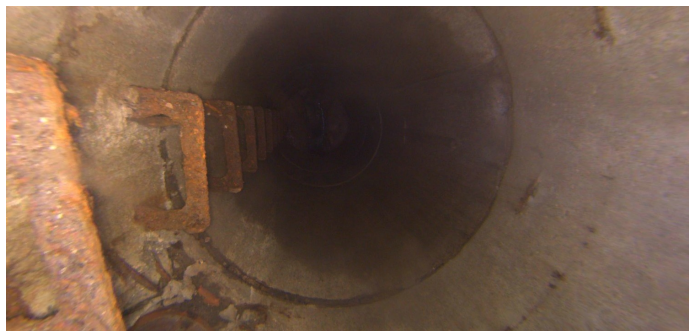
Code: **SRV**
Description: **Surface Reinforcement Visible**

Distance (ft): **1.5**
Structural Grade: **5**
O&M Grade: **0**
Clock Start/From: **12**
Clock To: **12**
1st Value:
2nd Value:
Value Percent:
Step: **NO**
Remarks:

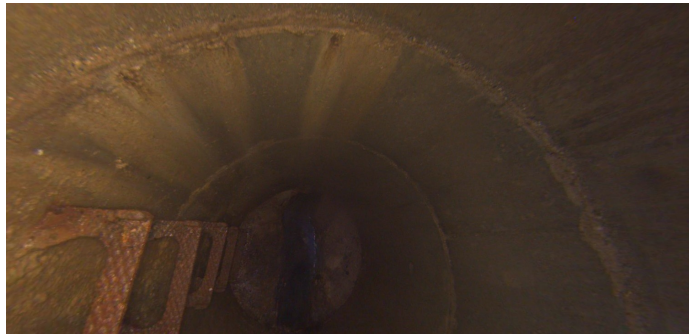
Code: **IS**
Description: **Infil Stain**

Distance (ft): **7.7**
Structural Grade: **0**
O&M Grade: **0**
Clock Start/From: **12**
Clock To: **12**
1st Value:
2nd Value:
Value Percent:
Step: **NO**
Remarks:

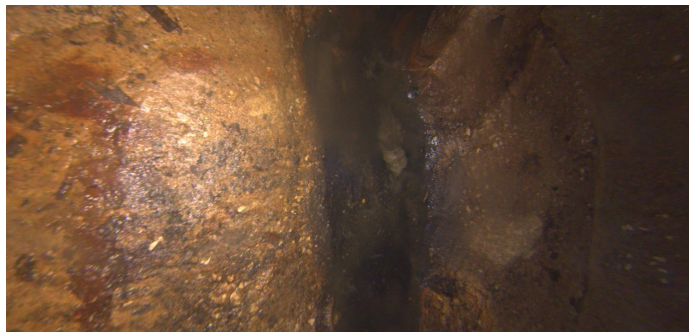
Code: **MGO**
Description: **General Observation**

Distance (ft): **13.9**
Structural Grade: **0**
O&M Grade: **0**
Clock Start/From:
Clock To:
1st Value:
2nd Value:
Value Percent:
Step: **NO**
Remarks: **END SURVEY**
