Manhole Inspection Report

Date:	04/26/2018	Weather:		Coding:	RZMACP
MH#:	M-606-089	Owner:	NA	Len. Surveyed:	14.5
P.O.#:		Surveyor:	Jen Costello	Rim to Invert:	14.9
Customer:		Cert. #:	U-907-5518	Wall Material:	Concrete (reinforced)

Street:	Lake Shore Dr. 76' West of Glendale	Project:	Hobart, IN
City:	Hobart, IN	GPS Northing:	2902138.145
Location:		GPS Easting:	2902138.145
Drain Area:	Southwest	GPS Accuracy:	Sub-Meter
Cover Shape:	Circular	Evidence of Surcharge:	No
Cover Size:	22.5	Potential for Runoff:	None
Comments:

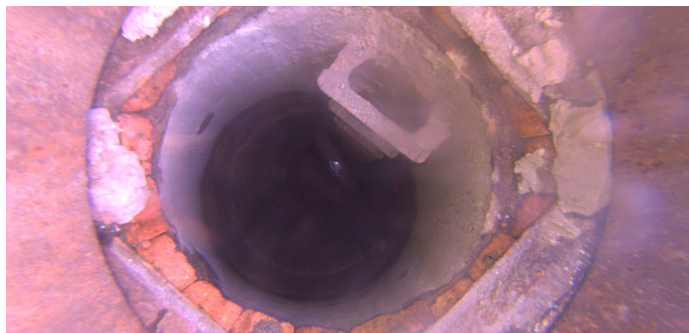
Code: **MGO**
Description: **General Observation**

Distance (ft): **.0**
Structural Grade: **0**
O&M Grade: **0**
Clock Start/From:
Clock To:
1st Value:
2nd Value:
Value Percent:
Step: **NO**
Remarks: **ACCESS MH**

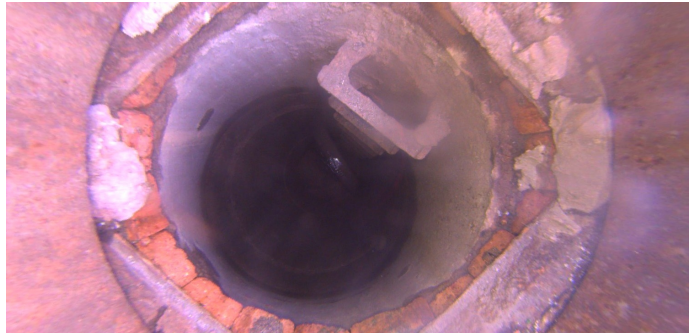
Code:	DAE
Description:	Deposits Attached Encrustation
Distance (ft):	.0
Structural Grade:	0
O&M Grade:	2
Clock Start/From:	12
Clock To:	12
1st Value:	
2nd Value:	
Value Percent:	5.000
Step:	NO
Remarks:

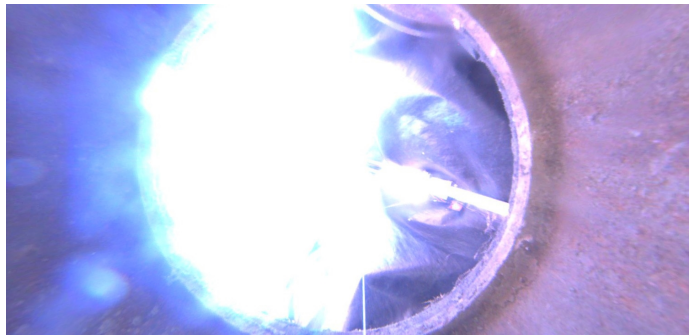
Code:	MGO
Description:	General Observation
Distance (ft):	1.3
Structural Grade:	0
O&M Grade:	0
Clock Start/From:	
Clock To:	
1st Value:	
2nd Value:	
Value Percent:	
Step:	NO
Remarks:	UNDERSIDE OF FRAME

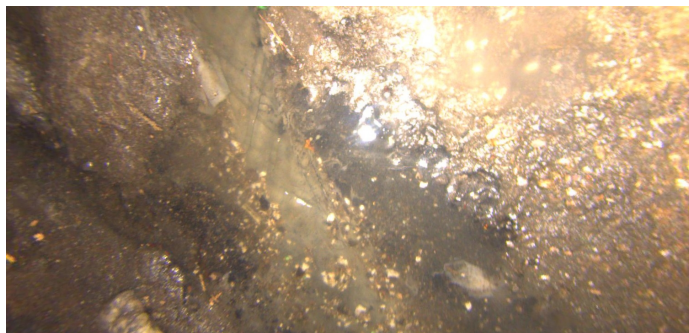
Code:	MGO
Description:	General Observation
Distance (ft):	14.5
Structural Grade:	0
O&M Grade:	0
Clock Start/From:	
Clock To:	
1st Value:	
2nd Value:	
Value Percent:	
Step:	NO
Remarks:	END SURVEY
