Manhole Inspection Report

| MH#: | M-606-090 | Owner: | NA | Len. Surveyed: | 12.5 |

| Street: | Lake Shore Dr. 164' West of Glendal | Project: | Hobart, IN |

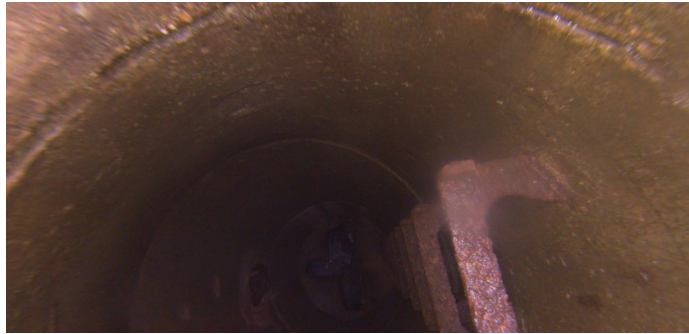
| Code: | SAV |
| Description: | Surface Aggregate Visible |
| Distance (ft): | 1.2 |
| Structural Grade: | 3 |
| Clock Start/From: | 12 |

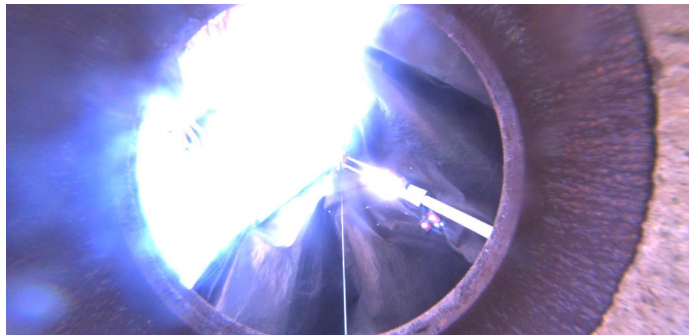
| Code: | MGO |
| Description: | General Observation |
| Remarks: | UNDERSIDE OF FRAME |

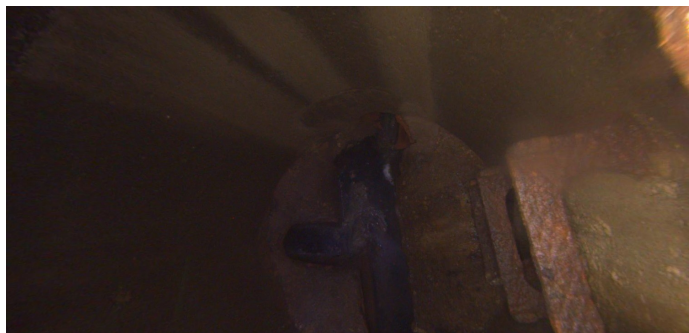
| Code: | IW |
| Description: | Infil Weeper |
| Distance (ft): | 9.0 |
| O&M Grade: | 2 |

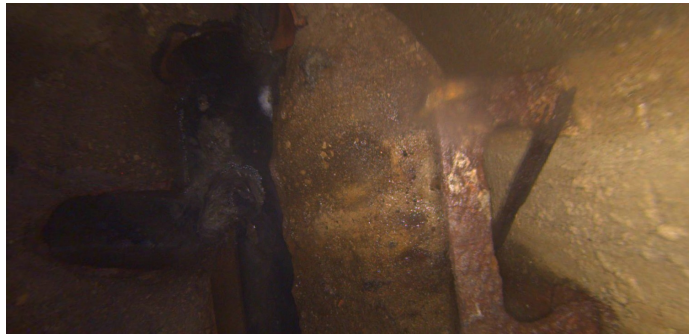
Code: **OBZ**
Description: **Obstacle Other**

Distance (ft): **11.3**
Structural Grade: **0**
O&M Grade: **2**
Clock Start/From: **3**
Clock To: **4**
1st Value:
2nd Value:
Value Percent: **5.000**
Step: **YES**
Remarks: **STICK**

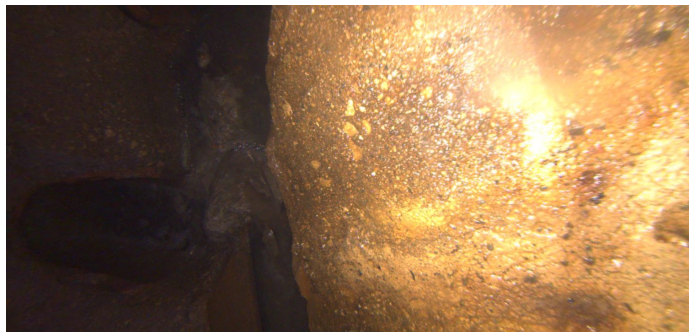
Code: **SAV**
Description: **Surface Aggregate Visible**

Distance (ft): **12.5**
Structural Grade: **3**
O&M Grade: **0**
Clock Start/From: **12**
Clock To: **12**
1st Value:
2nd Value:
Value Percent:
Step: **NO**
Remarks:

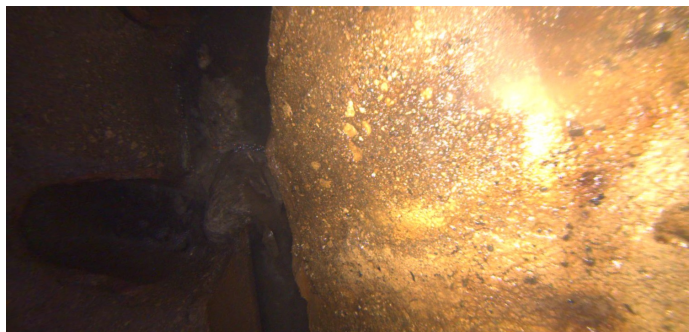
Code: **SAV**
Description: **Surface Aggregate Visible**

Distance (ft): **12.5**
Structural Grade: **3**
O&M Grade: **0**
Clock Start/From: **12**
Clock To: **12**
1st Value:
2nd Value:
Value Percent:
Step: **NO**
Remarks:
