Manhole Inspection Report

Date:	04/27/2018	Weather:		Coding:	RZMACP
MH#:	M-606-094	Owner:	NA	Len. Surveyed:	8.6
P.O.#:		Surveyor:	Jen Costello	Rim to Invert:	9.3
Customer:		Cert. #:	U-907-5518	Wall Material:	Brick

Street:	Lake Shore Dr. 73' East of Wisconsin	Project:	Hobart, IN
City:	Hobart, IN	GPS Northing:	2901901.027
Location:		GPS Easting:	2901901.027
Drain Area:	Southwest	GPS Accuracy:	Sub-Meter
Cover Shape:	Circular	Evidence of Surcharge:	No
Cover Size:	22.5	Potential for Runoff:	None
Comments:

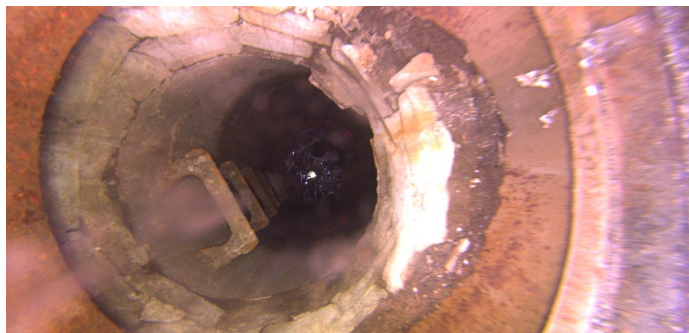
Code: **MGP**
Description: **General Photo**

Distance (ft): **.0**
Structural Grade: **0**
O&M Grade: **0**
Clock Start/From:
Clock To:
1st Value:
2nd Value:
Value Percent:
Step: **NO**
Remarks: **ACCESS MH**

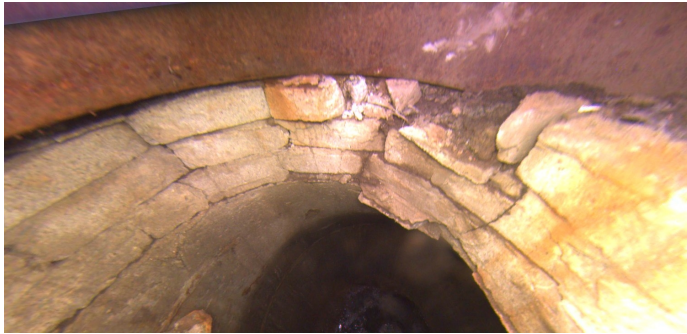
Code: **MB**
Description: **Missing Brick**

Distance (ft): **.7**
Structural Grade: **4**
O&M Grade: **0**
Clock Start/From: **1**
Clock To:
1st Value:
2nd Value:
Value Percent:
Step: **NO**
Remarks:

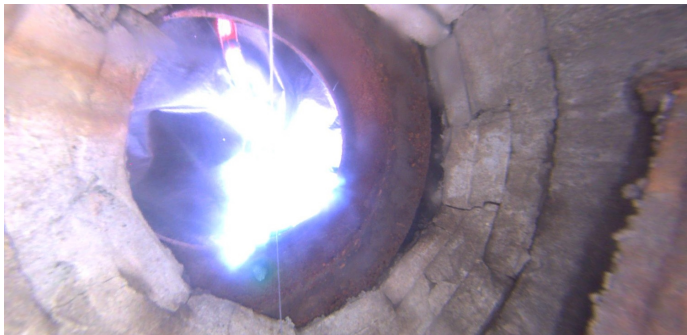
Code: **MGP**
Description: **General Photo**

Distance (ft): **2.5**
Structural Grade: **0**
O&M Grade: **0**
Clock Start/From:
Clock To:
1st Value:
2nd Value:
Value Percent:
Step: **NO**
Remarks: **UNDERSIDE OF FRAME**

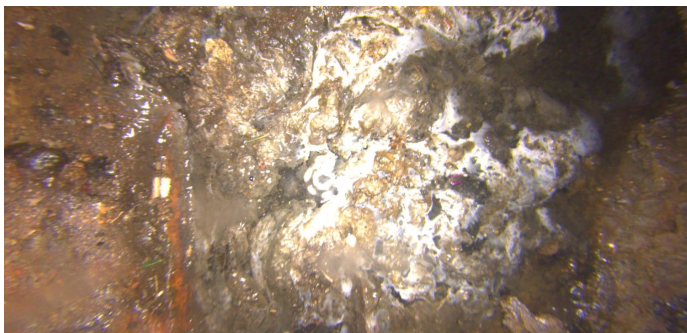
Code: **MGO**
Description: **General Observation**

Distance (ft): **8.6**
Structural Grade: **0**
O&M Grade: **0**
Clock Start/From:
Clock To:
1st Value:
2nd Value:
Value Percent:
Step: **NO**
Remarks: **END SURVEY**
