Manhole Inspection Report

Date:	04/08/2018	Weather:		Coding:	RZMACP
MH#:	M-607-001	Owner:	NA	Len. Surveyed:	13.1
P.O.#:		Surveyor:	John Kuglmaier	Rim to Invert:	13.5
Customer:		Cert. #:	U-1215-07002349	Wall Material:	Concrete (reinforced)

Street:	14th St. 331' West of Hwy 51.	Project:	Hobart, IN
City:	Hobart, IN	GPS Northing:	2904325.707
Location:		GPS Easting:	2904325.707
Drain Area:	Southwest	GPS Accuracy:	Sub-Meter
Cover Shape:	Circular	Evidence of Surcharge:	Yes
Cover Size:	22.5	Potential for Runoff:	None
Comments:

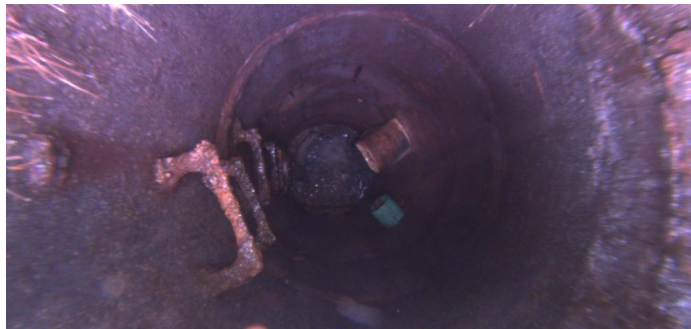
Code: **MGP**
Description: **General Photo**

Distance (ft): **.0**
Structural Grade: **0**
O&M Grade: **0**
Clock Start/From:
Clock To:
1st Value:
2nd Value:
Value Percent:
Step: **NO**
Remarks:

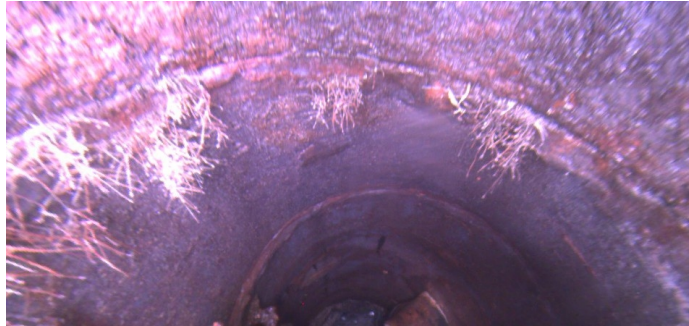
Code: **RFJ**
Description: **Roots Fine Joint**

Distance (ft): **.0**
Structural Grade: **0**
O&M Grade: **1**
Clock Start/From: **6**
Clock To: **2**
1st Value:
2nd Value:
Value Percent:
Step: **NO**
Remarks:

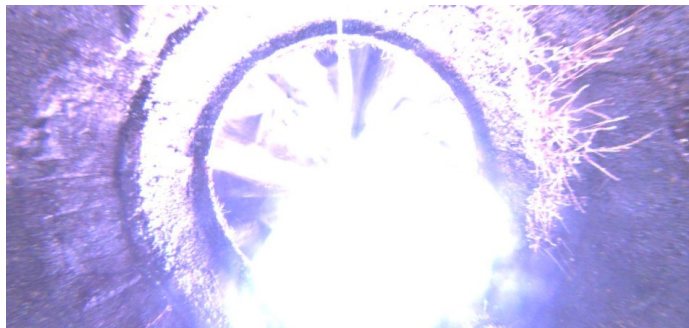
Code: **MGP**
Description: **General Photo**

Distance (ft): **2.4**
Structural Grade: **0**
O&M Grade: **0**
Clock Start/From:
Clock To:
1st Value:
2nd Value:
Value Percent:
Step: **NO**
Remarks:

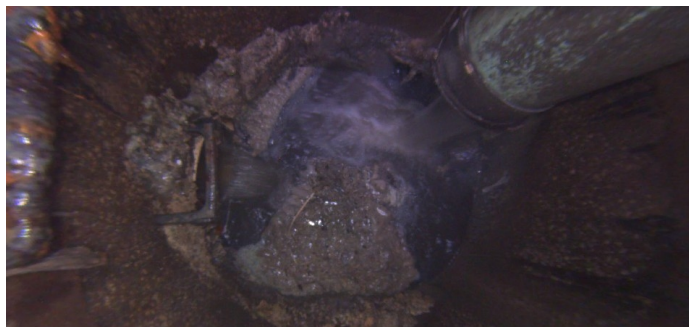
Code: **DAZ**
Description: **Deposits Attached Other**

Distance (ft): **9.4**
Structural Grade: **0**
O&M Grade: **3**
Clock Start/From: **12**
Clock To: **12**
1st Value:
2nd Value:
Value Percent: **20.000**
Step: **NO**
Remarks: **Mixed materials**

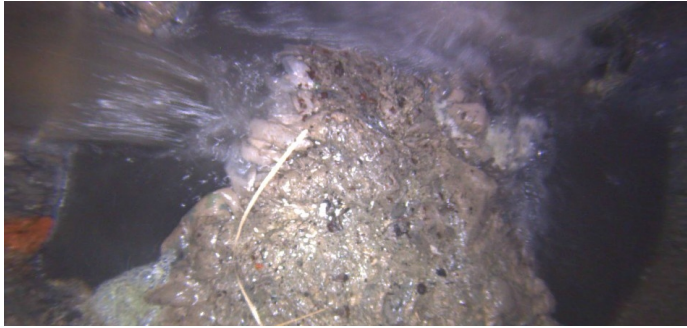
Code:	MGO
Description:	General Observation
Distance (ft):	11.9
Structural Grade:	0
O&M Grade:	0
Clock Start/From:	
Clock To:	
1st Value:	
2nd Value:	
Value Percent:	
Step:	NO
Remarks:	Ins. Comp.
