Manhole Inspection Report

Date:	04/08/2018	Weather:		Coding:	RZMACP
MH#:	M-607-002	Owner:	NA	Len. Surveyed:	13.8
P.O.#:		Surveyor:	John Kuglmaier	Rim to Invert:	14.3
Customer:		Cert. #:	U-1215-07002349	Wall Material:	Concrete (reinforced)

Street:	West of Lake Park Ave. 254' North of	Project:	Hobart, IN
City:	Hobart, IN	GPS Northing:	0.0
Location:		GPS Easting:	0.0
Drain Area:	Southwest	GPS Accuracy:	Nearest Meter
Cover Shape:	Circular	Evidence of Surcharge:	Yes
Cover Size:	22.5	Potential for Runoff:	None
Comments:

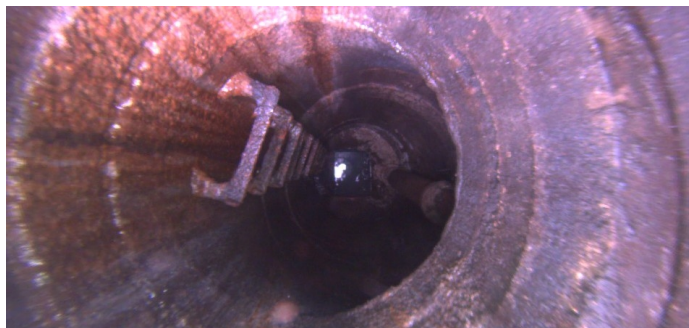
Code: **MGP**
Description: **General Photo**

Distance (ft): **.0**
Structural Grade: **0**
O&M Grade: **0**
Clock Start/From:
Clock To:
1st Value:
2nd Value:
Value Percent:
Step: **NO**
Remarks:

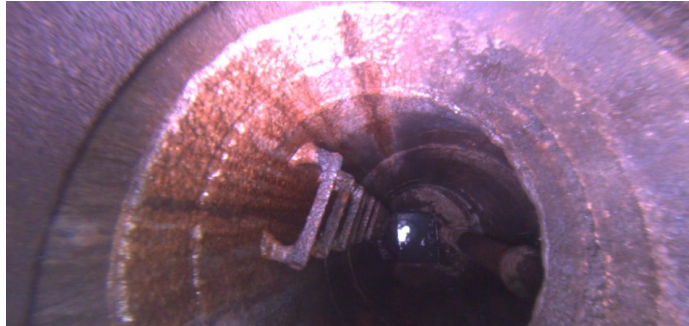
Code: **IS**
Description: **Infil Stain**

Distance (ft): **.0**
Structural Grade: **0**
O&M Grade: **0**
Clock Start/From: **8**
Clock To: **11**
1st Value:
2nd Value:
Value Percent:
Step: **NO**
Remarks:

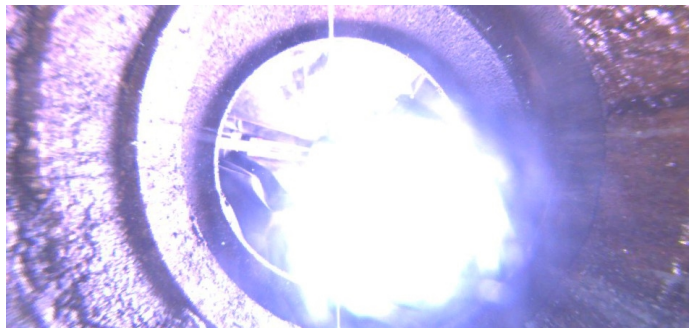
Code: **MGP**
Description: **General Photo**

Distance (ft): **2.5**
Structural Grade: **0**
O&M Grade: **0**
Clock Start/From:
Clock To:
1st Value:
2nd Value:
Value Percent:
Step: **NO**
Remarks:

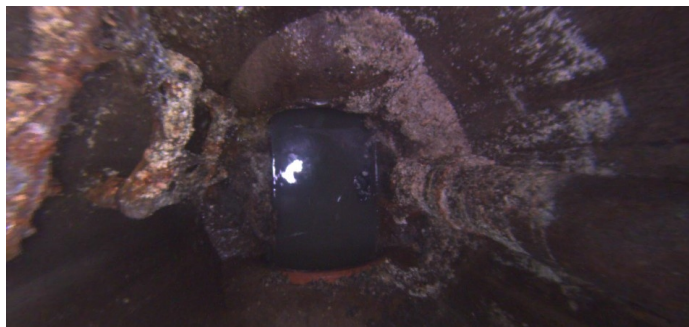
Code: **DAZ**
Description: **Deposits Attached Other**

Distance (ft): **9.6**
Structural Grade: **0**
O&M Grade: **2**
Clock Start/From: **12**
Clock To: **12**
1st Value:
2nd Value:
Value Percent: **5.000**
Step: **NO**
Remarks: **Mixed materials**

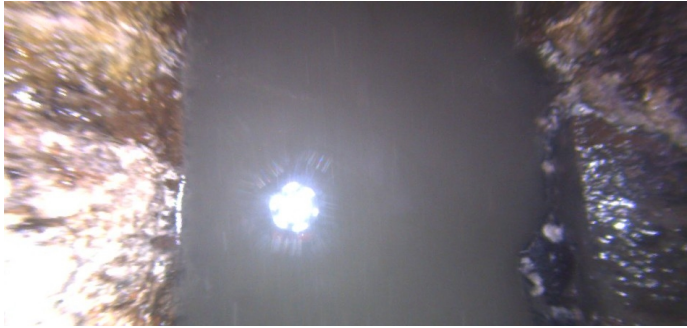
Code:	MGO
Description:	General Observation
Distance (ft):	13.2
Structural Grade:	0
O&M Grade:	0
Clock Start/From:	
Clock To:	
1st Value:	
2nd Value:	
Value Percent:	
Step:	NO
Remarks:	Ins. Comp.
