Manhole Inspection Report

Date:	04/09/2018	Weather:		Coding:	RZMACP
MH#:	M-607-003	Owner:	NA	Len. Surveyed:	12.2
P.O.#:		Surveyor:	John Kuglmaier	Rim to Invert:	13.2
Customer:		Cert. #:	U-1215-07002349	Wall Material:	Concrete (reinforced)

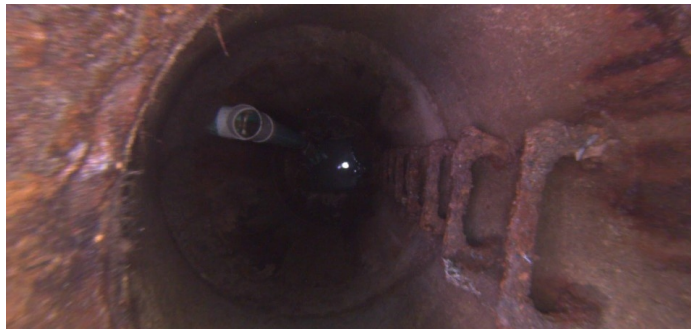
Code: **MGP**
Description: **General Photo**

Distance (ft): **.0**
Structural Grade: **0**
O&M Grade: **0**
Clock Start/From:
Clock To:
1st Value:
2nd Value:
Value Percent:
Step: **NO**
Remarks:

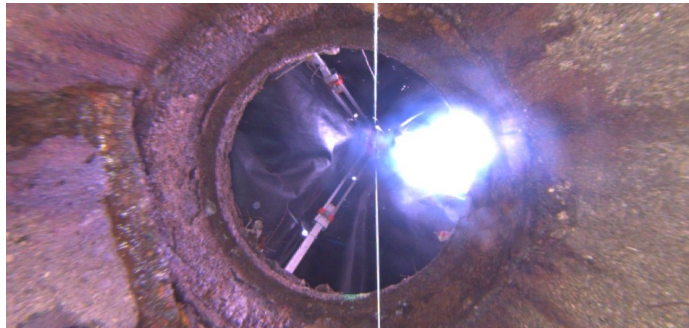
Code: **MGP**
Description: **General Photo**

Distance (ft): **2.5**
Structural Grade: **0**
O&M Grade: **0**
Clock Start/From:
Clock To:
1st Value:
2nd Value:
Value Percent:
Step: **NO**
Remarks:

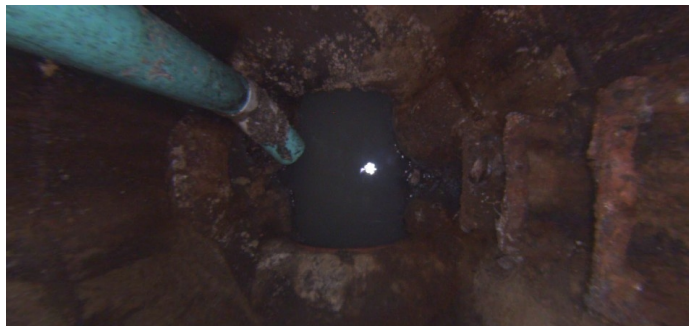
Code: **DAZ**
Description: **Deposits Attached Other**

Distance (ft): **8.3**
Structural Grade: **0**
O&M Grade: **2**
Clock Start/From: **12**
Clock To: **12**
1st Value:
2nd Value:
Value Percent: **5.000**
Step: **NO**
Remarks: **Mixed materials**

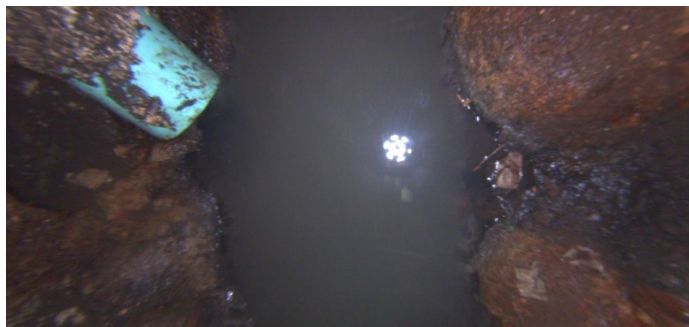
Code: **MGO**
Description: **General Observation**

Distance (ft): **11.1**
Structural Grade: **0**
O&M Grade: **0**
Clock Start/From:
Clock To:
1st Value:
2nd Value:
Value Percent:
Step: **NO**
Remarks: **Ins. Comp.**
