Manhole Inspection Report

Date:	04/26/2018	Weather:		Coding:	RZMACP
MH#:	M-607-009	Owner:	NA	Len. Surveyed:	9.2
P.O.#:		Surveyor:	Jen Costello	Rim to Invert:	10.0
Customer:		Cert. #:	U-907-5518	Wall Material:	Concrete (reinforced)

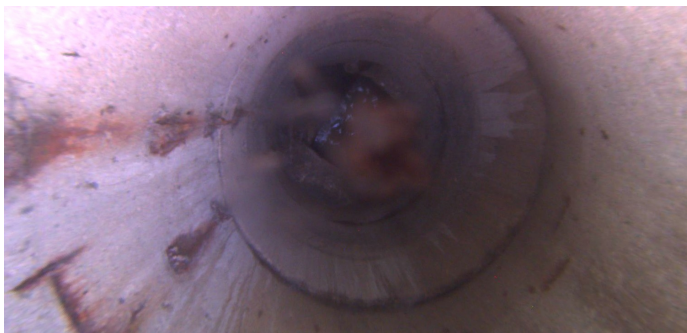
Code: **MGO**
Description: **General Observation**

Distance (ft): **.0**
Structural Grade: **0**
O&M Grade: **0**
Clock Start/From:
Clock To:
1st Value:
2nd Value:
Value Percent:
Step: **NO**
Remarks: **ACCESS MH**

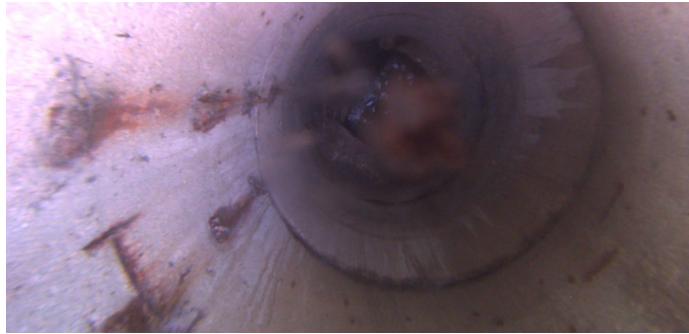
Code: **SRV**
Description: **Surface Reinforcement Visible**

Distance (ft): **.0**
Structural Grade: **5**
O&M Grade: **0**
Clock Start/From: **8**
Clock To: **9**
1st Value:
2nd Value:
Value Percent:
Step: **NO**
Remarks:

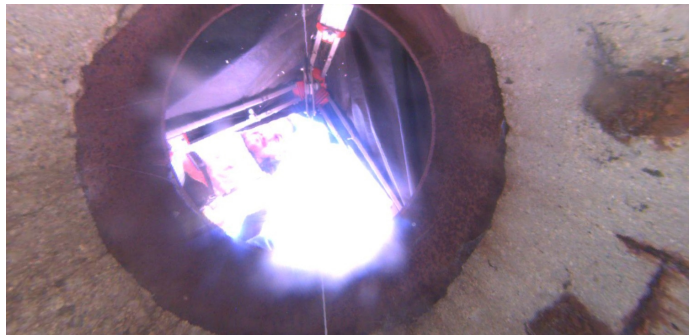
Code: **MGO**
Description: **General Observation**

Distance (ft): **2.0**
Structural Grade: **0**
O&M Grade: **0**
Clock Start/From:
Clock To:
1st Value:
2nd Value:
Value Percent:
Step: **NO**
Remarks: **UNDERSIDE OF FRAME**

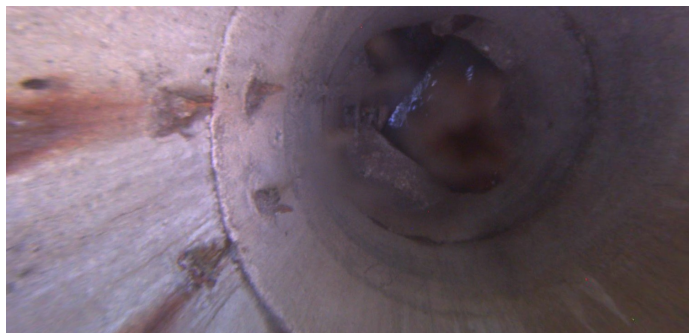
Code: **MGO**
Description: **General Observation**

Distance (ft): **2.0**
Structural Grade: **0**
O&M Grade: **0**
Clock Start/From:
Clock To:
1st Value:
2nd Value:
Value Percent:
Step: **NO**
Remarks: **MISSING AND BROKEN STEPS**

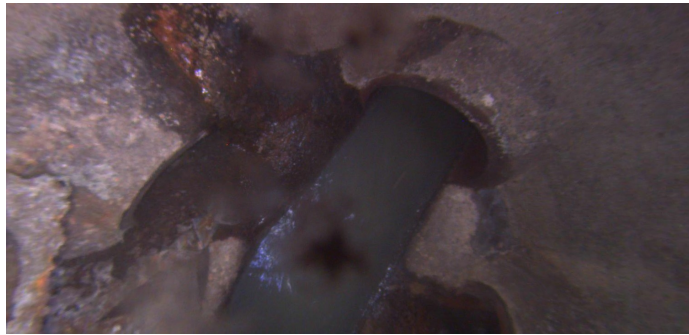
Code: **IW**
Description: **Infil Weeper**

Distance (ft): **6.8**
Structural Grade: **0**
O&M Grade: **2**
Clock Start/From: **11**
Clock To:
1st Value:
2nd Value:
Value Percent:
Step: **NO**
Remarks:

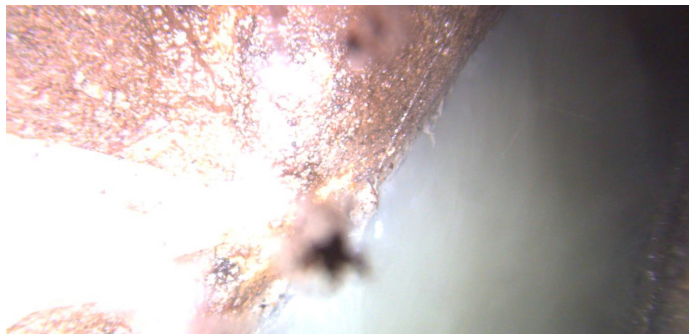
Code: **MGO**
Description: **General Observation**

Distance (ft): **9.2**
Structural Grade: **0**
O&M Grade: **0**
Clock Start/From:
Clock To:
1st Value:
2nd Value:
Value Percent:
Step: **NO**
Remarks: **END SURVEY**
