Manhole Inspection Report

Date:	04/26/2018	Weather:		Coding:	RZMACP
MH#:	M-607-010	Owner:	NA	Len. Surveyed:	15.6
P.O.#:		Surveyor:	Jen Costello	Rim to Invert:	15.5
Customer:		Cert. #:	U-907-5518	Wall Material:	Concrete (reinforced)

Street:	West of Lake Park Ave. 385' South of	Project:	Hobart, IN
City:	Hobart, IN	GPS Northing:	2904296.405
Location:		GPS Easting:	2904296.405
Drain Area:	Southwest	GPS Accuracy:	Sub-Meter
Cover Shape:	Circular	Evidence of Surcharge:	No
Cover Size:	22.5	Potential for Runoff:	None
Comments:

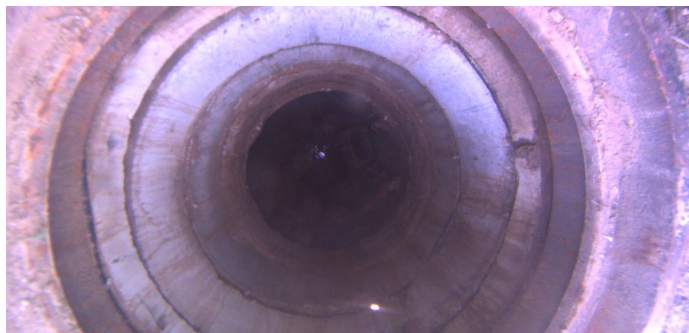
Code: **MGO**
Description: **General Observation**

Distance (ft): **.0**
Structural Grade: **0**
O&M Grade: **0**
Clock Start/From:
Clock To:
1st Value:
2nd Value:
Value Percent:
Step: **NO**
Remarks: **ACCESS MH**

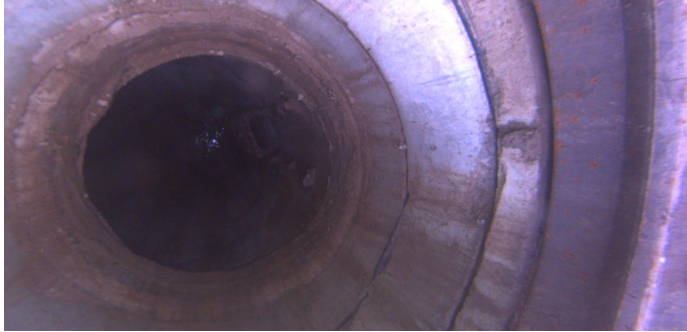
Code: **FL**
Description: **Fracture Longitudinal**

Distance (ft): **.8**
Structural Grade: **3**
O&M Grade: **0**
Clock Start/From: **3**
Clock To:
1st Value:
2nd Value:
Value Percent:
Step: **NO**
Remarks:

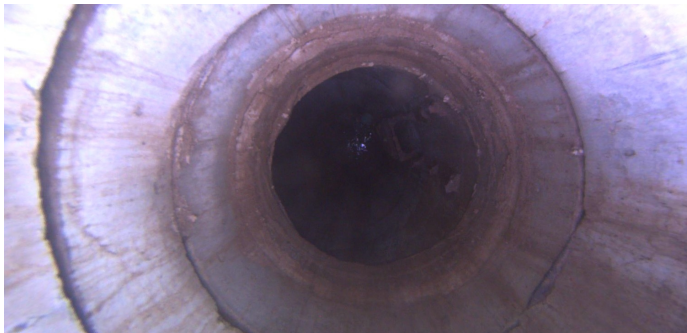
Code: **CM**
Description: **Crack Multiple**

Distance (ft): **.8**
Structural Grade: **3**
O&M Grade: **0**
Clock Start/From: **8**
Clock To: **9**
1st Value:
2nd Value:
Value Percent:
Step: **NO**
Remarks:

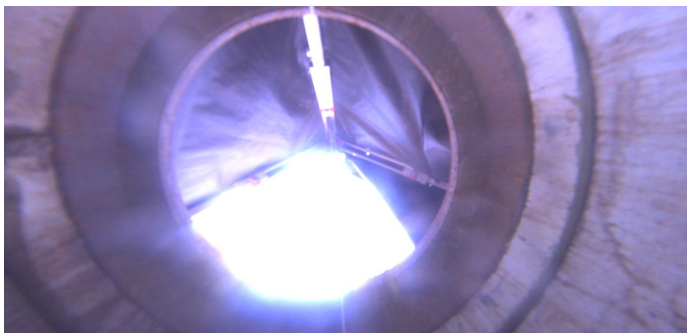
Code: **MGP**
Description: **General Photo**

Distance (ft): **1.8**
Structural Grade: **0**
O&M Grade: **0**
Clock Start/From:
Clock To:
1st Value:
2nd Value:
Value Percent:
Step: **NO**
Remarks: **UNDERSIDE OF FRAME**

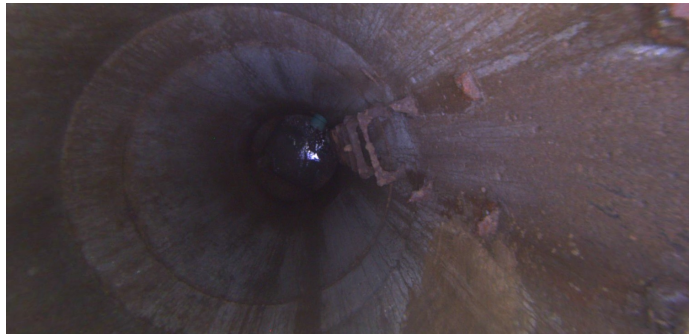
Code: **MGO**
Description: **General Observation**

Distance (ft): **3.4**
Structural Grade: **0**
O&M Grade: **0**
Clock Start/From:
Clock To:
1st Value:
2nd Value:
Value Percent:
Step: **NO**
Remarks: **MISSING AND BROKEN STEPS**

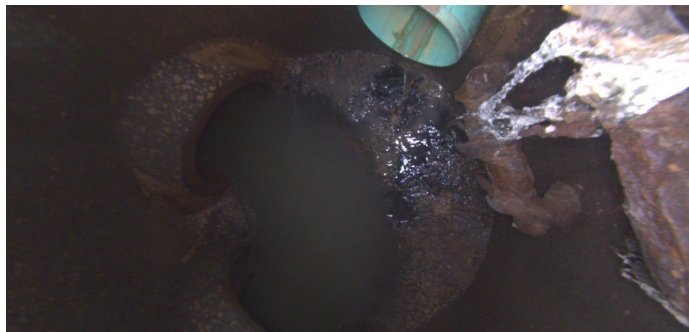
Code: **DAR**
Description: **Deposits Attached Ragging**

Distance (ft): **13.1**
Structural Grade: **0**
O&M Grade: **2**
Clock Start/From: **2**
Clock To:
1st Value:
2nd Value:
Value Percent: **5.000**
Step: **YES**
Remarks:

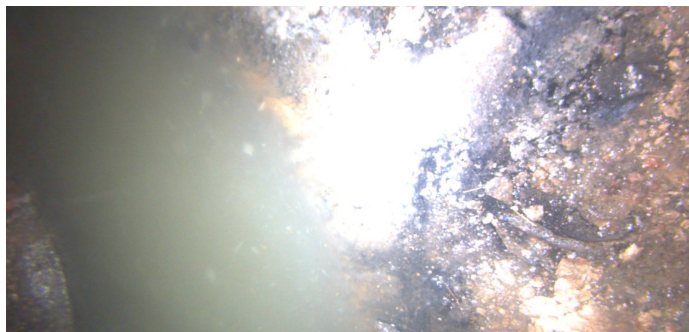
Code: **MGO**
Description: **General Observation**

Distance (ft): **15.6**
Structural Grade: **0**
O&M Grade: **0**
Clock Start/From:
Clock To:
1st Value:
2nd Value:
Value Percent:
Step: **NO**
Remarks: **END SURVEY**
