Manhole Inspection Report

Date:	04/26/2018	Weather:		Coding:	RZMACP
MH#:	M-607-011	Owner:	NA	Len. Surveyed:	15.3
P.O.#:		Surveyor:	Jen Costello	Rim to Invert:	16.1
Customer:		Cert. #:	U-907-5518	Wall Material:	Concrete (reinforced)

Street:	South of 10th St. 87' West of Lake P	Project:	Hobart, IN
City:	Hobart, IN	GPS Northing:	2904536.845
Location:		GPS Easting:	2904536.845
Drain Area:	Southwest	GPS Accuracy:	Sub-Meter
Cover Shape:	Circular	Evidence of Surcharge:	No
Cover Size:	22.5	Potential for Runoff:	None
Comments:

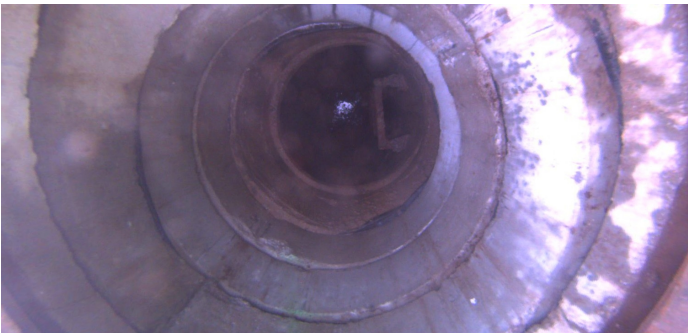
Code:

MGO

Description:

General Observation

Distance (ft):

.0

Structural Grade:

0

O&M Grade:

Remarks:

ACCESS MH

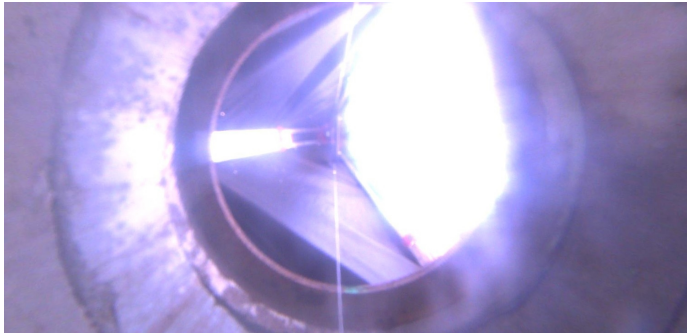
Code:	MGP
Description:	General Photo
Distance (ft):	2.0
Structural Grade:	0
O&M Grade:	0
Clock Start/From:	
Clock To:	
1st Value:	
2nd Value:	
Value Percent:	
Step:	NO
Remarks:	UNDERSIDE OF FRAME

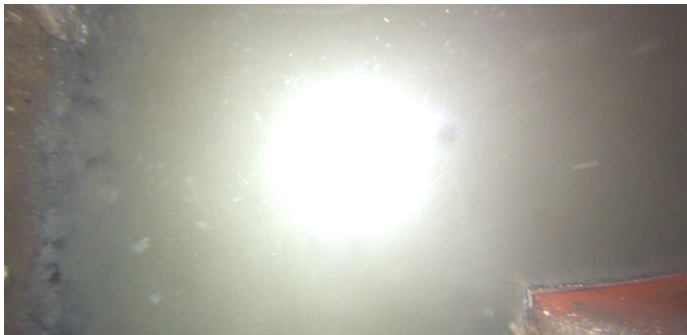
Code:	MGO
Description:	General Observation
Distance (ft):	15.3
Structural Grade:	0
O&M Grade:	0
Clock Start/From:	
Clock To:	
1st Value:	
2nd Value:	
Value Percent:	
Step:	NO
Remarks:	END SURVEY
