Manhole Inspection Report

Date:	09/24/2022	Weather:		Coding:	RZMACP
MH#:	M-607-012	Owner:	NA	Len. Surveyed:	14.9
P.O.#:		Surveyor:	Jen Costello	Rim to Invert:	16.4
Customer:		Cert. #:	U-907-5518	Wall Material:	Concrete (cast in place)

Street:	West of Lake Park Ave. 185' South of	Project:	Hobart, IN
City:	Hobart, IN	GPS Northing:	2284978.098
Location:	Local Rural Streets	GPS Easting:	2904553.537
Drain Area:	Southwest	GPS Accuracy:	Sub-Meter
Cover Shape:	Circular	Evidence of Surcharge:	Yes
Cover Size:	24.0	Potential for Runoff:	None
Comments:

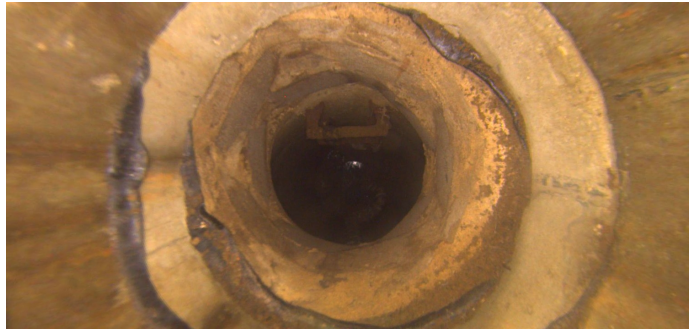
Code:	SAV
Description:	Surface Aggregate Visible
Distance (ft):	.0
Structural Grade:	3
O&M Grade:	0
Clock Start/From:	12
Clock To:	12
1st Value:	
2nd Value:	
Value Percent:	
Step:	NO
Remarks:

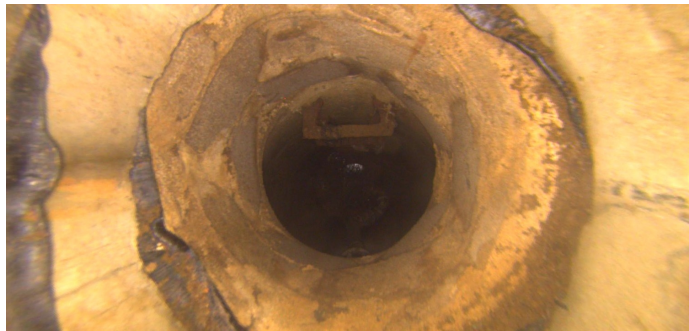
Code:	ISGT
Description:	Intruding Sealing Grout
Distance (ft):	.5
Structural Grade:	0
O&M Grade:	2
Clock Start/From:	6
Clock To:	12
1st Value:	
2nd Value:	
Value Percent:	5.000
Step:	NO
Remarks:

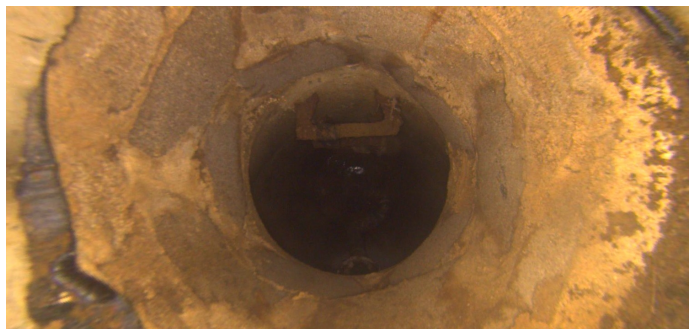
Code:	ISGT
Description:	Intruding Sealing Grout
Distance (ft):	.9
Structural Grade:	0
O&M Grade:	2
Clock Start/From:	12
Clock To:	12
1st Value:	
2nd Value:	
Value Percent:	5.000
Step:	NO
Remarks:

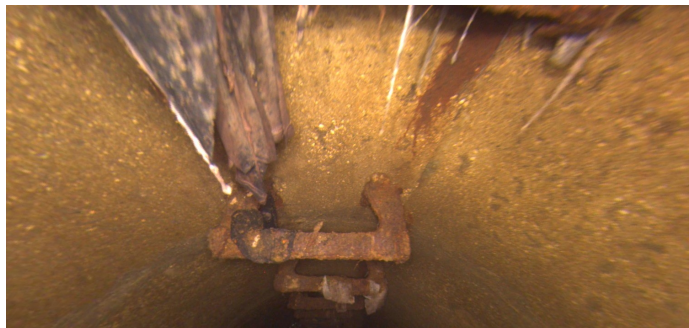
Code: **DAR**
Description: **Deposits Attached Ragging**

Distance (ft): **4.1**
Structural Grade: **0**
O&M Grade: **2**
Clock Start/From: **11**
Clock To: **1**
1st Value:
2nd Value:
Value Percent: **5.000**
Step: **YES**
Remarks:

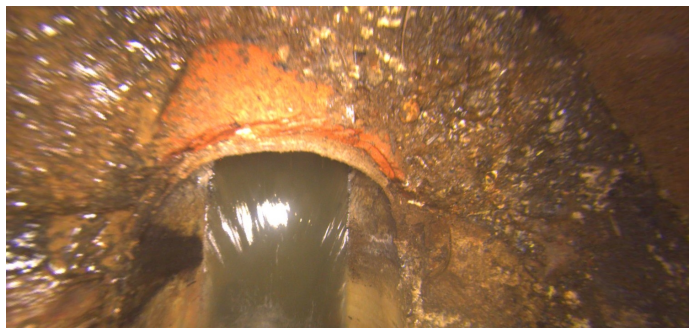
Code: **DSGV**
Description: **Deposits Settled Gravel**

Distance (ft): **14.1**
Structural Grade: **0**
O&M Grade: **2**
Clock Start/From: **12**
Clock To: **2**
1st Value:
2nd Value:
Value Percent: **5.000**
Step: **NO**
Remarks:

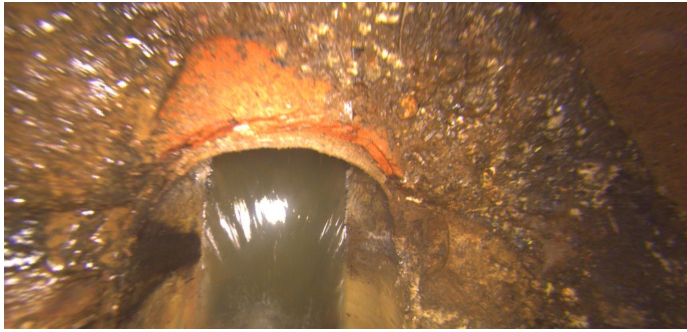
Code: **DAR**
Description: **Deposits Attached Ragging**

Distance (ft): **14.1**
Structural Grade: **0**
O&M Grade: **2**
Clock Start/From: **11**
Clock To: **1**
1st Value:
2nd Value:
Value Percent: **5.000**
Step: **NO**
Remarks:

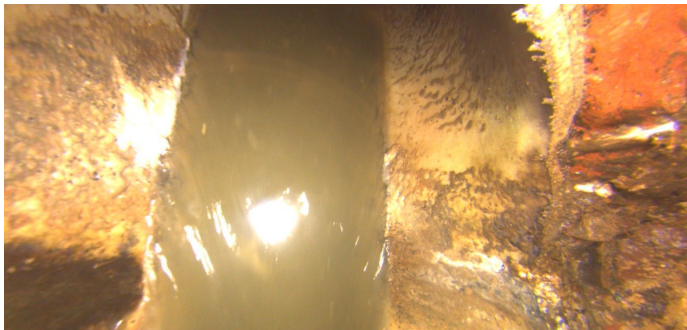
Code: **SAV**
Description: **Surface Aggregate Visible**

Distance (ft): **14.8**
Structural Grade: **3**
O&M Grade: **0**
Clock Start/From: **12**
Clock To: **12**
1st Value:
2nd Value:
Value Percent:
Step: **NO**
Remarks:
