Manhole Inspection Report

Date:	04/25/2018	Weather:		Coding:	RZMACP
MH#:	M-607-013	Owner:	NA	Len. Surveyed:	15.0
P.O.#:		Surveyor:	John Kuglmaier	Rim to Invert:	11.8
Customer:	8.7	Cert. #:	U-1215-07002349	Wall Material:	Concrete (reinforced)

Street:	Lake Park Ave. and 10th St. Middle E	Project:	Hobart, IN
City:	Hobart, IN	GPS Northing:	0.0
Location:		GPS Easting:	0.0
Drain Area:	Southwest	GPS Accuracy:	Nearest Meter
Cover Shape:	Circular	Evidence of Surcharge:	Yes
Cover Size:	22.5	Potential for Runoff:	None
Comments:

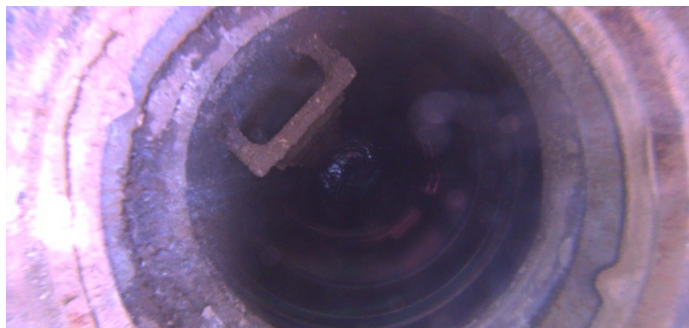
Code: **MGP**
Description: **General Photo**

Distance (ft): **.0**
Structural Grade: **0**
O&M Grade: **0**
Clock Start/From:
Clock To:
1st Value:
2nd Value:
Value Percent:
Step: **NO**
Remarks:

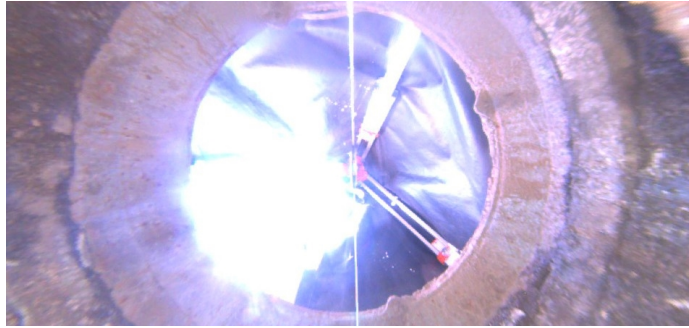
Code: **MGP**
Description: **General Photo**

Distance (ft): **2.7**
Structural Grade: **0**
O&M Grade: **0**
Clock Start/From:
Clock To:
1st Value:
2nd Value:
Value Percent:
Step: **NO**
Remarks:

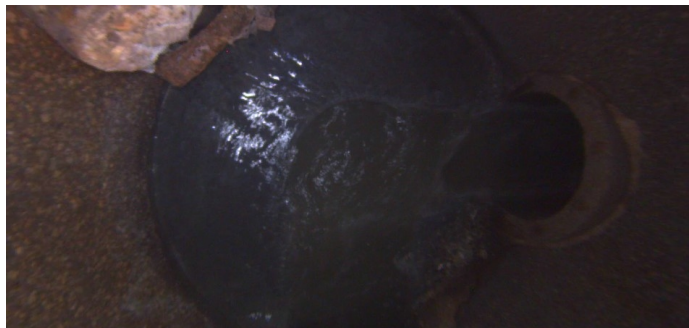
Code: **MGO**
Description: **General Observation**

Distance (ft): **12.3**
Structural Grade: **0**
O&M Grade: **0**
Clock Start/From:
Clock To:
1st Value:
2nd Value:
Value Percent:
Step: **NO**
Remarks: **Surcharge**

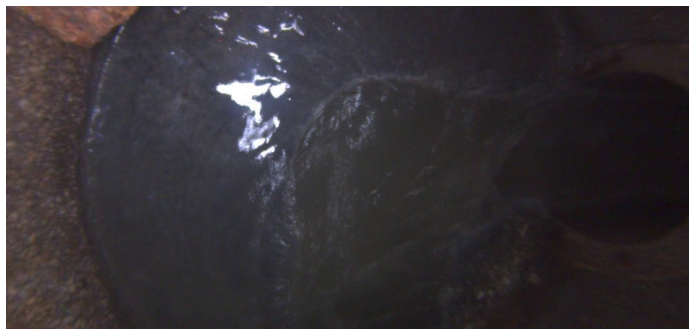
Code: **MGO**
Description: **General Observation**

Distance (ft): **13.5**
Structural Grade: **0**
O&M Grade: **0**
Clock Start/From:
Clock To:
1st Value:
2nd Value:
Value Percent:
Step: **NO**
Remarks: **Ins. Comp.**
