Manhole Inspection Report

Date:	04/25/2018	Weather:		Coding:	RZMACP
MH#:	M-607-015	Owner:	NA	Len. Surveyed:	12.7
P.O.#:		Surveyor:	John Kuglmaier	Rim to Invert:	13.5
Customer:	8.7	Cert. #:	U-1215-07002349	Wall Material:	Concrete (reinforced)

Street:	10th St. 298' West of Lake Park.	Project:	Hobart, IN
City:	Hobart, IN	GPS Northing:	0.0
Location:		GPS Easting:	0.0
Drain Area:	Southwest	GPS Accuracy:	Nearest Meter
Cover Shape:	Circular	Evidence of Surcharge:	No
Cover Size:	22.5	Potential for Runoff:	None
Comments:

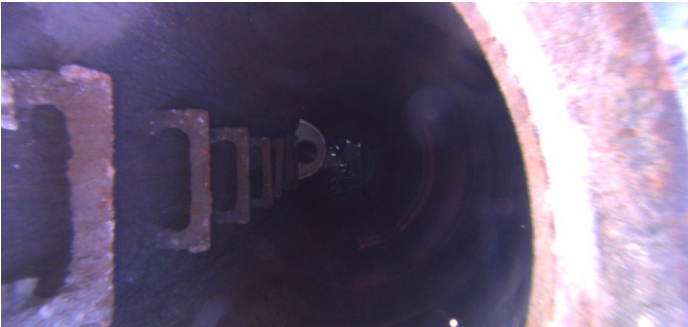
Code:

MGP

Description:

General Photo

Distance (ft):

.0

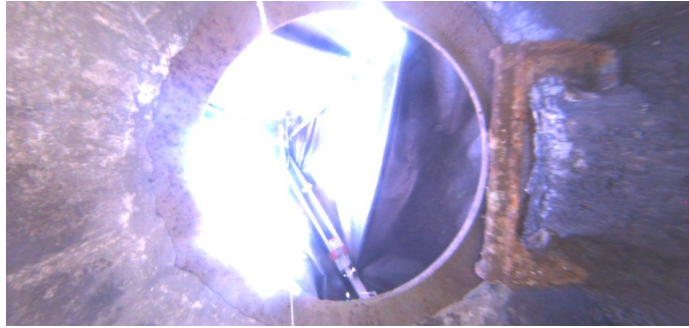
Code:	MGP
Description:	General Photo
Distance (ft):	2.5
Structural Grade:	0
O&M Grade:	0
Clock Start/From:	
Clock To:	
1st Value:	
2nd Value:	
Value Percent:	
Step:	NO
Remarks:

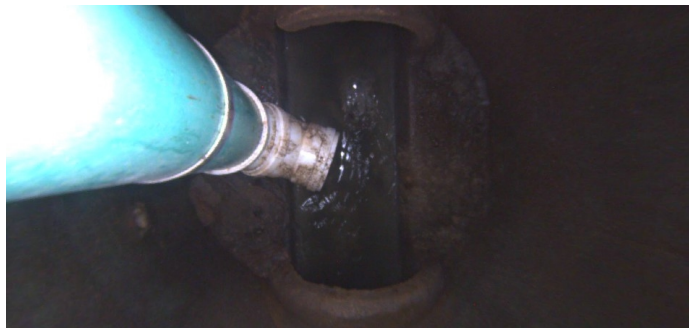
Code:	DAZ
Description:	Deposits Attached Other
Distance (ft):	10.2
Structural Grade:	0
O&M Grade:	2
Clock Start/From:	12
Clock To:	12
1st Value:	
2nd Value:	
Value Percent:	10.000
Step:	NO
Remarks:	Mixed materials

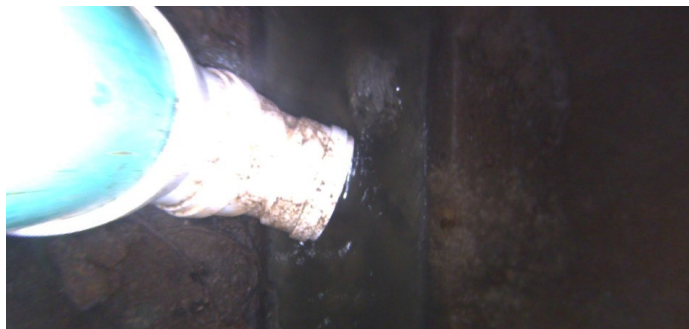
Code:	MGO
Description:	General Observation
Distance (ft):	11.7
Structural Grade:	0
O&M Grade:	0
Clock Start/From:	
Clock To:	
1st Value:	
2nd Value:	
Value Percent:	
Step:	NO
Remarks:	Ins. Comp.
