Manhole Inspection Report

Date:	04/25/2018	Weather:		Coding:	RZMACP
MH#:	M-607-016	Owner:	NA	Len. Surveyed:	8.7
P.O.#:		Surveyor:	John Kuglmaier	Rim to Invert:	8.7
Customer:	8.7	Cert. #:	U-1215-07002349	Wall Material:	Concrete (reinforced)

Street:	10th St. 727' East of Ash St.	Project:	Hobart, IN
City:	Hobart, IN	GPS Northing:	0.0
Location:		GPS Easting:	0.0
Drain Area:	Southwest	GPS Accuracy:	Nearest Meter
Cover Shape:	Circular	Evidence of Surcharge:	Yes
Cover Size:	22.5	Potential for Runoff:	None
Comments:

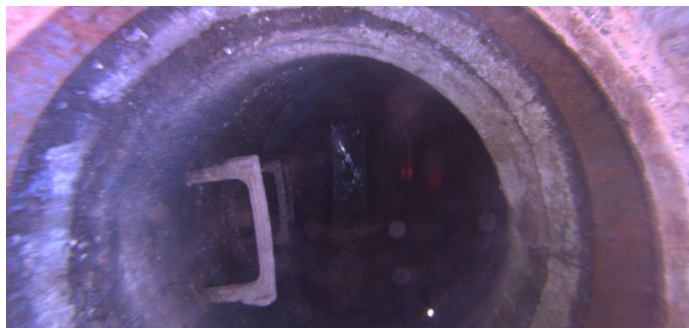
Code: **MGP**
Description: **General Photo**

Distance (ft): **.0**
Structural Grade: **0**
O&M Grade: **0**
Clock Start/From:
Clock To:
1st Value:
2nd Value:
Value Percent:
Step: **NO**
Remarks:

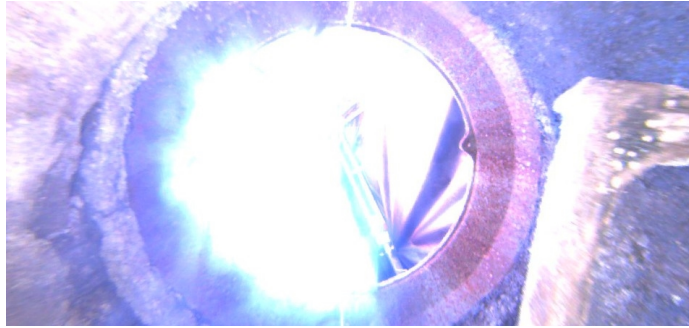
Code: **MGP**
Description: **General Photo**

Distance (ft): **2.7**
Structural Grade: **0**
O&M Grade: **0**
Clock Start/From:
Clock To:
1st Value:
2nd Value:
Value Percent:
Step: **NO**
Remarks:

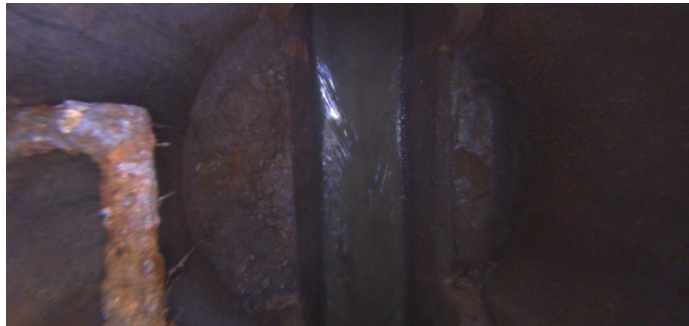
Code: **DSF**
Description: **Deposits Settled Fine**

Distance (ft): **5.9**
Structural Grade: **0**
O&M Grade: **2**
Clock Start/From: **12**
Clock To: **12**
1st Value:
2nd Value:
Value Percent: **10.000**
Step: **NO**
Remarks:

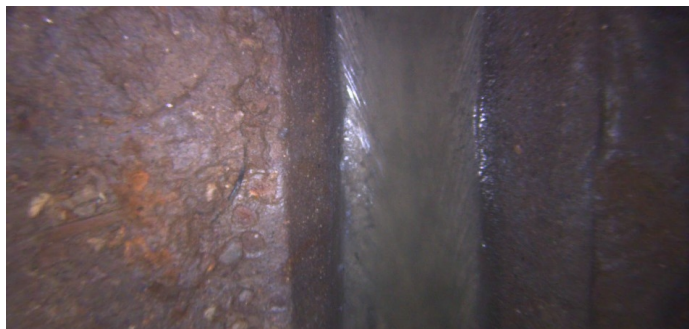
Code: **MGO**
Description: **General Observation**

Distance (ft): **7.6**
Structural Grade: **0**
O&M Grade: **0**
Clock Start/From:
Clock To:
1st Value:
2nd Value:
Value Percent:
Step: **NO**
Remarks: **Ins. Comp.**
