Manhole Inspection Report

Date:	04/25/2018	Weather:		Coding:	RZMACP
MH#:	M-607-017	Owner:	NA	Len. Surveyed:	12.1
P.O.#:		Surveyor:	John Kuglmaier	Rim to Invert:	11.8
Customer:	8.7	Cert. #:	U-1215-07002349	Wall Material:	Concrete (reinforced)

Street:	10th St. 306' East of Ash St.	Project:	Hobart, IN
City:	Hobart, IN	GPS Northing:	0.0
Location:		GPS Easting:	0.0
Drain Area:	Southwest	GPS Accuracy:	Nearest Meter
Cover Shape:	Circular	Evidence of Surcharge:	Yes
Cover Size:	22.5	Potential for Runoff:	None
Comments:

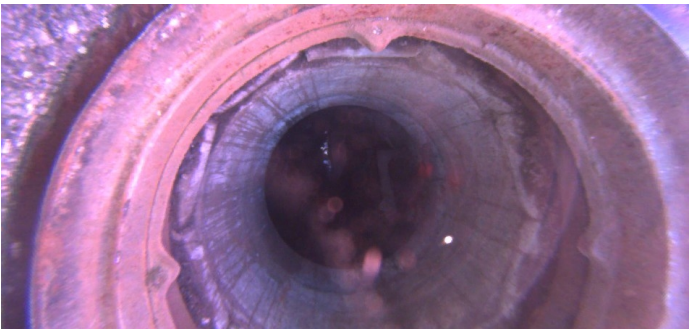
Code:

MGP

Description:

General Photo

Distance (ft):

.0

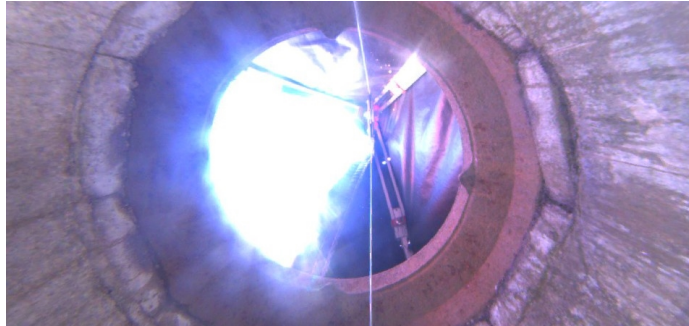
Code: **MGP**
Description: **General Photo**

Distance (ft): **3.0**
Structural Grade: **0**
O&M Grade: **0**
Clock Start/From:
Clock To:
1st Value:
2nd Value:
Value Percent:
Step: **NO**
Remarks:

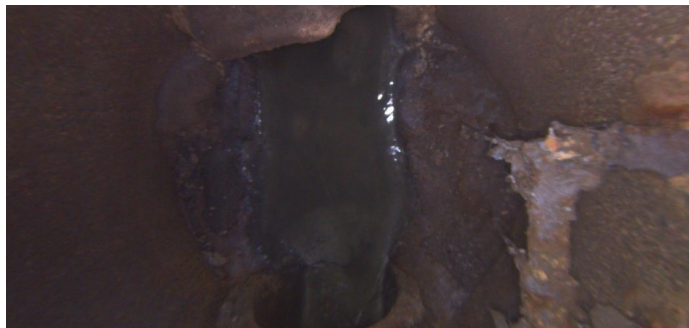
Code: **DAZ**
Description: **Deposits Attached Other**

Distance (ft): **9.5**
Structural Grade: **0**
O&M Grade: **3**
Clock Start/From: **12**
Clock To: **12**
1st Value:
2nd Value:
Value Percent: **15.000**
Step: **NO**
Remarks: **Mixed materials**

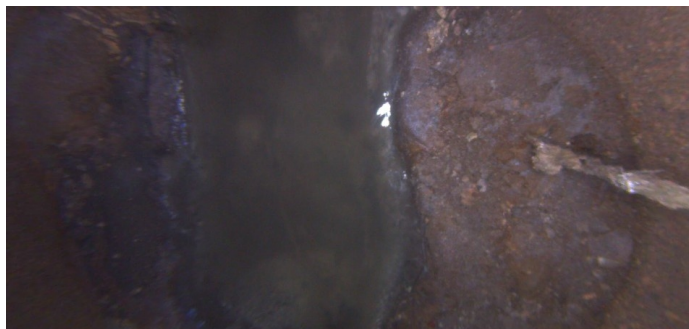
Code: **MGO**
Description: **General Observation**

Distance (ft): **10.9**
Structural Grade: **0**
O&M Grade: **0**
Clock Start/From:
Clock To:
1st Value:
2nd Value:
Value Percent:
Step: **NO**
Remarks: **Ins. Comp.**
