# Manhole Inspection Report

| MH#: | <b>M-607-018</b> | Owner: | <b>NA</b> | Len. Surveyed: | <b>12.4</b> |

| Street: | <b>10th St. 108' East of Ash St.</b> | Project: | <b>Hobart, IN</b> |

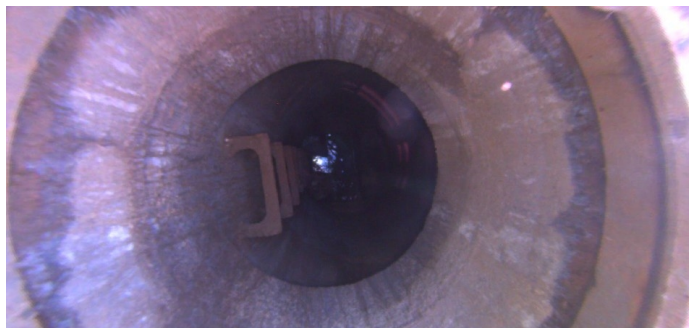
Code: **MGP**  
Description: **General Photo**

Distance (ft): **.0**  
Structural Grade: **0**  
O&M Grade: **0**  
Clock Start/From:  
Clock To:  
1st Value:  
2nd Value:  
Value Percent:  
Step: **NO**  
Remarks:

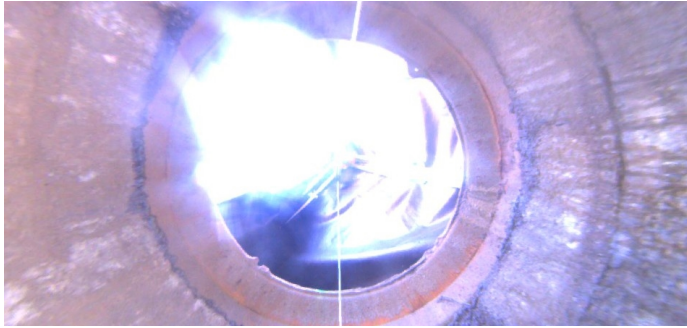
Code: **MGP**  
Description: **General Photo**

Distance (ft): **2.8**  
Structural Grade: **0**  
O&M Grade: **0**  
Clock Start/From:  
Clock To:  
1st Value:  
2nd Value:  
Value Percent:  
Step: **NO**  
Remarks:

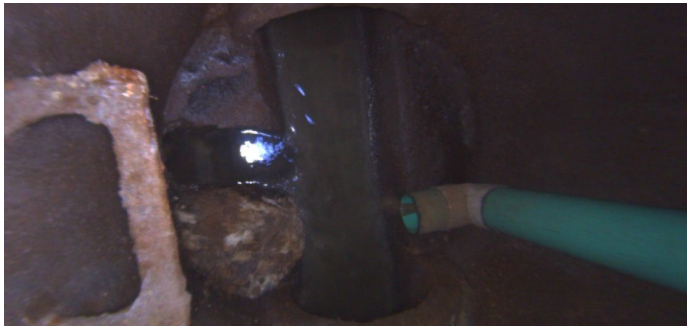
Code: **DAZ**  
Description: **Deposits Attached Other**

Distance (ft): **9.5**  
Structural Grade: **0**  
O&M Grade: **2**  
Clock Start/From: **7**  
Clock To: **9**  
1st Value:  
2nd Value:  
Value Percent: **5.000**  
Step: **NO**  
Remarks: **Mixed materials**

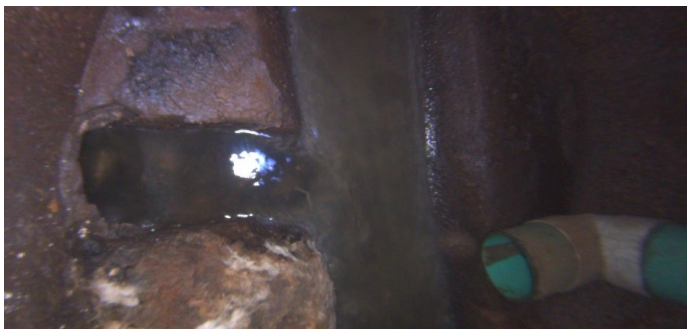
Code: **MGO**  
Description: **General Observation**

Distance (ft): **11.1**  
Structural Grade: **0**  
O&M Grade: **0**  
Clock Start/From:  
Clock To:  
1st Value:  
2nd Value:  
Value Percent:  
Step: **NO**  
Remarks: **Ins. Comp.**
