Manhole Inspection Report

Date:	04/25/2018	Weather:		Coding:	RZMACP
MH#:	M-607-021	Owner:	NA	Len. Surveyed:	5.6
P.O.#:		Surveyor:	John Kuglmaier	Rim to Invert:	5.4
Customer:	8.7	Cert. #:	U-1215-07002349	Wall Material:	Concrete (reinforced)

Street:	Pennsylvania St. and 10th St.	Project:	Hobart, IN
City:	Hobart, IN	GPS Northing:	0.0
Location:		GPS Easting:	0.0
Drain Area:	Southwest	GPS Accuracy:	Nearest Meter
Cover Shape:	Circular	Evidence of Surcharge:	Yes
Cover Size:	22.5	Potential for Runoff:	None
Comments:

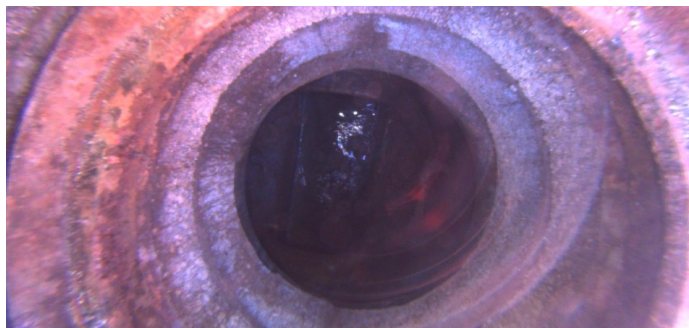
Code: **MGP**
Description: **General Photo**

Distance (ft): **.0**
Structural Grade: **0**
O&M Grade: **0**
Clock Start/From:
Clock To:
1st Value:
2nd Value:
Value Percent:
Step: **NO**
Remarks:

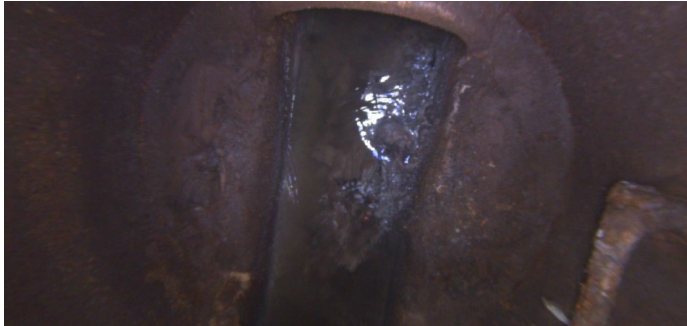
Code: **DSF**
Description: **Deposits Settled Fine**

Distance (ft): **2.9**
Structural Grade: **0**
O&M Grade: **2**
Clock Start/From: **12**
Clock To: **12**
1st Value:
2nd Value:
Value Percent: **10.000**
Step: **NO**
Remarks:

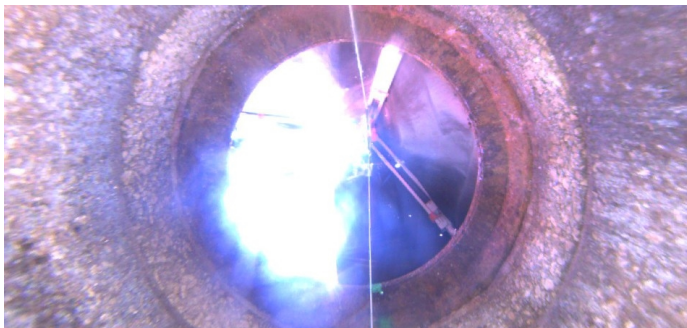
Code: **MGP**
Description: **General Photo**

Distance (ft): **3.1**
Structural Grade: **0**
O&M Grade: **0**
Clock Start/From:
Clock To:
1st Value:
2nd Value:
Value Percent:
Step: **NO**
Remarks:

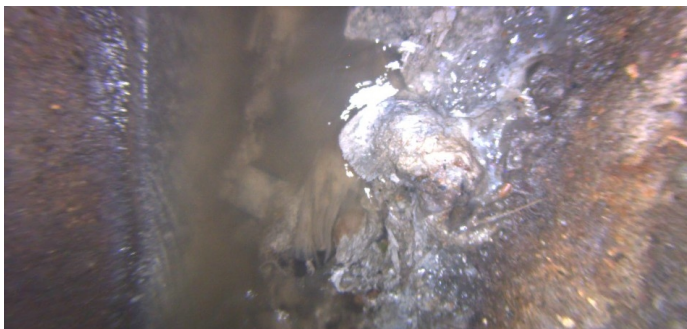
Code: **MGO**
Description: **General Observation**

Distance (ft): **5.0**
Structural Grade: **0**
O&M Grade: **0**
Clock Start/From:
Clock To:
1st Value:
2nd Value:
Value Percent:
Step: **NO**
Remarks: **Ins. Comp.**
