Manhole Inspection Report

Date:	04/25/2018	Weather:		Coding:	RZMACP
MH#:	M-607-021	Owner:	NA	Len. Surveyed:	10.4
P.O.#:		Surveyor:	John Kuglmaier	Rim to Invert:	12.1
Customer:	8.7	Cert. #:	U-1215-07002349	Wall Material:	Concrete (reinforced)

Street:	Pennsylvania St. and 10th St.	Project:	Hobart, IN
City:	Hobart, IN	GPS Northing:	0.0
Location:		GPS Easting:	0.0
Drain Area:	Southwest	GPS Accuracy:	Nearest Meter
Cover Shape:	Circular	Evidence of Surcharge:	Yes
Cover Size:	22.5	Potential for Runoff:	None
Comments:

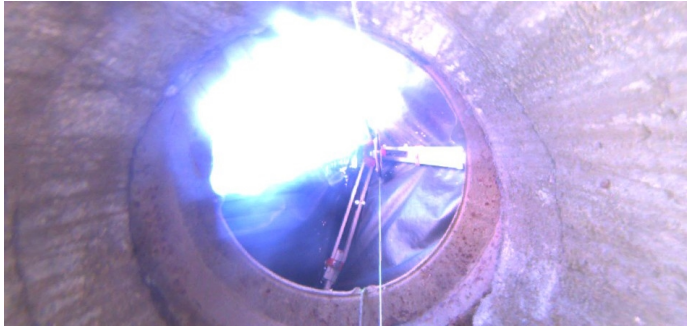
Code: **MGP**
Description: **General Photo**

Distance (ft): **1.0**
Structural Grade: **0**
O&M Grade: **0**
Clock Start/From:
Clock To:
1st Value:
2nd Value:
Value Percent:
Step: **NO**
Remarks:

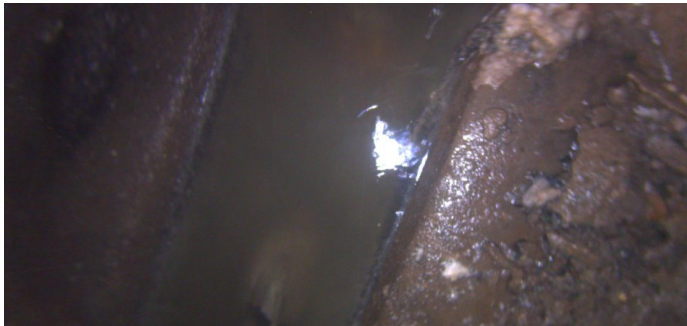
Code: **MGO**
Description: **General Observation**

Distance (ft): **9.2**
Structural Grade: **0**
O&M Grade: **0**
Clock Start/From:
Clock To:
1st Value:
2nd Value:
Value Percent:
Step: **NO**
Remarks: **Ins. Comp.**
