Manhole Inspection Report

Date:	04/25/2018	Weather:		Coding:	RZMACP
MH#:	M-607-022	Owner:	NA	Len. Surveyed:	9.5
P.O.#:		Surveyor:	John Kuglmaier	Rim to Invert:	9.3
Customer:	8.7	Cert. #:	U-1215-07002349	Wall Material:	Concrete (reinforced)

Street:	10th St. 336' East of Wisconsin St.	Project:	Hobart, IN
City:	Hobart, IN	GPS Northing:	0.0
Location:		GPS Easting:	0.0
Drain Area:	Southwest	GPS Accuracy:	Nearest Meter
Cover Shape:	Circular	Evidence of Surcharge:	Yes
Cover Size:	22.5	Potential for Runoff:	None
Comments:

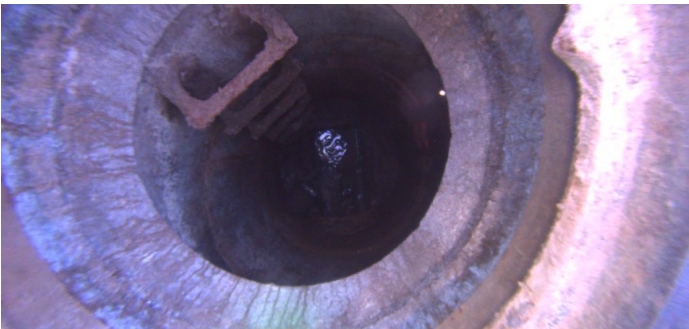
Code: **MGP**
 Description: **General Photo**

Distance (ft): **.0**
 Structural Grade: **0**
 O&M Grade: **0**
 Clock Start/From:
 Clock To:
 1st Value:
 2nd Value:
 Value Percent:
 Step: **NO**
 Remarks:

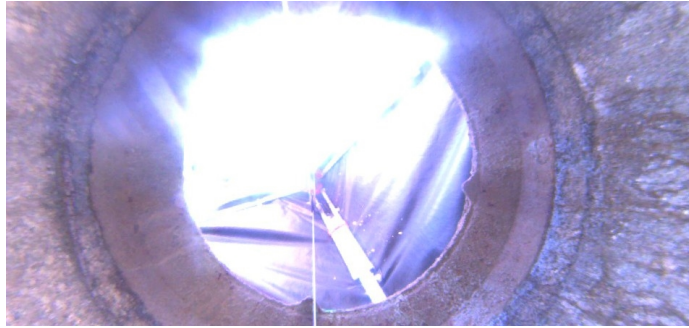
Code: **MGP**
Description: **General Photo**

Distance (ft): **2.8**
Structural Grade: **0**
O&M Grade: **0**
Clock Start/From:
Clock To:
1st Value:
2nd Value:
Value Percent:
Step: **NO**
Remarks:

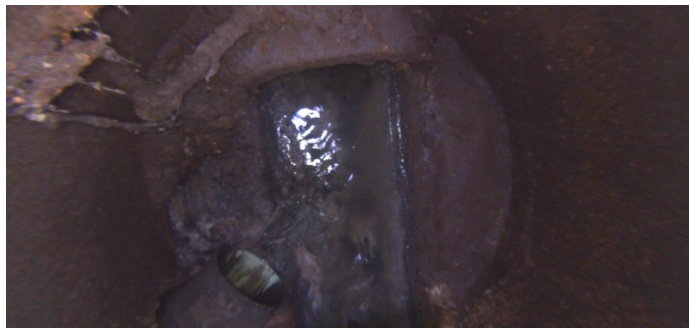
Code: **DSF**
Description: **Deposits Settled Fine**

Distance (ft): **6.7**
Structural Grade: **0**
O&M Grade: **3**
Clock Start/From: **12**
Clock To: **12**
1st Value:
2nd Value:
Value Percent: **15.000**
Step: **NO**
Remarks:

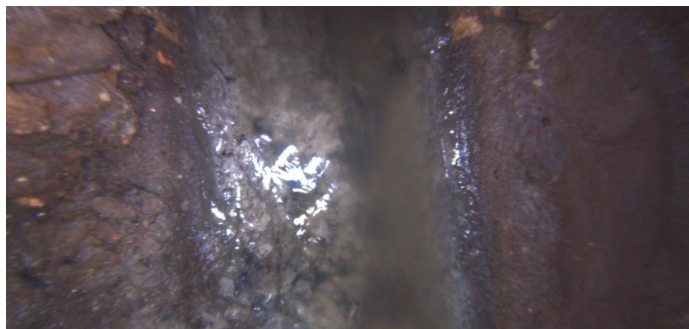
Code: **MGO**
Description: **General Observation**

Distance (ft): **8.7**
Structural Grade: **0**
O&M Grade: **0**
Clock Start/From:
Clock To:
1st Value:
2nd Value:
Value Percent:
Step: **NO**
Remarks: **Ins. Comp.**
