Manhole Inspection Report

Date:	04/06/2018	Weather:		Coding:	RZMACP
MH#:	M-607-024	Owner:	NA	Len. Surveyed:	11.5
P.O.#:		Surveyor:	John Kuglmaier	Rim to Invert:	12.8
Customer:		Cert. #:	U-1215-07002349	Wall Material:	Concrete (reinforced)

Street:	Laura Ln. 365' West of Lake Park Av	Project:	Hobart, IN
City:	Hobart, IN	GPS Northing:	0.0
Location:		GPS Easting:	0.0
Drain Area:	Southwest	GPS Accuracy:	Nearest Meter
Cover Shape:	Circular	Evidence of Surcharge:	Yes
Cover Size:	22.5	Potential for Runoff:	None
Comments:

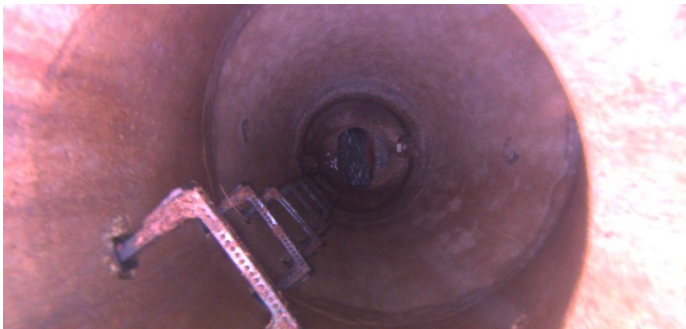
Code:	MGP
Description:	General Photo

Distance (ft):	.0
Structural Grade:	0
O&M Grade:	0
Clock Start/From:	
Clock To:	
1st Value:	
2nd Value:	
Value Percent:	
Step:	NO
Remarks:

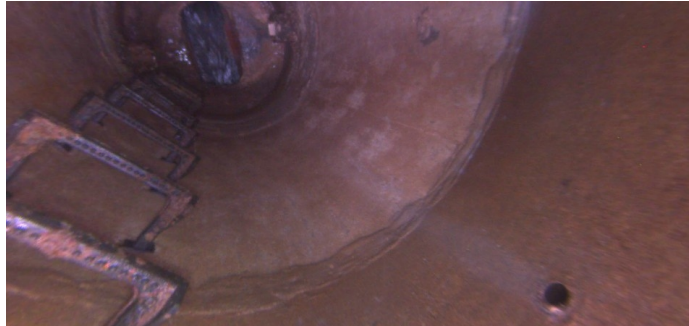
Code: **IS**
Description: **Infil Stain**

Distance (ft): **1.4**
Structural Grade: **0**
O&M Grade: **0**
Clock Start/From: **5**
Clock To:
1st Value:
2nd Value:
Value Percent:
Step: **NO**
Remarks:

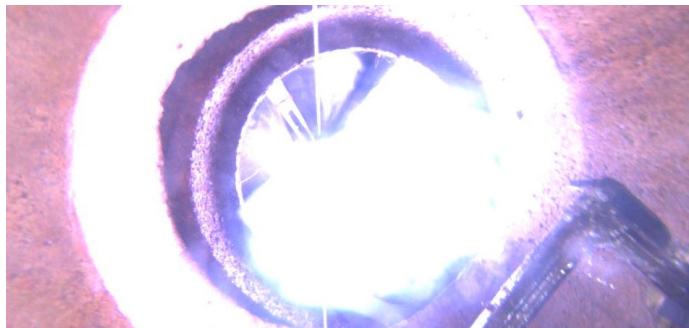
Code: **MGP**
Description: **General Photo**

Distance (ft): **2.6**
Structural Grade: **0**
O&M Grade: **0**
Clock Start/From:
Clock To:
1st Value:
2nd Value:
Value Percent:
Step: **NO**
Remarks:

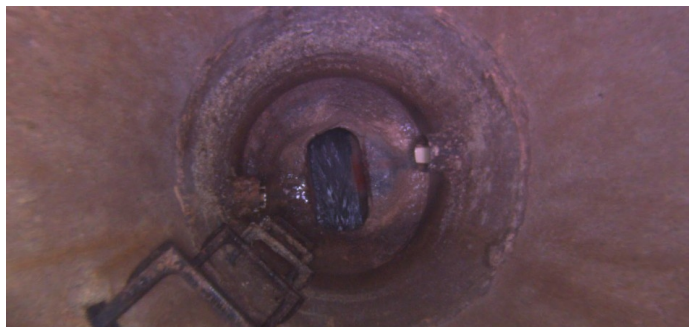
Code: **DAGS**
Description: **Deposits Attached Grease**

Distance (ft): **5.1**
Structural Grade: **0**
O&M Grade: **2**
Clock Start/From: **12**
Clock To: **12**
1st Value:
2nd Value:
Value Percent: **10.000**
Step: **NO**
Remarks:

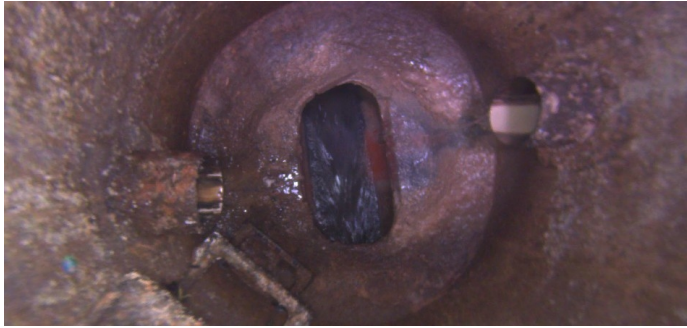
Code:	DAZ
Description:	Deposits Attached Other
Distance (ft):	7.4
Structural Grade:	0
O&M Grade:	2
Clock Start/From:	12
Clock To:	12
1st Value:	
2nd Value:	
Value Percent:	10.000
Step:	NO
Remarks:	Mixed materials

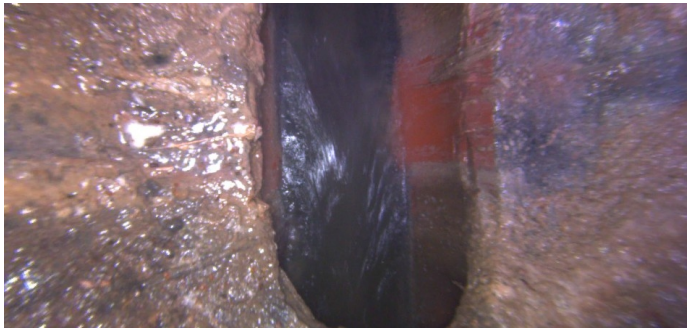
Code:	MGO
Description:	General Observation
Distance (ft):	10.3
Structural Grade:	0
O&M Grade:	0
Clock Start/From:	
Clock To:	
1st Value:	
2nd Value:	
Value Percent:	
Step:	NO
Remarks:	Ins. Comp.
