Manhole Inspection Report

Date:	04/09/2018	Weather:		Coding:	RZMACP
MH#:	M-607-025	Owner:	NA	Len. Surveyed:	5.8
P.O.#:		Surveyor:	John Kuglmaier	Rim to Invert:	6.5
Customer:		Cert. #:	U-1215-07002349	Wall Material:	Concrete (reinforced)

Street:	Polly Ln. East Cul De Sac.	Project:	Hobart, IN
City:	Hobart, IN	GPS Northing:	2904435.032
Location:		GPS Easting:	2904435.032
Drain Area:	Southwest	GPS Accuracy:	Sub-Meter
Cover Shape:	Circular	Evidence of Surcharge:	No
Cover Size:	22.5	Potential for Runoff:	None
Comments:

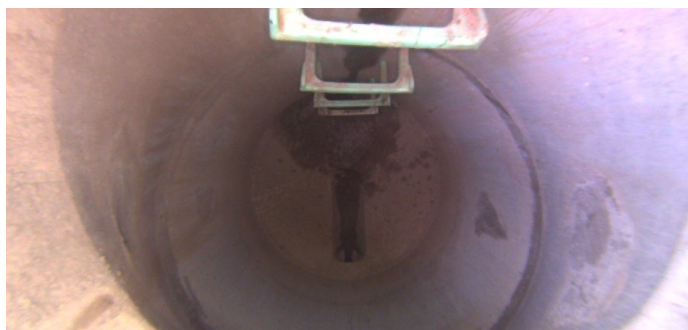
Code: **MGP**
Description: **General Photo**

Distance (ft): **.0**
Structural Grade: **0**
O&M Grade: **0**
Clock Start/From:
Clock To:
1st Value:
2nd Value:
Value Percent:
Step: **NO**
Remarks:

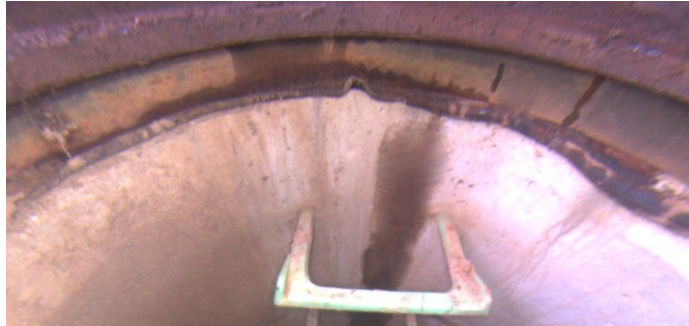
Code: **IS**
Description: **Infil Stain**

Distance (ft): **.0**
Structural Grade: **0**
O&M Grade: **0**
Clock Start/From: **1**
Clock To:
1st Value:
2nd Value:
Value Percent:
Step: **NO**
Remarks:

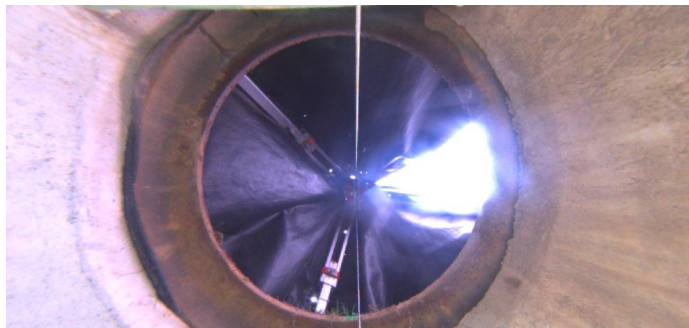
Code: **MGP**
Description: **General Photo**

Distance (ft): **2.3**
Structural Grade: **0**
O&M Grade: **0**
Clock Start/From:
Clock To:
1st Value:
2nd Value:
Value Percent:
Step: **NO**
Remarks:

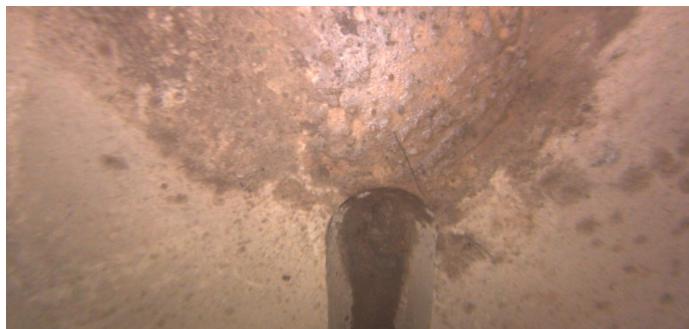
Code: **MGO**
Description: **General Observation**

Distance (ft): **4.7**
Structural Grade: **0**
O&M Grade: **0**
Clock Start/From:
Clock To:
1st Value:
2nd Value:
Value Percent:
Step: **NO**
Remarks: **Ins. Comp.**
