Manhole Inspection Report

Date:	04/09/2018	Weather:		Coding:	RZMACP
MH#:	M-607-026	Owner:	NA	Len. Surveyed:	7.2
P.O.#:		Surveyor:	John Kuglmaier	Rim to Invert:	7.7
Customer:		Cert. #:	U-1215-07002349	Wall Material:	Concrete (reinforced)

Street:	Polly Ln. 3rd Manhole From West Cu	Project:	Hobart, IN
City:	Hobart, IN	GPS Northing:	2904026.122
Location:		GPS Easting:	2904026.122
Drain Area:	Southwest	GPS Accuracy:	Sub-Meter
Cover Shape:	Circular	Evidence of Surcharge:	No
Cover Size:	22.5	Potential for Runoff:	None
Comments:

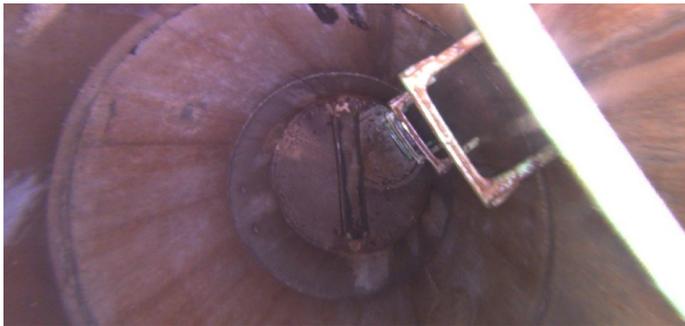
Code: **MGP**
Description: **General Photo**

Distance (ft): **.0**
Structural Grade: **0**
O&M Grade: **0**
Clock Start/From:
Clock To:
1st Value:
2nd Value:
Value Percent:
Step: **NO**
Remarks:

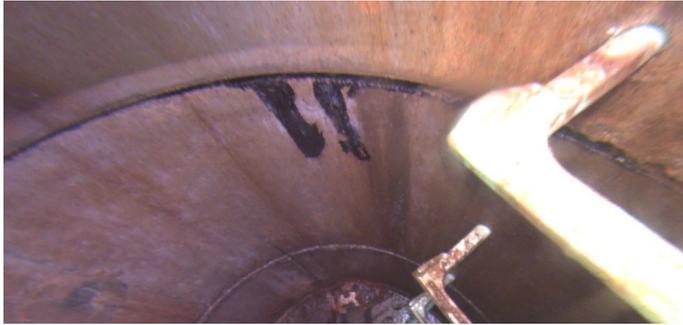
Code: **IS**
Description: **Infil Stain**

Distance (ft): **1.4**
Structural Grade: **0**
O&M Grade: **0**
Clock Start/From: **1**
Clock To:
1st Value:
2nd Value:
Value Percent:
Step: **NO**
Remarks:

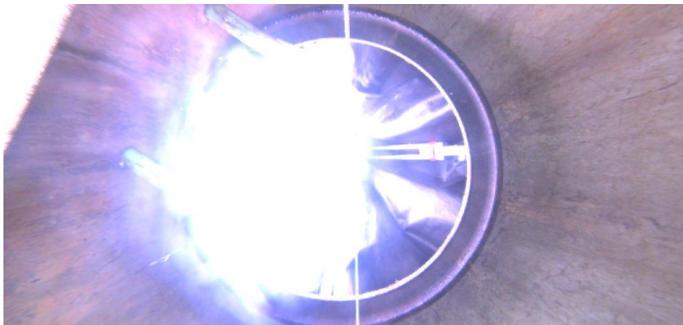
Code: **MGP**
Description: **General Photo**

Distance (ft): **2.1**
Structural Grade: **0**
O&M Grade: **0**
Clock Start/From:
Clock To:
1st Value:
2nd Value:
Value Percent:
Step: **NO**
Remarks:

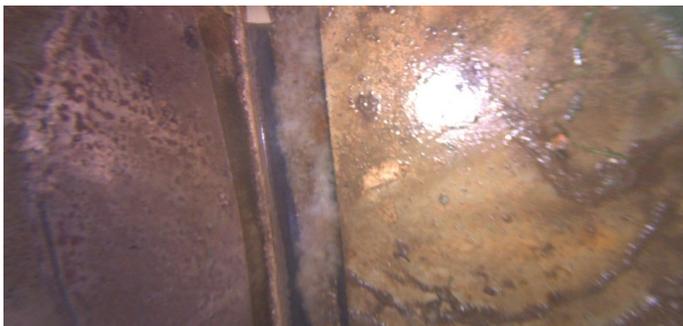
Code: **MGO**
Description: **General Observation**

Distance (ft): **5.8**
Structural Grade: **0**
O&M Grade: **0**
Clock Start/From:
Clock To:
1st Value:
2nd Value:
Value Percent:
Step: **NO**
Remarks: **Ins. Comp.**
