# Manhole Inspection Report

Date:	<b>04/06/2018</b>	Weather:		Coding:	<b>RZMACP</b>
MH#:	<b>M-607-028</b>	Owner:	<b>NA</b>	Len. Surveyed:	<b>6.5</b>
P.O.#:		Surveyor:	<b>John Kuglmaier</b>	Rim to Invert:	<b>6.9</b>
Customer:		Cert. #:	<b>U-1215-07002349</b>	Wall Material:	<b>Concrete (reinforced)</b>

Street:	<b>Polly Ln. the West End.</b>	Project:	<b>Hobart, IN</b>
City:	<b>Hobart, IN</b>	GPS Northing:	<b>0.0</b>
Location:		GPS Easting:	<b>0.0</b>
Drain Area:	<b>Southwest</b>	GPS Accuracy:	<b>Nearest Meter</b>
Cover Shape:	<b>Circular</b>	Evidence of Surcharge:	<b>No</b>
Cover Size:	<b>22.5</b>	Potential for Runoff:	<b>None</b>
Comments:

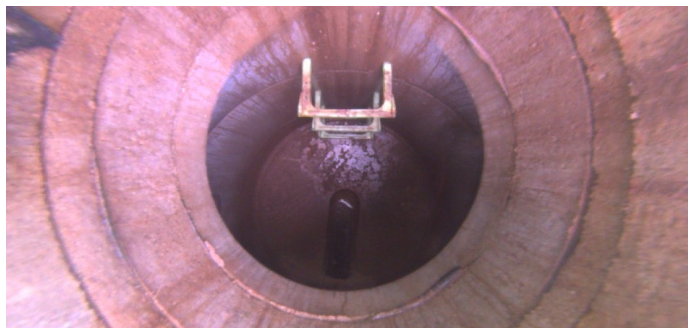
Code: **MGP**  
Description: **General Photo**

Distance (ft): **.0**  
Structural Grade: **0**  
O&M Grade: **0**  
Clock Start/From:  
Clock To:  
1st Value:  
2nd Value:  
Value Percent:  
Step: **NO**  
Remarks:

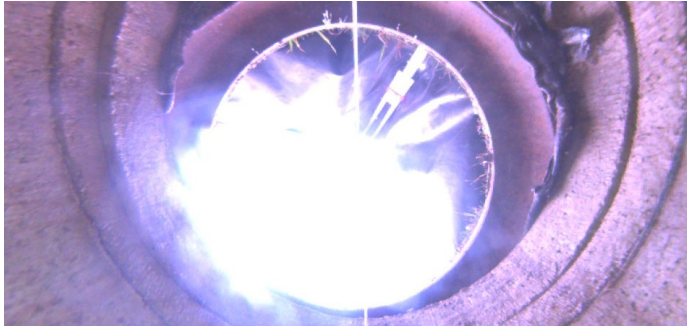
Code: **MGP**  
Description: **General Photo**

Distance (ft): **2.2**  
Structural Grade: **0**  
O&M Grade: **0**  
Clock Start/From:  
Clock To:  
1st Value:  
2nd Value:  
Value Percent:  
Step: **NO**  
Remarks:

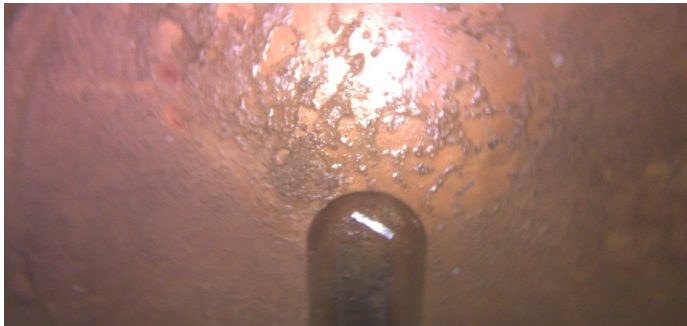
Code: **MGO**  
Description: **General Observation**

Distance (ft): **5.1**  
Structural Grade: **0**  
O&M Grade: **0**  
Clock Start/From:  
Clock To:  
1st Value:  
2nd Value:  
Value Percent:  
Step: **NO**  
Remarks: **Ins. Comp.**
