Manhole Inspection Report

Date:	04/06/2018	Weather:		Coding:	RZMACP
MH#:	M-607-030	Owner:	NA	Len. Surveyed:	9.1
P.O.#:		Surveyor:	John Kuglmaier	Rim to Invert:	9.7
Customer:		Cert. #:	U-1215-07002349	Wall Material:	Concrete (reinforced)

Street:	Laura Ln. 162' East of Laura Ct.	Project:	Hobart, IN
City:	Hobart, IN	GPS Northing:	0.0
Location:		GPS Easting:	0.0
Drain Area:	Southwest	GPS Accuracy:	Nearest Meter
Cover Shape:	Circular	Evidence of Surcharge:	No
Cover Size:	22.5	Potential for Runoff:	None
Comments:

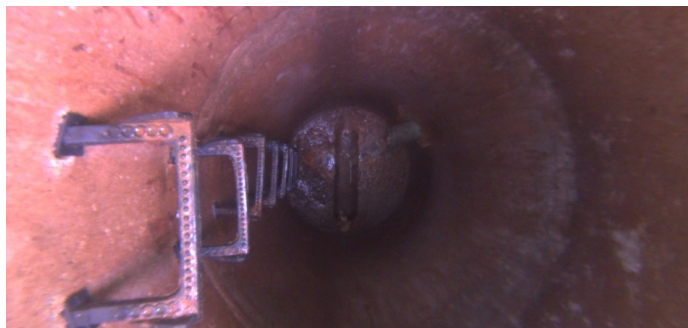
Code: **MGP**
Description: **General Photo**

Distance (ft): **.0**
Structural Grade: **0**
O&M Grade: **0**
Clock Start/From:
Clock To:
1st Value:
2nd Value:
Value Percent:
Step: **NO**
Remarks:

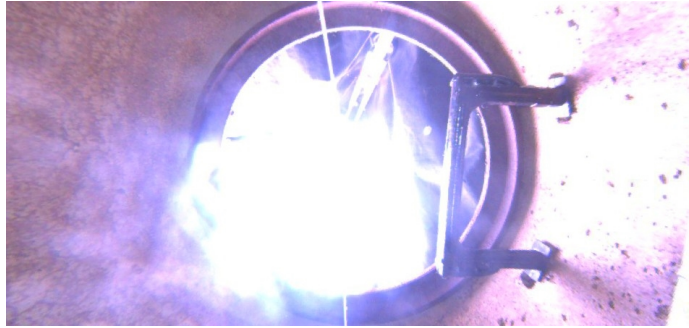
Code: **MGP**
Description: **General Photo**

Distance (ft): **2.1**
Structural Grade: **0**
O&M Grade: **0**
Clock Start/From:
Clock To:
1st Value:
2nd Value:
Value Percent:
Step: **NO**
Remarks:

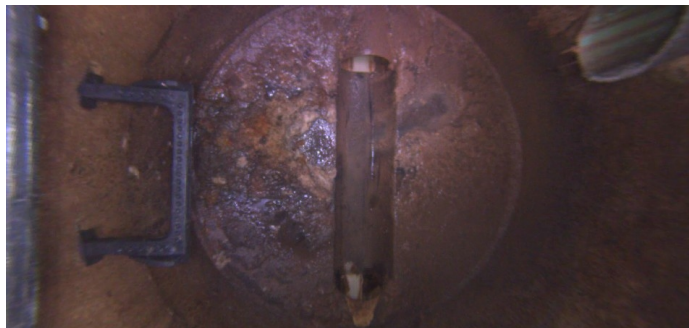
Code: **DAZ**
Description: **Deposits Attached Other**

Distance (ft): **6.1**
Structural Grade: **0**
O&M Grade: **2**
Clock Start/From: **12**
Clock To: **12**
1st Value:
2nd Value:
Value Percent: **5.000**
Step: **NO**
Remarks: **Mixed materials**

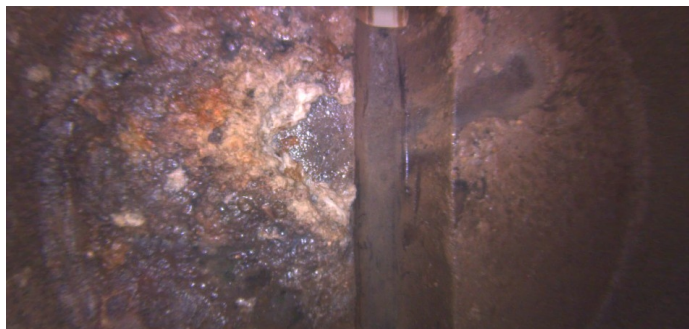
Code: **MGO**
Description: **General Observation**

Distance (ft): **7.5**
Structural Grade: **0**
O&M Grade: **0**
Clock Start/From:
Clock To:
1st Value:
2nd Value:
Value Percent:
Step: **NO**
Remarks: **Ins. Comp.**
