Manhole Inspection Report

Date:	04/06/2018	Weather:		Coding:	RZMACP
MH#:	M-607-031	Owner:	NA	Len. Surveyed:	5.4
P.O.#:		Surveyor:	John Kuglmaier	Rim to Invert:	6.1
Customer:		Cert. #:	U-1215-07002349	Wall Material:	Concrete (reinforced)

Street:	Laura Ct. and Laura Ln. Slightly to th	Project:	Hobart, IN
City:	Hobart, IN	GPS Northing:	0.0
Location:		GPS Easting:	0.0
Drain Area:	Southwest	GPS Accuracy:	Nearest Meter
Cover Shape:	Circular	Evidence of Surcharge:	No
Cover Size:	22.5	Potential for Runoff:	None
Comments:

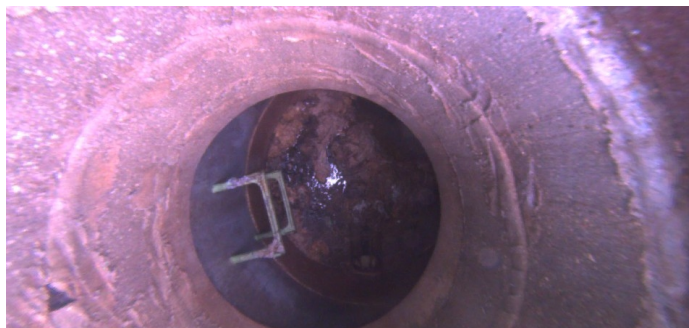
Code: **MGP**
Description: **General Photo**

Distance (ft): **.0**
Structural Grade: **0**
O&M Grade: **0**
Clock Start/From:
Clock To:
1st Value:
2nd Value:
Value Percent:
Step: **NO**
Remarks:

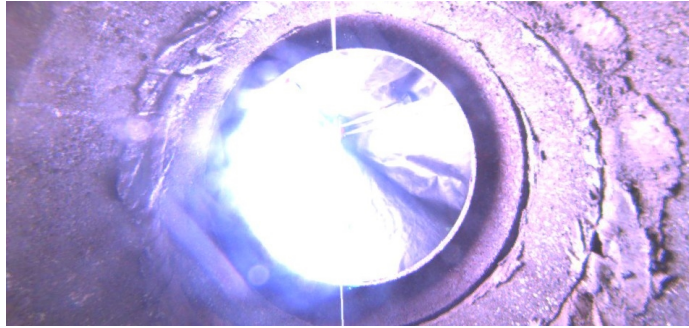
Code: **MGP**
Description: **General Photo**

Distance (ft): **2.5**
Structural Grade: **0**
O&M Grade: **0**
Clock Start/From:
Clock To:
1st Value:
2nd Value:
Value Percent:
Step: **NO**
Remarks:

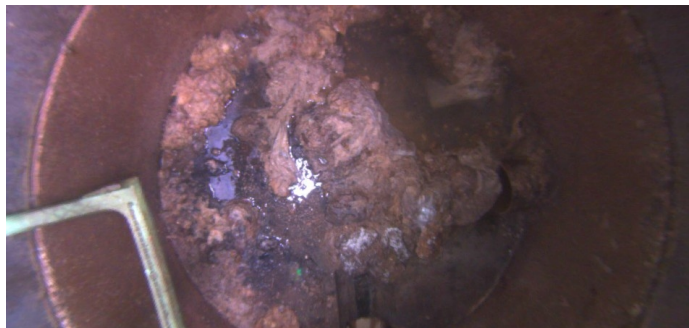
Code: **DAZ**
Description: **Deposits Attached Other**

Distance (ft): **2.8**
Structural Grade: **0**
O&M Grade: **3**
Clock Start/From: **12**
Clock To: **12**
1st Value:
2nd Value:
Value Percent: **15.000**
Step: **NO**
Remarks: **Mixed materials**

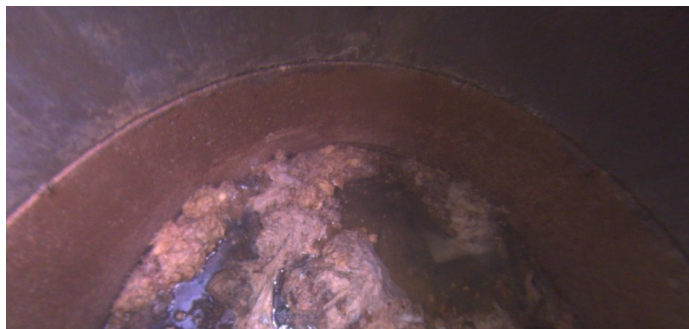
Code: **IS**
Description: **Infil Stain**

Distance (ft): **3.0**
Structural Grade: **0**
O&M Grade: **0**
Clock Start/From: **12**
Clock To: **12**
1st Value:
2nd Value:
Value Percent:
Step: **NO**
Remarks:

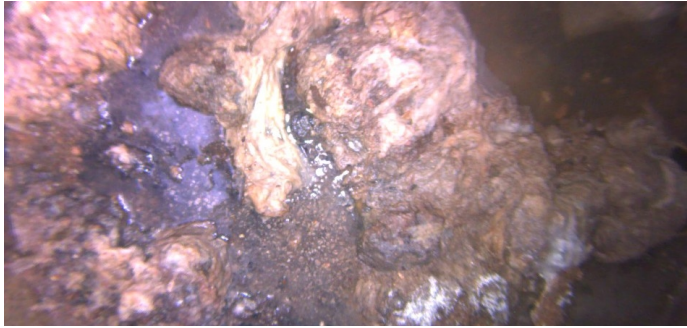
Code:	MGO
Description:	General Observation
Distance (ft):	4.4
Structural Grade:	0
O&M Grade:	0
Clock Start/From:	
Clock To:	
1st Value:	
2nd Value:	
Value Percent:	
Step:	NO
Remarks:	Ins. Comp.
