Manhole Inspection Report

Date:	04/25/2018	Weather:		Coding:	RZMACP
MH#:	M-607-032	Owner:	NA	Len. Surveyed:	4.8
P.O.#:		Surveyor:	John Kuglmaier	Rim to Invert:	4.4
Customer:	8.7	Cert. #:	U-1215-07002349	Wall Material:	Concrete (reinforced)

Street:	Laura Ct. the North End.	Project:	Hobart, IN
City:	Hobart, IN	GPS Northing:	0.0
Location:		GPS Easting:	0.0
Drain Area:	Southwest	GPS Accuracy:	Nearest Meter
Cover Shape:	Circular	Evidence of Surcharge:	No
Cover Size:	22.5	Potential for Runoff:	None
Comments:

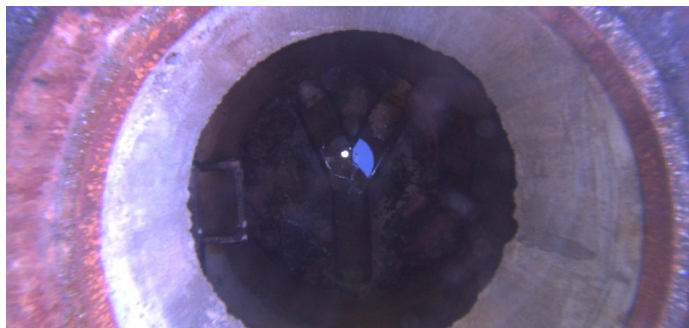
Code: **MGP**
Description: **General Photo**

Distance (ft): **.0**
Structural Grade: **0**
O&M Grade: **0**
Clock Start/From:
Clock To:
1st Value:
2nd Value:
Value Percent:
Step: **NO**
Remarks:

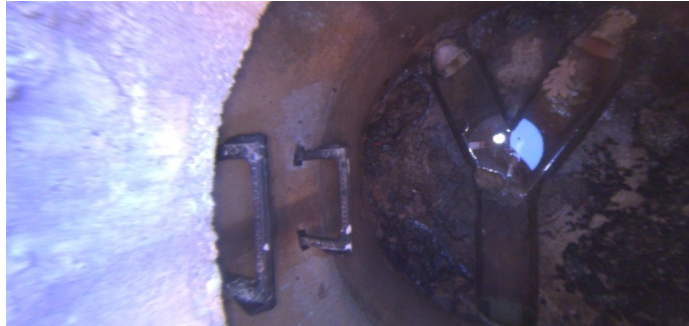
Code: **IS**
Description: **Infil Stain**

Distance (ft): **1.0**
Structural Grade: **0**
O&M Grade: **0**
Clock Start/From: **8**
Clock To:
1st Value:
2nd Value:
Value Percent:
Step: **NO**
Remarks:

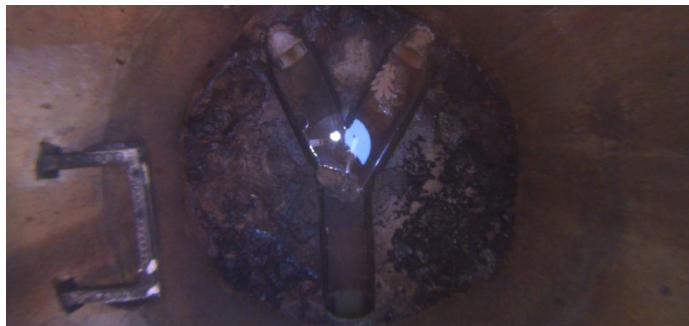
Code: **DAZ**
Description: **Deposits Attached Other**

Distance (ft): **1.5**
Structural Grade: **0**
O&M Grade: **2**
Clock Start/From: **12**
Clock To: **12**
1st Value:
2nd Value:
Value Percent: **10.000**
Step: **NO**
Remarks: **Mixed materials**

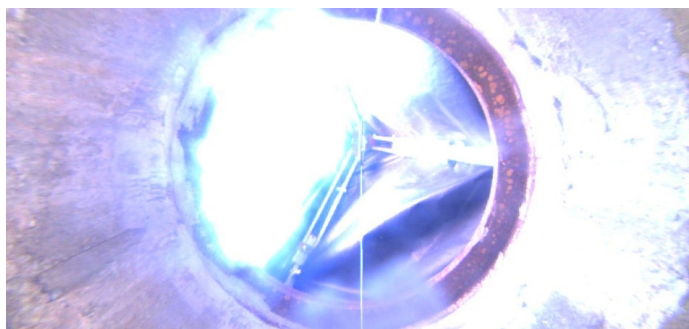
Code: **MGP**
Description: **General Photo**

Distance (ft): **2.8**
Structural Grade: **0**
O&M Grade: **0**
Clock Start/From:
Clock To:
1st Value:
2nd Value:
Value Percent:
Step: **NO**
Remarks:

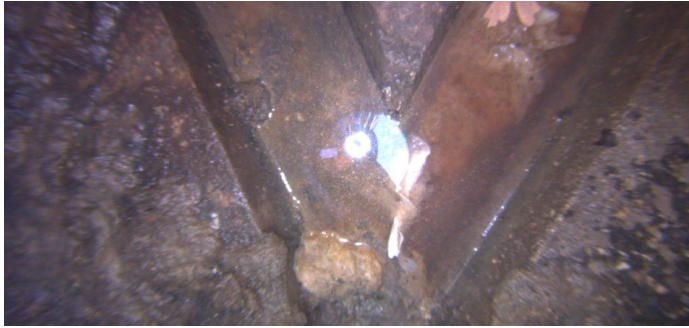
Code:	MGO
Description:	General Observation
Distance (ft):	4.2
Structural Grade:	0
O&M Grade:	0
Clock Start/From:	
Clock To:	
1st Value:	
2nd Value:	
Value Percent:	
Step:	NO
Remarks:	Ins. Comp.
